Transport Accident  
Investigation  
Commission

# **Final report**

***Rail inquiry RO-2021-104***  
***Passenger train 6205***  
***Train derailment***  
***Kāpiti***  
***17 August 2021***

**October 2024**

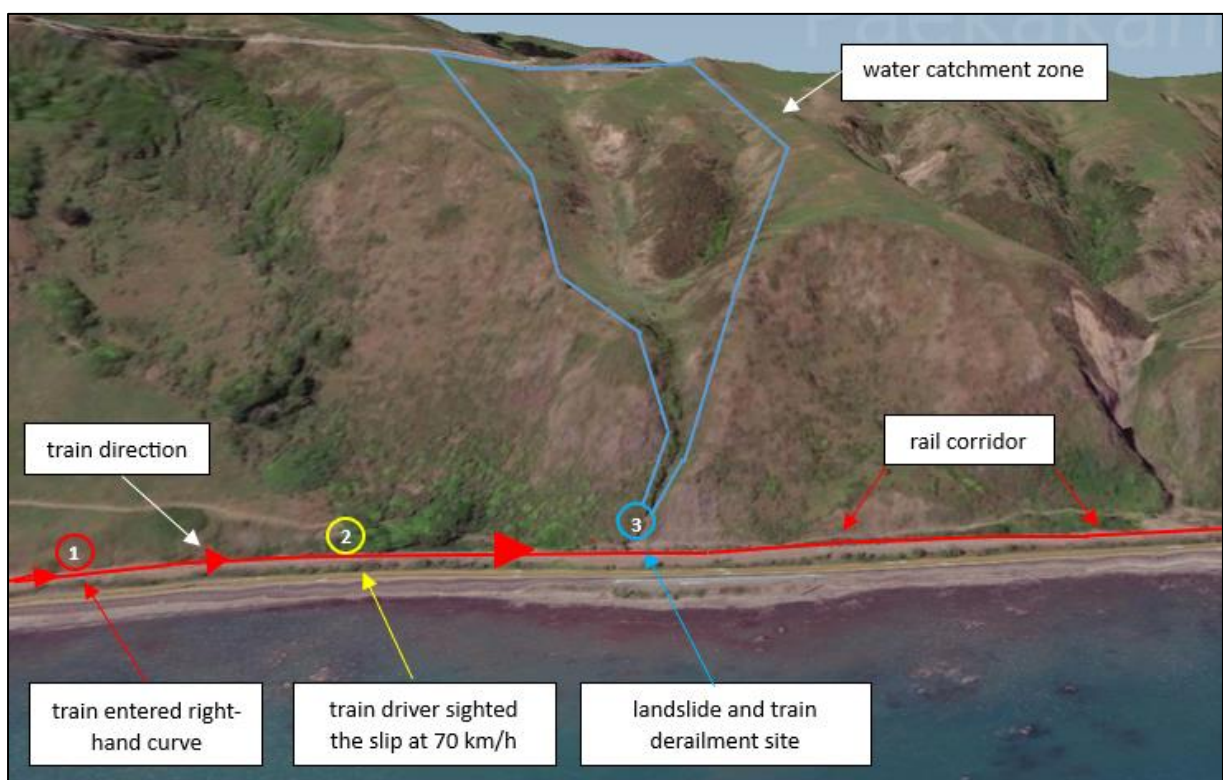
**Figure 4: Location map leading up to the derailment site**

- 2.8. At about 0546 the train entered a right-hand curve, and the driver applied the train brake, reducing the speed to approximately 70 km/h as required for the section of track ahead (see Figure 4, number 1).

- 2.9. At about 0547, as the train entered a small section of straight track, the driver saw a large amount of water flowing off the hillside and across the track approximately 40 metres (m) in front of the train (see Figure 4, number 2). Simultaneously a landslide crossed both the down main line and the up main line in front of the train (see Figure 4, number 3).

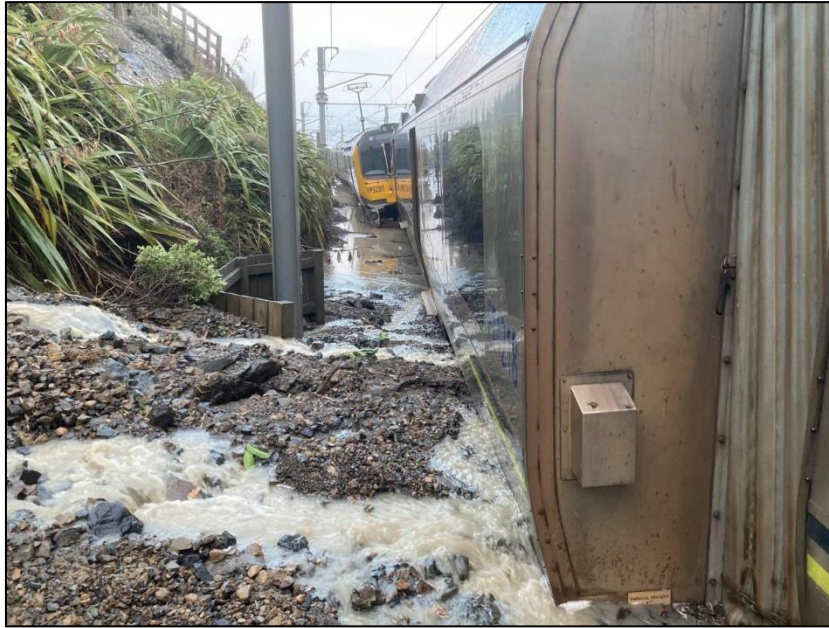
**Figure 5: Derailed carriage and debris against and under carriage**  
(Photographed at approximately 1210)

- 2.10. Debris and rainfall water overwhelmed a drainage culvert<sup>10</sup> near the derailment area, below the rail corridor.
- 2.11. At 0547:07 the driver applied the train's emergency brake. However, they were unable to stop the train – which initially travelled at approximately 69 km/h – before striking the slip debris.
- 2.12. The debris acted as a ramp, with the train's leading wheels riding up onto the debris and derailing the first, second and third passenger cars before coming to rest approximately 50 m past the slip (see Figure 5).

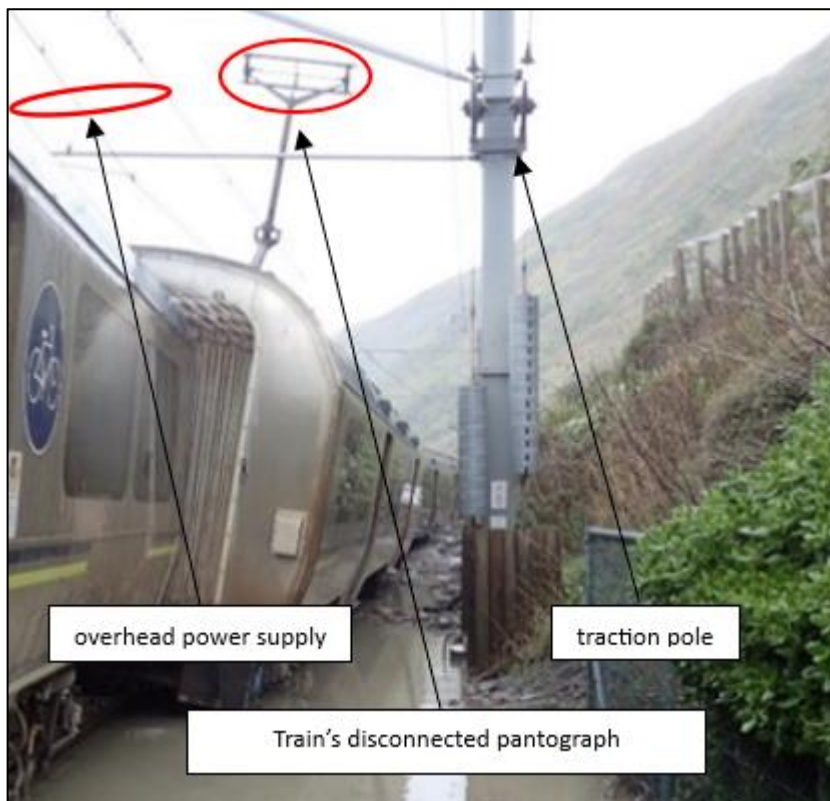
**Figure 6: Disconnected pantograph and power-supply connection**

- 2.13. The rear passenger car came to a stop before encountering the debris and remained on the track.
- 2.14. During the derailment the train's pantograph<sup>11</sup> lost contact with the overhead wire, resulting in the train losing its overhead power source (see Figure 6).

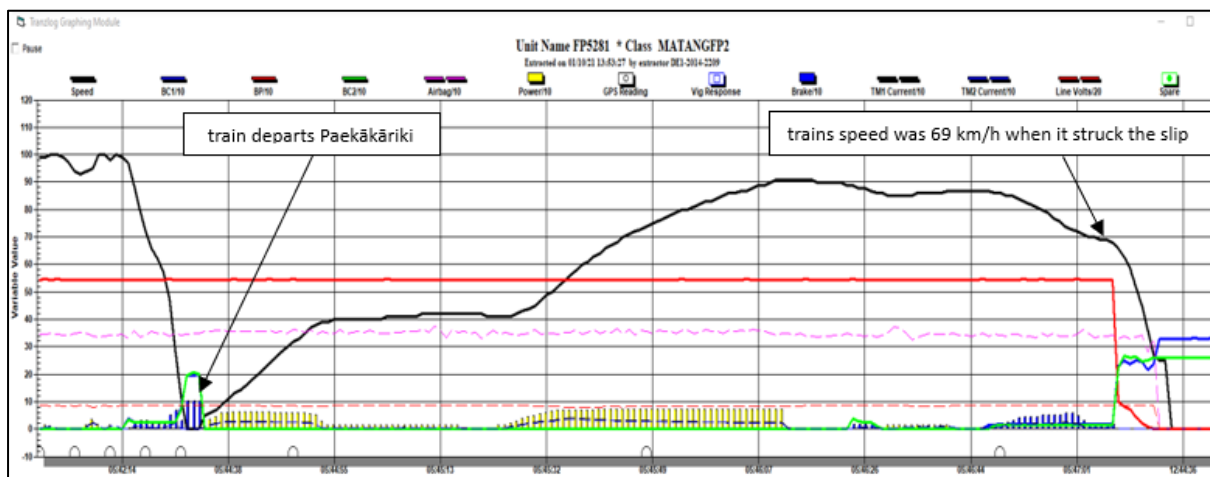
**Figure 11: Tranzlog data of train departing Paekākāriki station and the lead-up to and after striking the slip**  
(Credit: Transdev Wellington)

2.34. The EMU was fitted with a Tranzlog data recorder system<sup>17</sup> (see Figure 11). The downloaded data confirmed that the train speed and train handling controls made by the driver were in accordance with the operating rules and procedures.

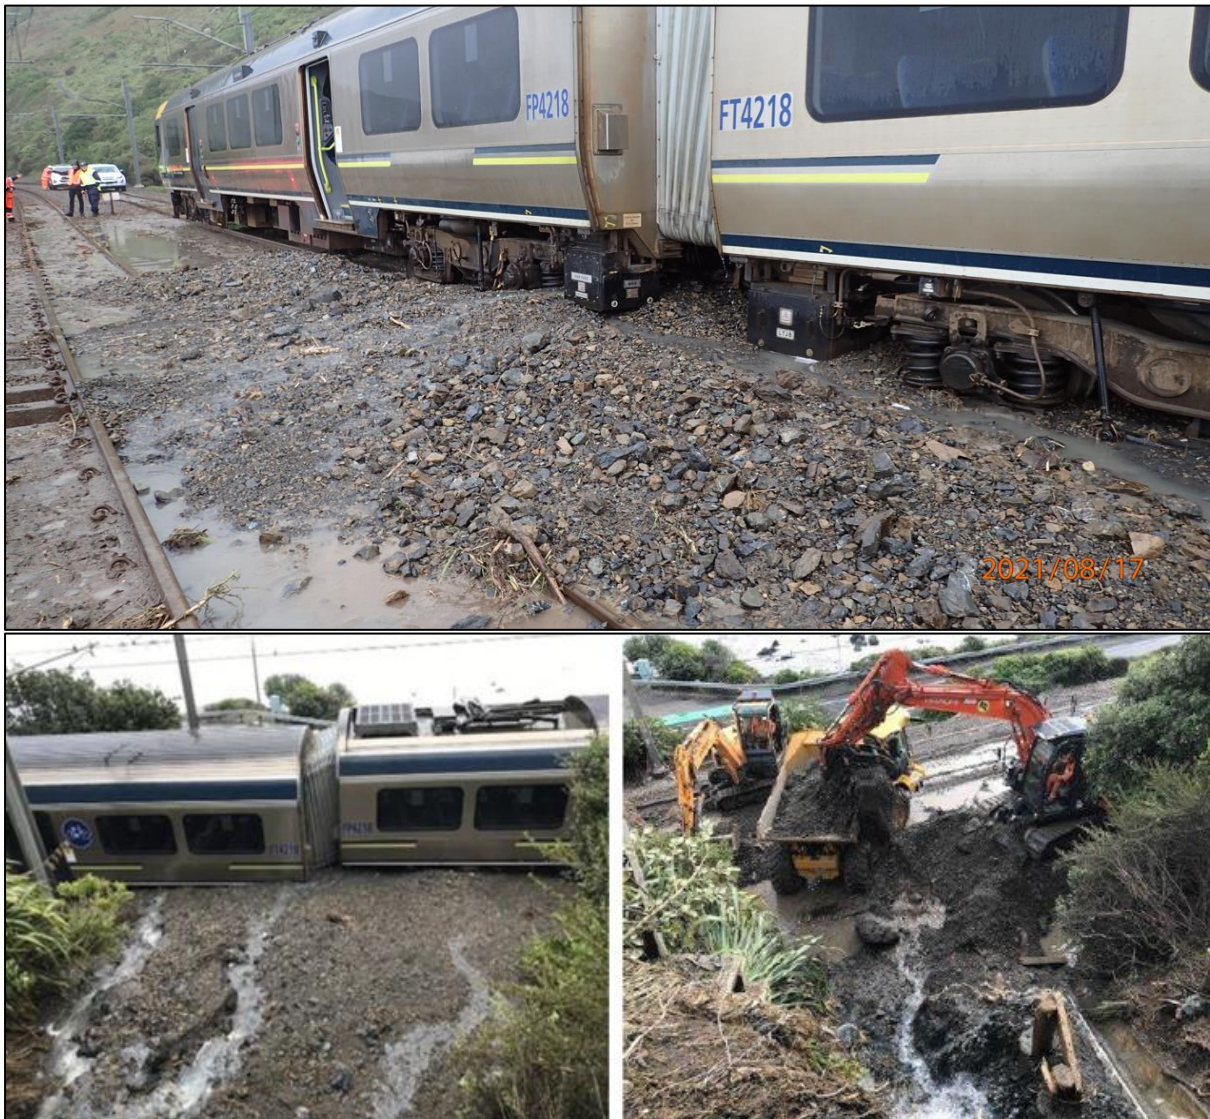
**Figure 12: Rear portion of train with debris across the up and down main lines**  
(Credit: KiwiRail).

- 2.40. Two days after the derailment, KiwiRail restored the accident site to allow both freight and passenger trains to resume operations on the portion of closed track and applied a temporary speed restriction to all train movements to the portion of track where the slip had occurred.

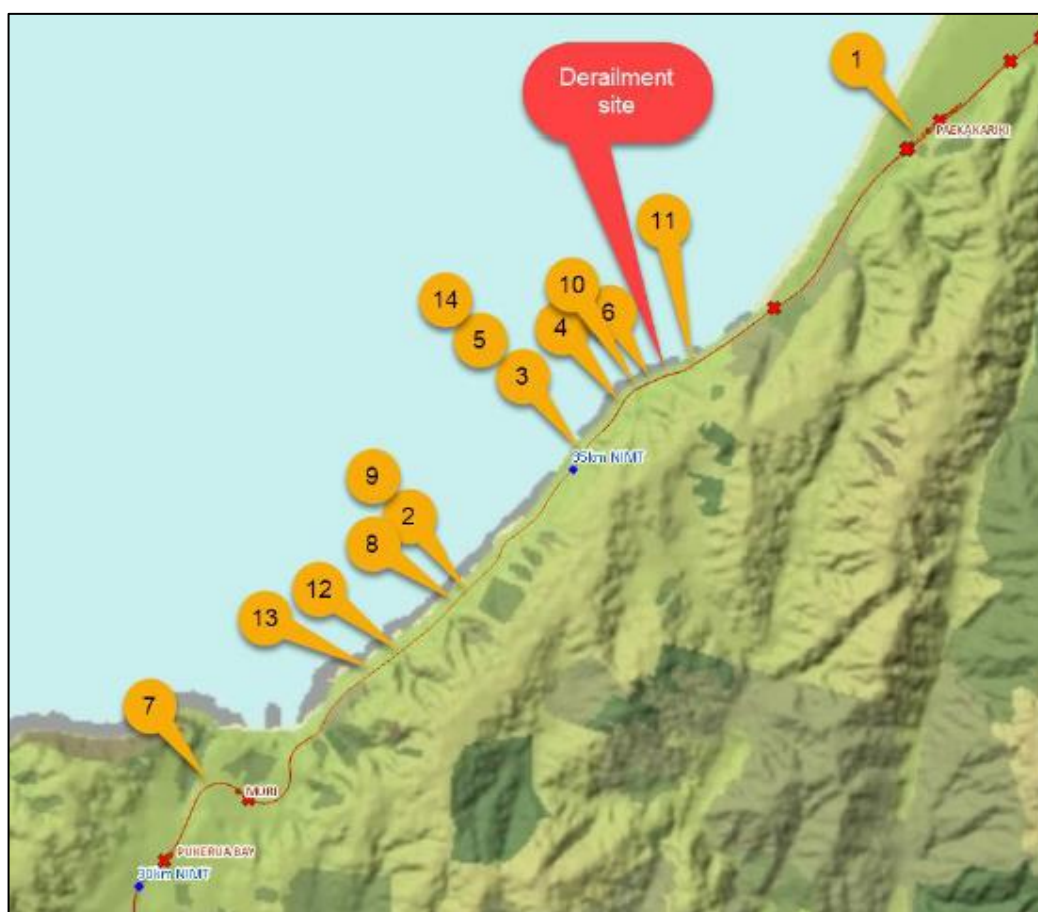
**Figure 13: Previous slip events on the NIMT**

2.45. Between 2005 and 2023 there were 15 recorded slip events between Paekākāriki and Pukerua Bay (see Figure 13).

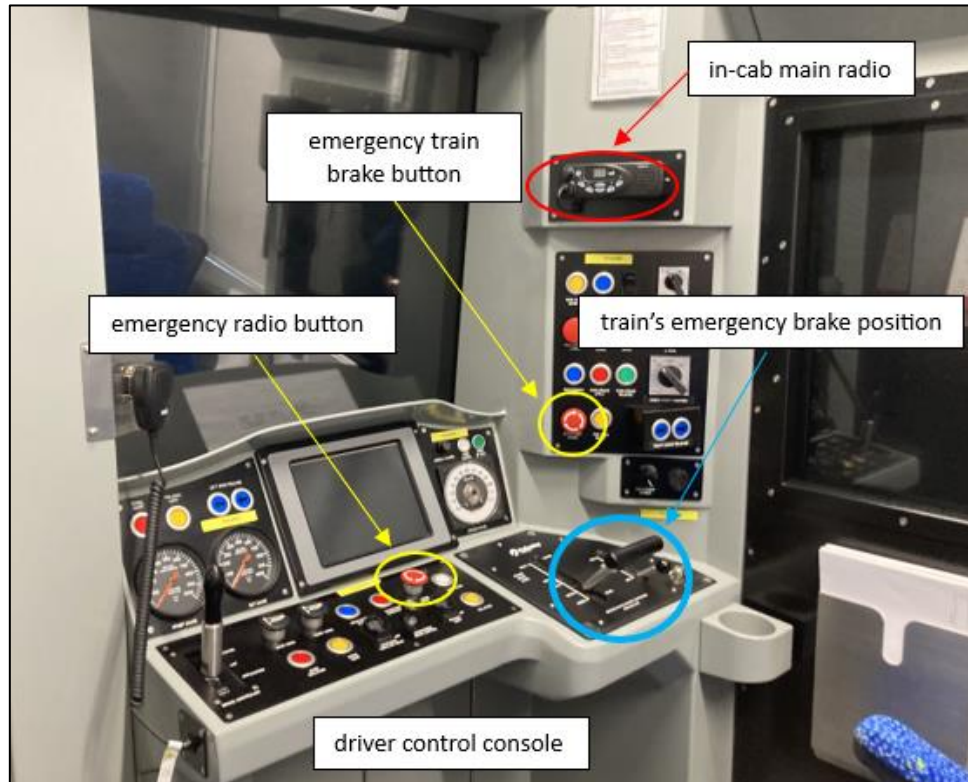
**Figure 16: Driver's in-cab equipment positions**

emergency situation. Currently this system does not work in conjunction with a train's emergency braking system to send an automatic radio call to train control, alerting it of an emergency. The Commission found in this accident that the driver did not have enough time after applying the emergency brake to activate the in-cab emergency radio button manually before the train's power was disconnected.

3.22. If an automatic alert system had been fitted to the train, it is **very likely** that the in-cab main radio would have sent an emergency alert call to train control. Train control was not immediately aware of the derailment and therefore was not able to respond immediately and put in place safety barriers to protect the derailed train and other rail vehicles.
