Transport Accident
Investigation
Commission

Final report

Rail inquiry RO-2022-102
L71 Mainline Shunt
Derailment and subsequent rollover
Tamaki
1 June 2022

December 2023

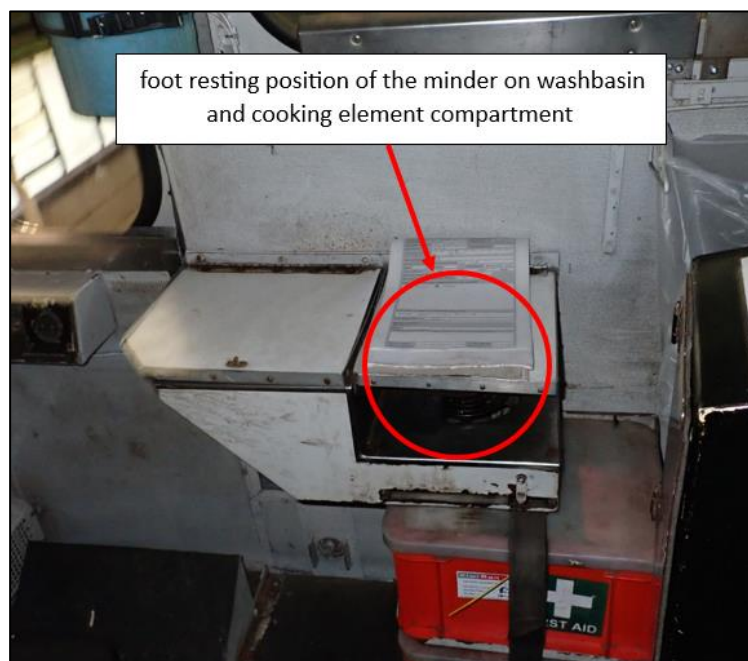
Figure 7: Wash basin on which minder rested their foot

- 2.9. The minder informed the LE and trainee that, as they had a sore foot, they preferred to elevate their leg as much as possible in the cab. The minder sat in the lunchroom chair with their back to the rear wall and their foot resting on the wash basin (see Figure 7)

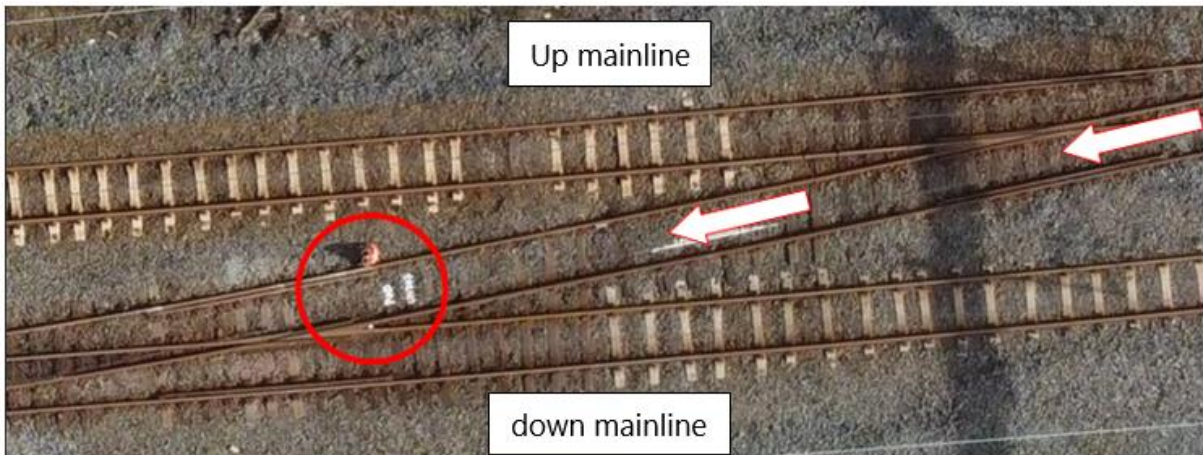
Figure 16: Point of derailment
(Credit: KiwiRail)

2.24. The locomotive then fell back onto the rail head, immediately before the frog junction (circled in red in Figure 16).⁸ The locomotive then fell further to the left and entirely off the track.

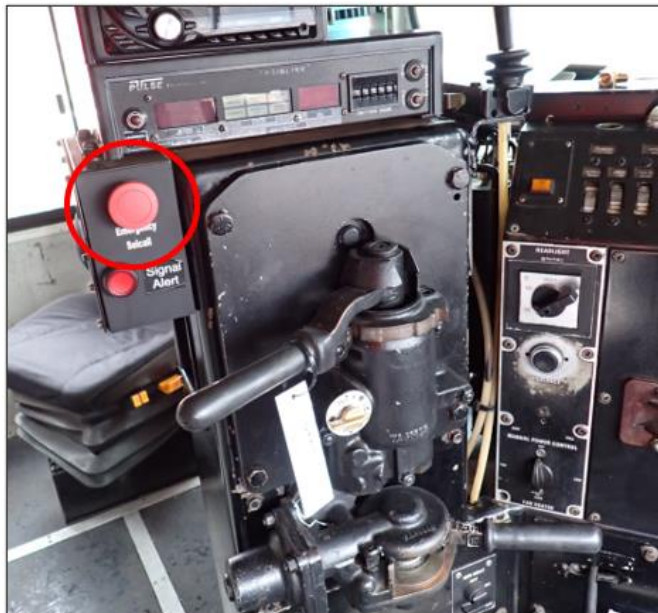
Figure 17: Emergency mushroom button

2.25. As the locomotive rolled, the LE was lifted out of their seat, unintentionally moving the throttle to maximum power (notch eight) and depressing the emergency mushroom button (see Figure 17). Depressing the emergency mushroom button sent an automatic alert to train control through the radio system.

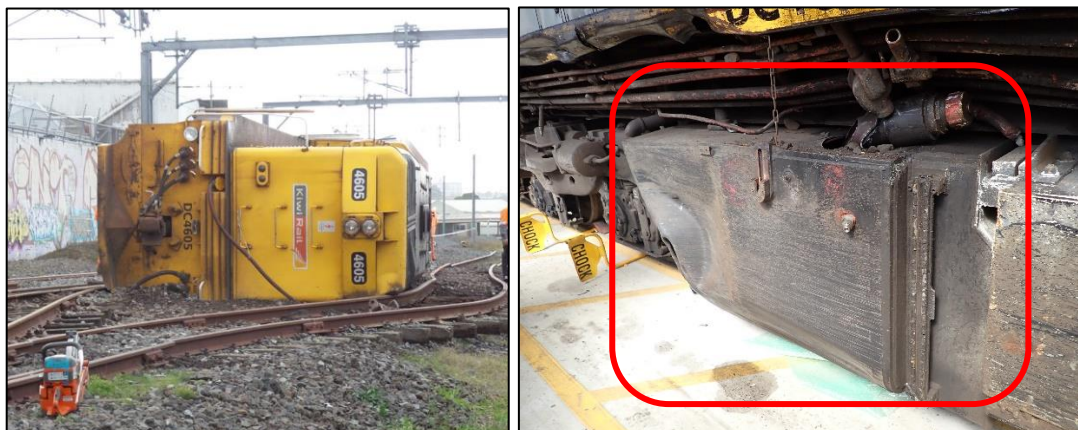
Figure 18: Position of locomotive following derailment (left) and ruptured fuel tank (right)

- 2.27. The locomotive slid a further 55 m on its side. The LE's side window shattered, allowing rail track ballast and spoil to enter the cab. The locomotive fuel tank ruptured, and the filling nozzle broke off, spilling diesel on to the ground (see Figure 18).
- 2.28. The locomotive came to a complete stop wedged between the down mainline and the adjacent track.

- 2.37. The locomotive's fuel tank ruptured when it rolled over, allowing approximately 1800 litres of diesel to be spilled under the overturned locomotive and surrounding area.

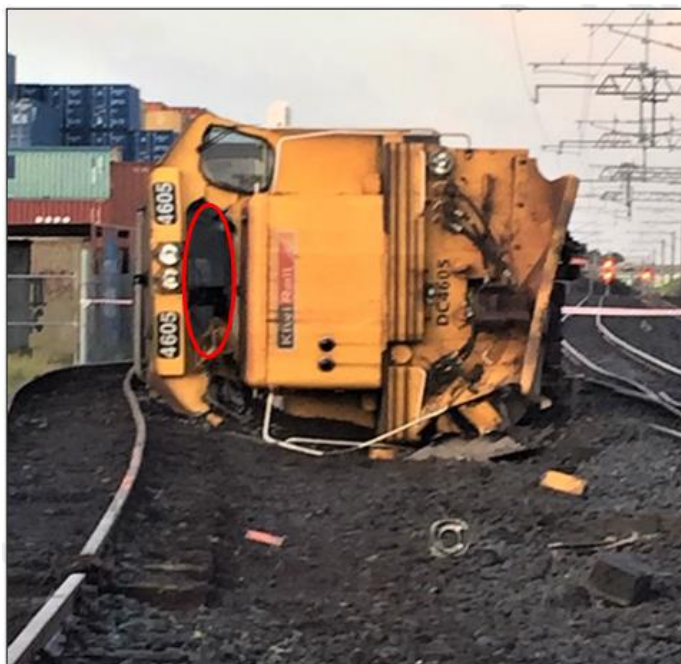
Figure 20: Locomotive following derailment, showing window through which crew exited.

- 2.31. The crew could hear the train controller trying to make contact, but the radio system was damaged when the locomotive overturned and they could not respond.
- 2.32. The LE exited the cab through the front middle window, followed by the minder and the trainee (see Figure 20).
