Transport Accident  
Investigation  
Commission

# **Final report**

***Rail inquiry RO-2023-102***  
***Freight train 360***  
***Derailment***  
***Te Puke***  
***29 January 2023***

**June 2024**

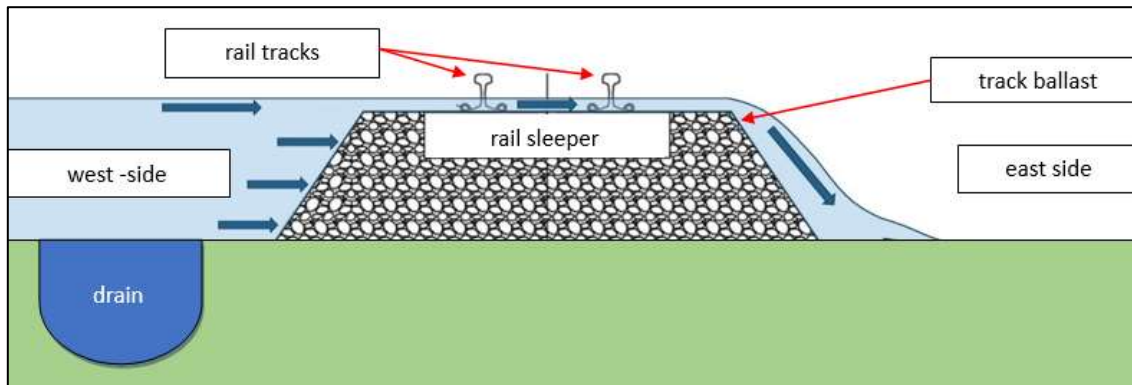
- 2.29. The crew disembarked from the locomotive and began walking towards the rear of the train. When they arrived at the fifth wagon, they realised that they could not see the remaining 34 wagons. From their location, they could see that the track's formation<sup>27</sup> had washed down the embankment (see Figure 6).

**Figure 6: Diagram of track formation and water loading**

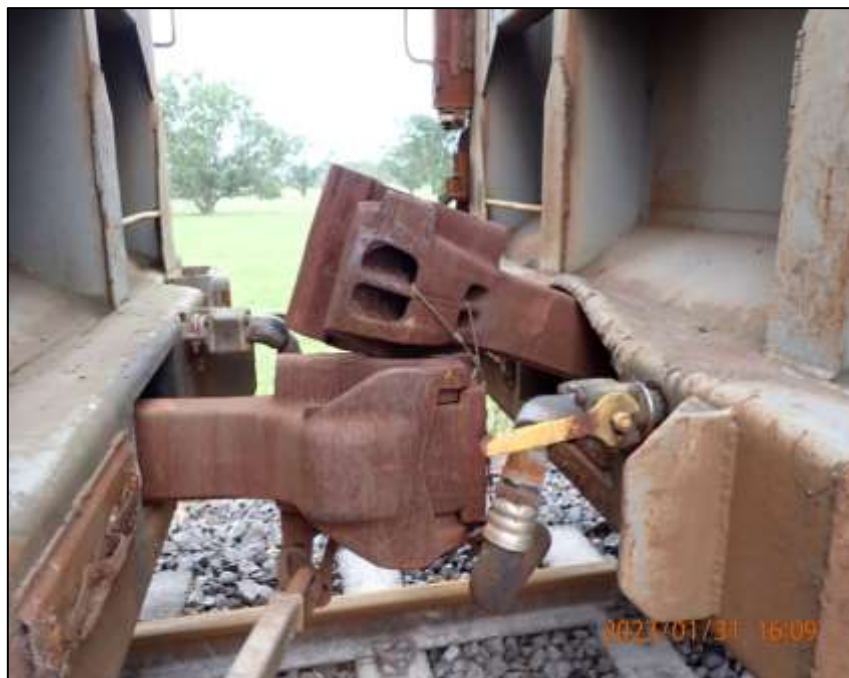
- 2.30. On inspection, the crew found that four of the five wagons remaining with the locomotive had decoupled (see Figure 7), leaving only one wagon still connected to the locomotive. The crew then returned to the cab of the locomotive.

**Figure 7: One of the four decoupled wagon connections.**

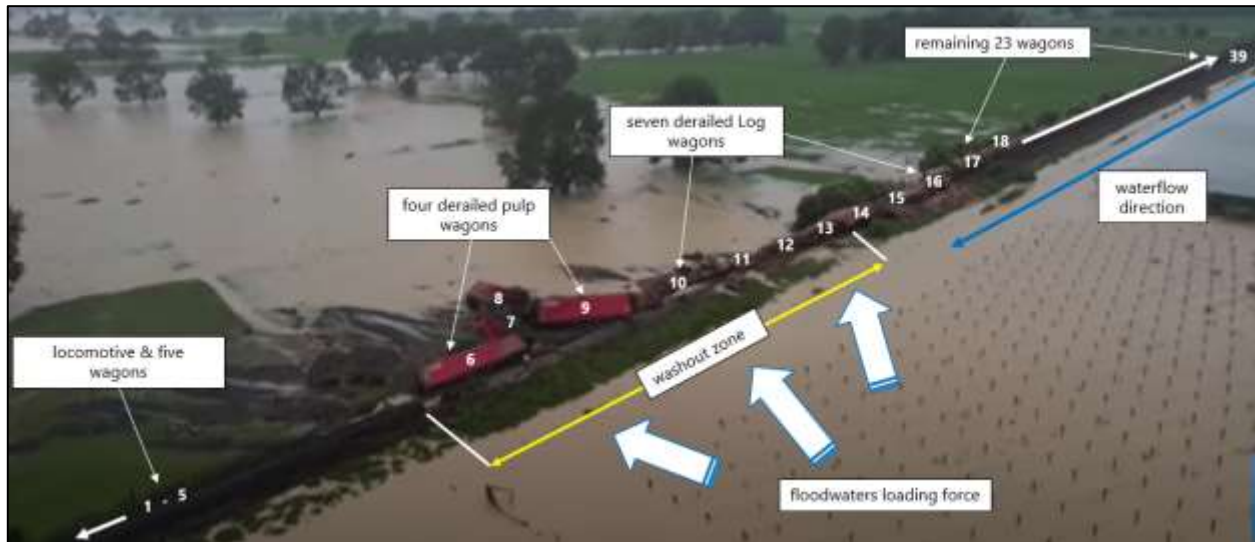
2.42. The accident site was at 115.715 km on the ECMT north of Te Puke. The track and infrastructure were maintained and inspected by KiwiRail. The derailment occurred on an elevated embankment that was between 2.4-3.5 m in height<sup>30</sup> with farmland on either side (see Figures 10 and 11).

**Figure 10: Derailment site from west side (drone footage taken at 0800 on 29 January 2023)**

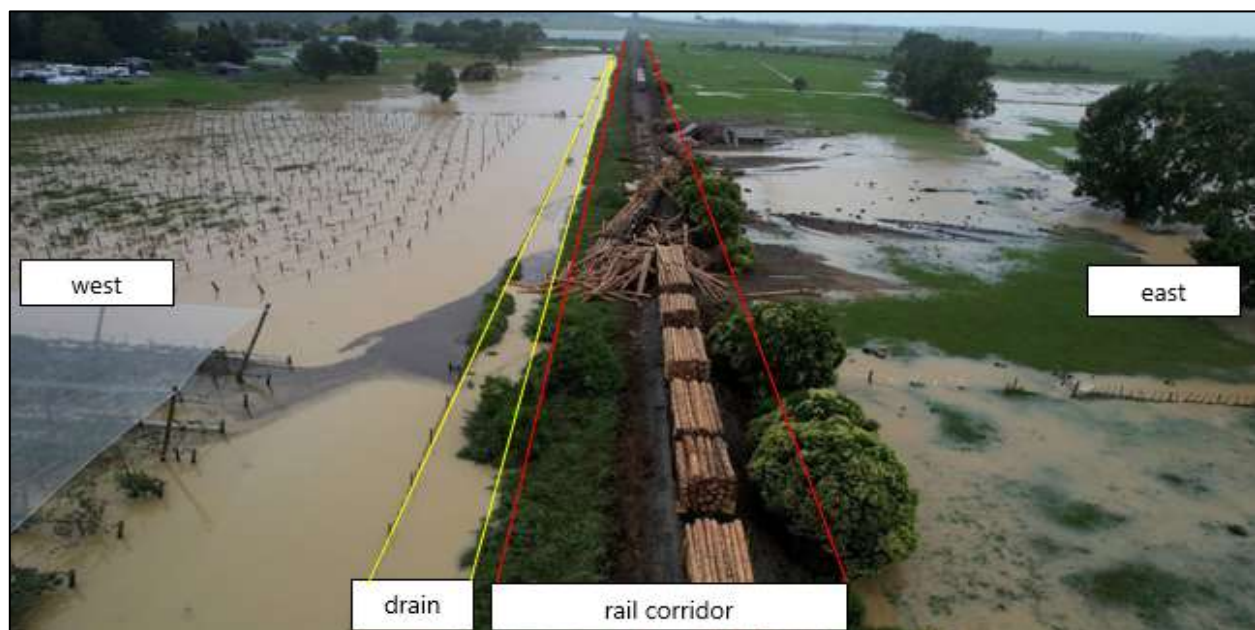
**Figure 11: Derailment from rear of the train (drone footage taken at 0800 on 29 January 2023)**

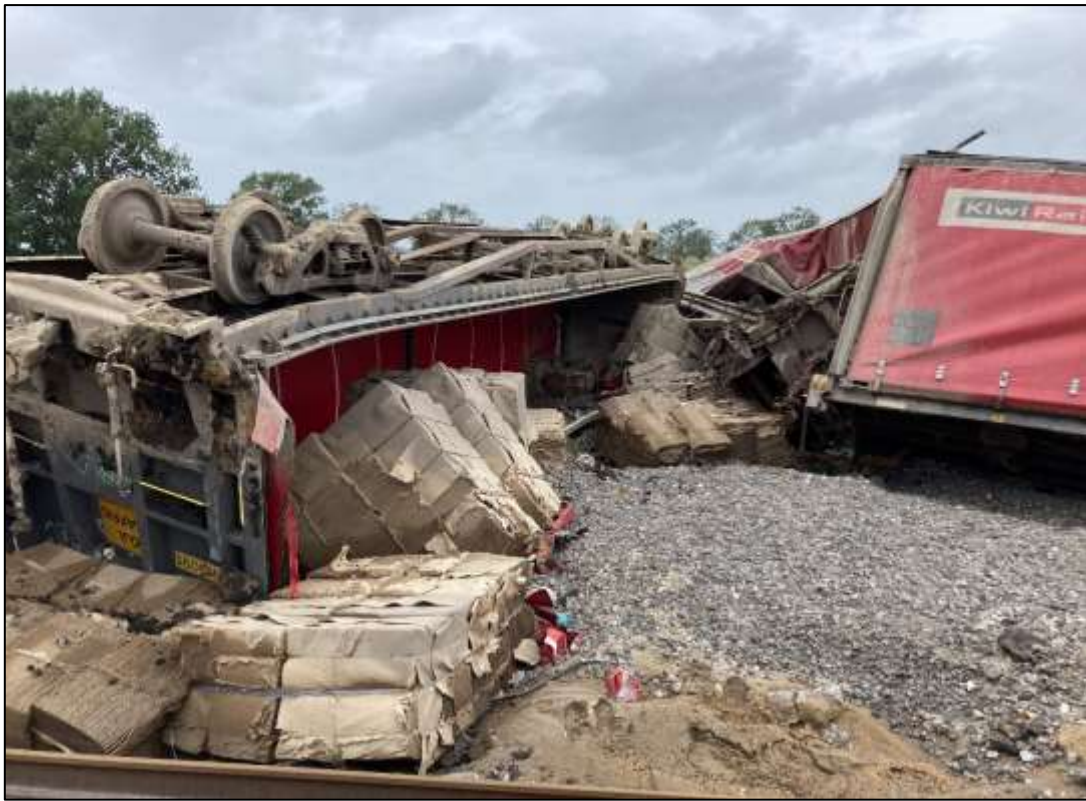
**Figure 12: Derailed wagons and ballast debris on the eastern side of the rail corridor**

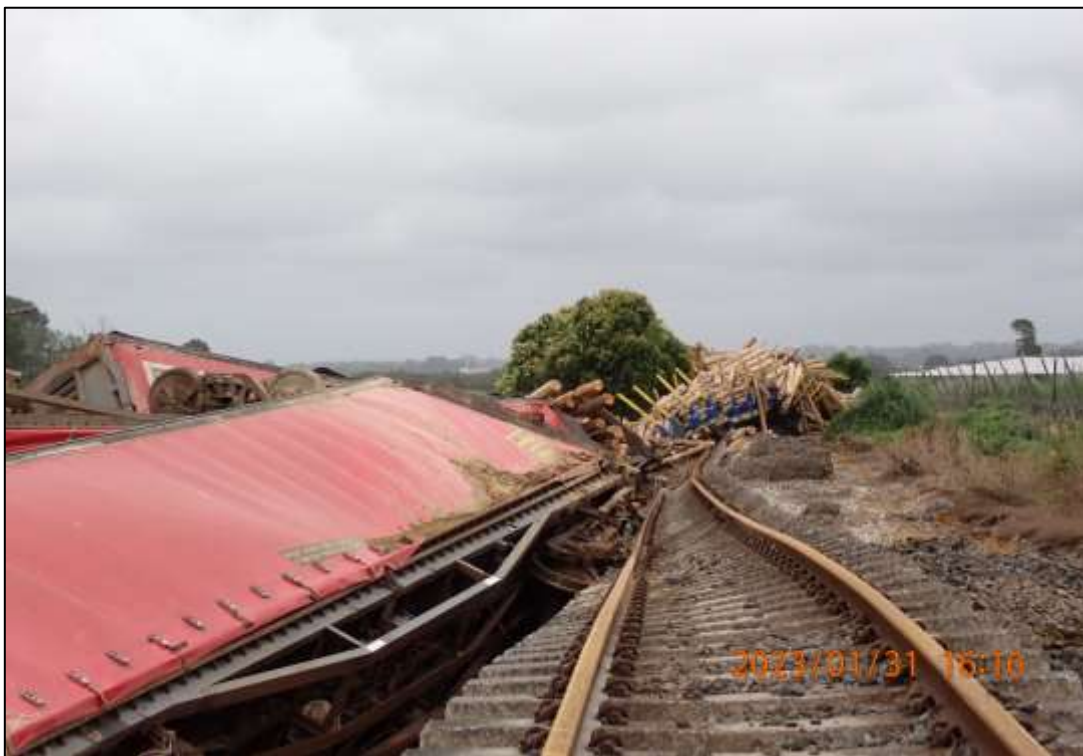
**Figure 13: Derailed wagons and washed-out track formation**

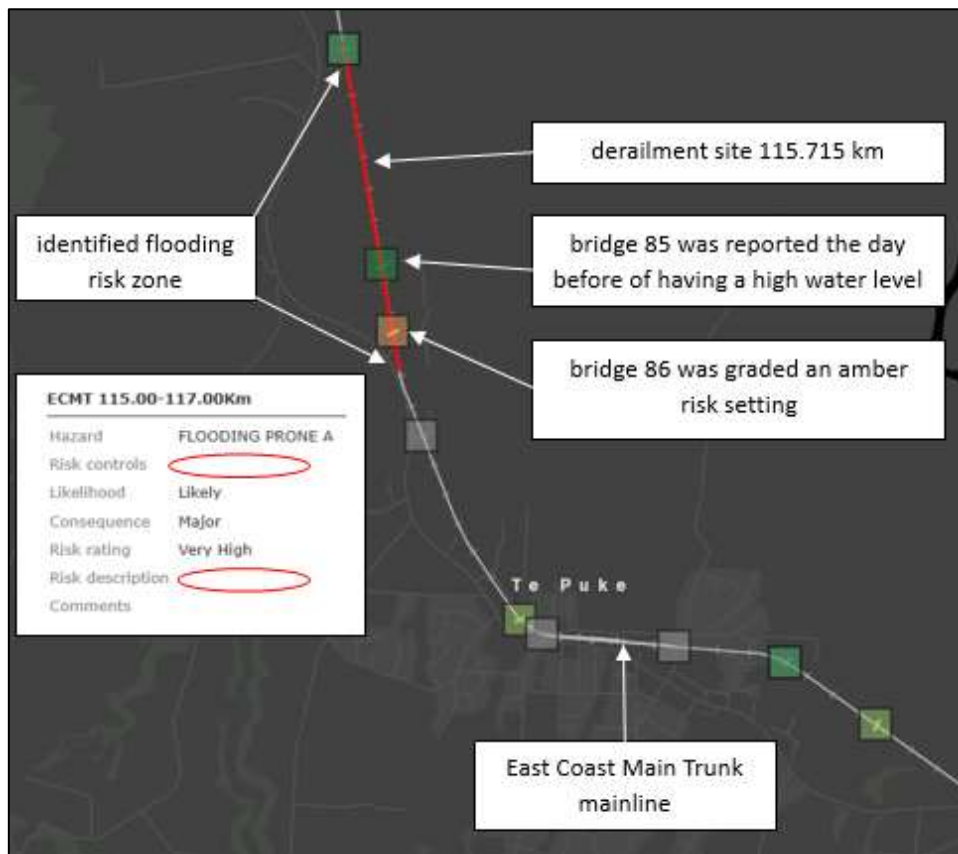
- 3.12. The rail resilience map was designed to help with hazard assessments for civil works and the management of severe weather events (see Figure 17). The map colour-coded and ranked areas of the rail network that were subject to flooding, slope instability and scouring of bridge supports.

**Figure 17: The rail resilience map at the accident site**

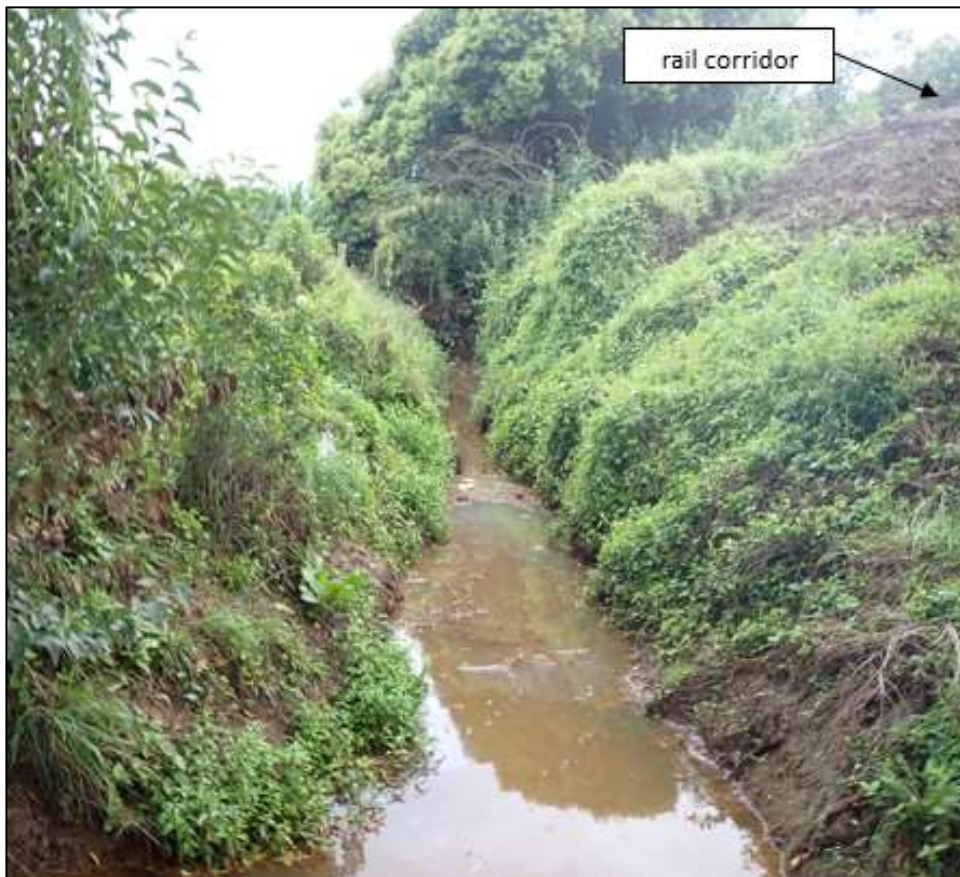
- 3.37. Where the Flaxton drain and Collins drain intersected, the vegetation on both sides had grown down to the water level (see Figure 21).

**Figure 21: Vegetation at junction of Flaxton drain and Collins drain**

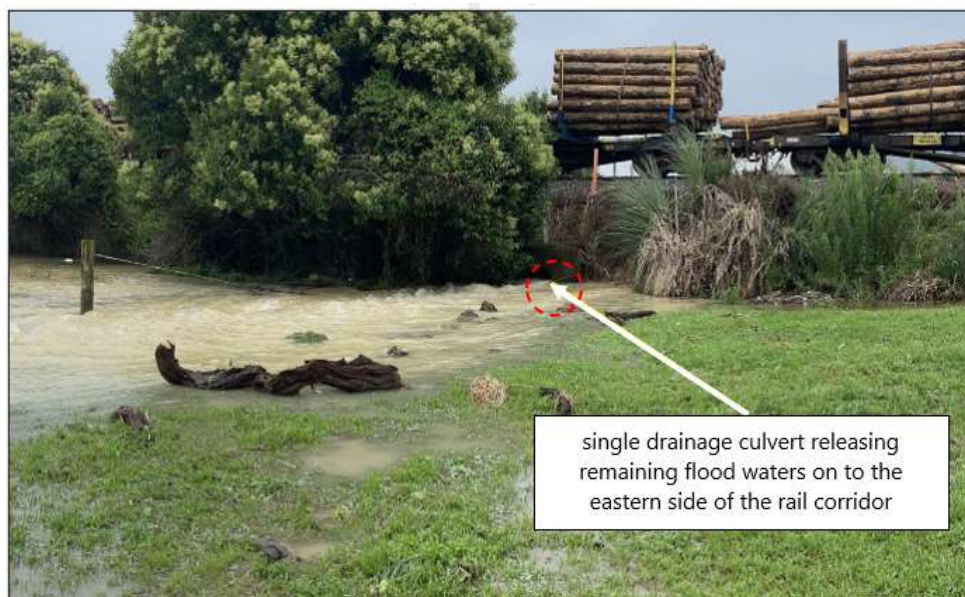
- 3.38. Located approximately 60 m south of the accident site was a single, 750 mm diameter concrete culvert, owned and maintained by KiwiRail. The culvert allowed water to flow beneath the rail corridor and was approximately 0.5 m above the Flaxton drain. The purpose of the culvert was to move excess water from the farmland in the east to the Flaxton drain in the west. It was not designed for flood mitigation.
- 3.39. However, when floodwaters breached the top of the Flaxton drain, the culvert allowed water to move from the drain east onto farmland (see Figure 22). Eventually the culvert was also overwhelmed by the volume of floodwater, resulting in the water crossing over the track, undermining the track formation and washing out the ballast.

**Figure 22: Culvert allowing floodwater to move east onto farmland**  
(Credit: KiwiRail – photograph taken at approximately 10:00 on 29 January)

- 3.40. The maximum capacity of the drainage system maintained by the Council was a daily rainfall of 37 mm for a maximum of three consecutive days, a one-in-five-year weather event. The heavy rainfall that fell during 27 and 28 January 2023 exceeded that capacity.

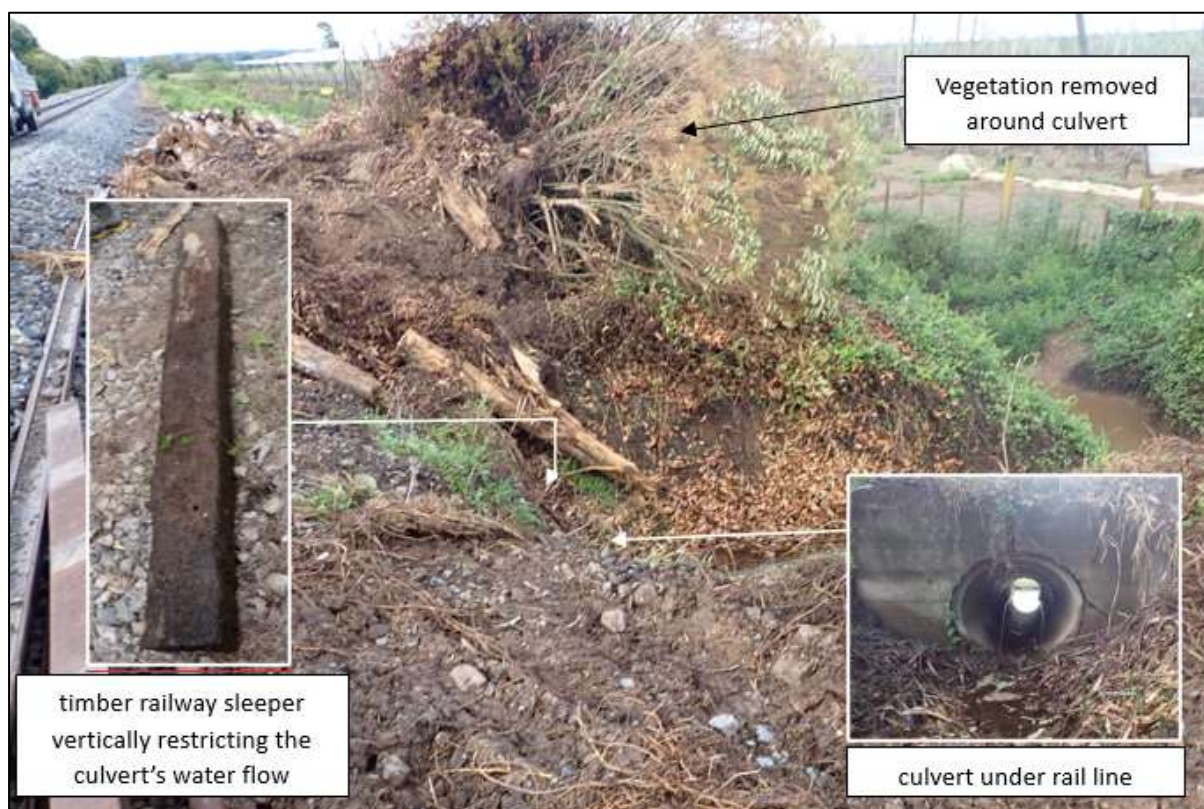
- 3.41. When attending the accident site after the floodwater had subsided, the Commission investigators found the culvert was partially blocked on the western side by a vertically positioned wooden railway sleeper and that vegetation had grown into the area where the Flaxton drain met the culvert (see Figure 23).

**Figure 23: Western entrance of culvert**

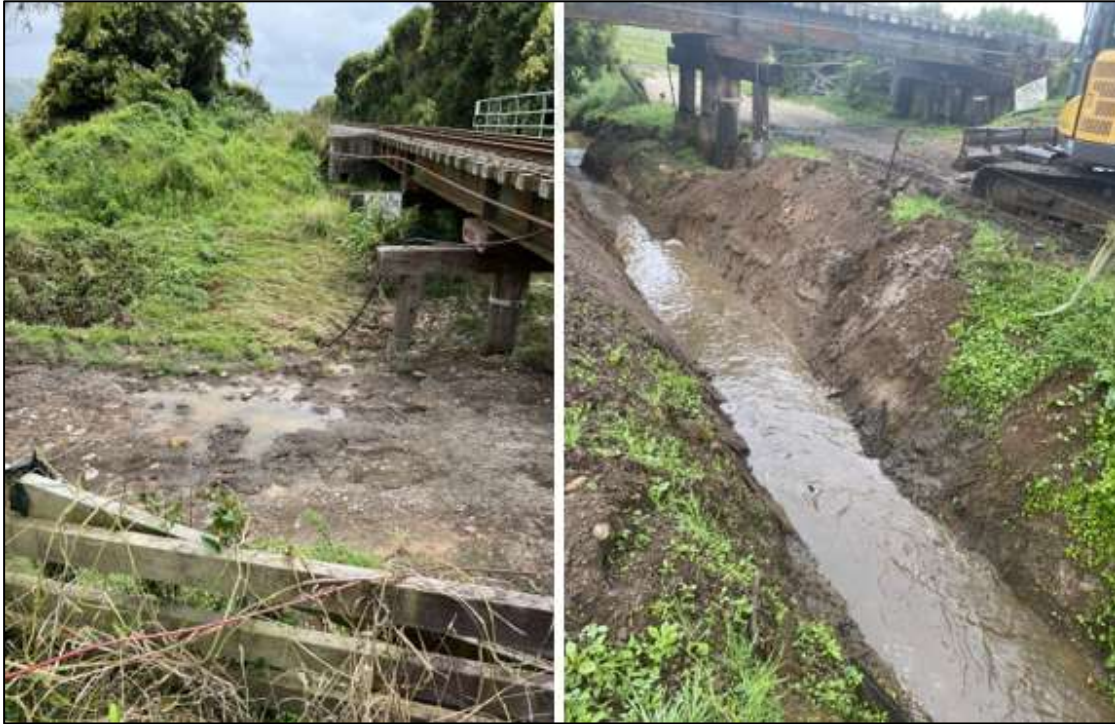
**Figure 24: Remedial work at Bridge 85 after the accident**  
(Credit: Bay of Plenty Regional Council)

- 3.45. Remedial works post the accident were completed by the Bay of Plenty Regional Council. This work included the removal of a culvert within Collins drain located near bridge 85, which was removed due to its being blocked with compacted soil. Upon its removal, a smaller pipe was found within the culvert. The culvert removal created an open drainage system up to and under bridge 85 (see Figure 24).
