Transport Accident
Investigation
Commission

Final report

Rail inquiry RO-2023-105
Derailment of Tamper 703
Purewa tunnel, Auckland
9 October 2023

June 2025

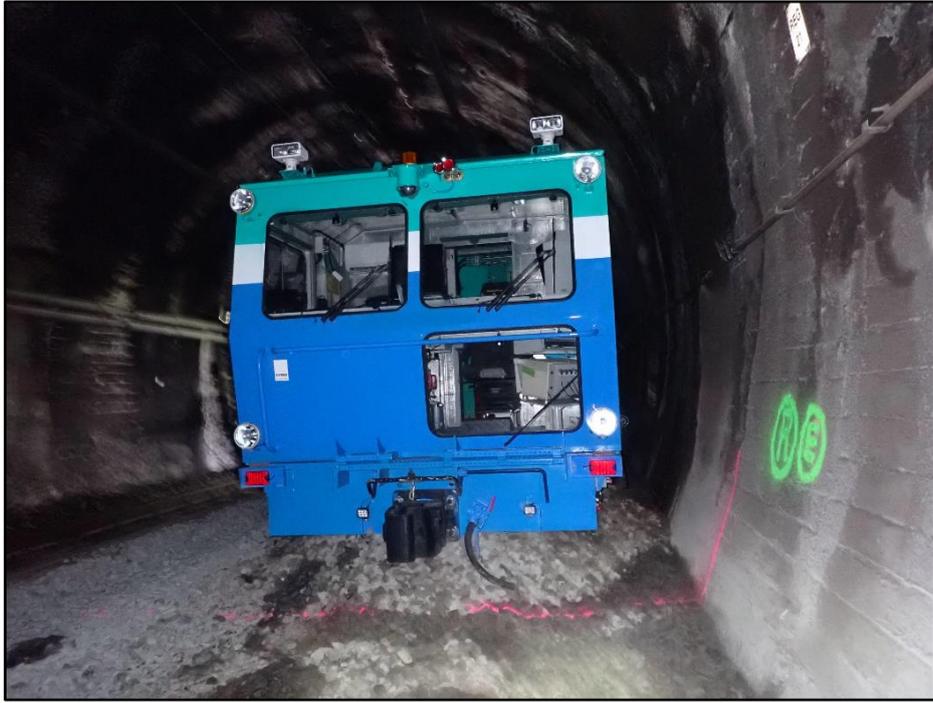
Figure 1: Tamper 703 at site of derailment

- 1.5. When the tamper group entered the tunnel, the operator on Tamper 703 noticed the missing track and applied emergency braking.
- 1.6. Tamper 703 was unable to stop before driving off the end of the track and into ballast, where it travelled for 16.4 metres before stopping. The rear two machines were able to stop and remain on the track.

- 1.7. None of the four crew was injured, but Tamper 703 was significantly damaged.

- 2.37. The tamper continued over the end of the track for 16.4 m, coming to a stop in the track ballast.
- 2.38. No crew members were injured in the derailment; however, the abrupt stop threw them off their seats. Equipment on the underside of the tamper was significantly damaged, requiring repairs costing several hundred thousand dollars.
- 2.39. The site was frozen pending an investigation of the circumstances of the incident.

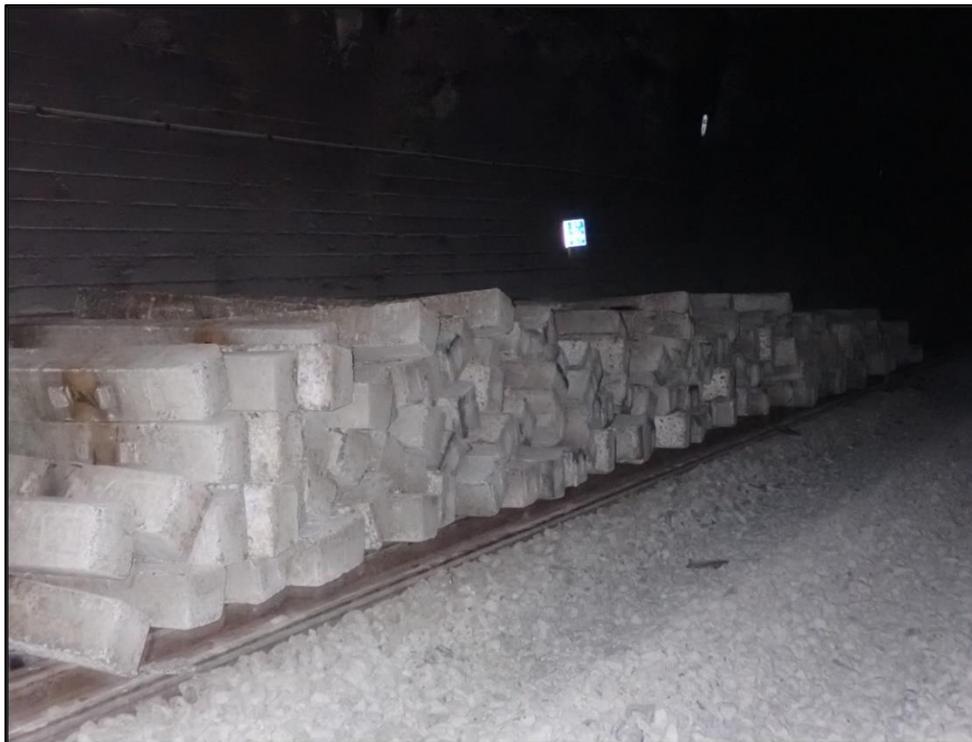
Figure 9: Concrete sleepers stacked on tunnel 19 up main line

- 3.50. RPO1 and the SP were both present at this safety briefing. In interview, the SP recalled hearing during the safety briefing that a section of track would be removed. RPO1 stated during interview that they could not recall what was discussed during the briefing.
- 3.51. Once the work group entered the tunnel, the SP remained inside a road vehicle in a carpark area nearby and outside the rail corridor known as the 'safe place'²¹.
- 3.52. RPO1 left the area immediately after the safety briefing to undertake other duties.
- 3.53. The work group removed approximately 100 m of track and concrete sleepers from the up main line inside the tunnel. The concrete sleepers were stacked for storage on the remaining rail track of the up main line, on the northern side of the area that had been removed (see Figure 9 and Figure 10).

- 3.54. Both the missing track and the stacked concrete sleepers posed an extreme risk to any rail traffic that might have used the line. However, no warning signs or devices were placed for additional protection as this was not required within the confines of the Mis.60 area.

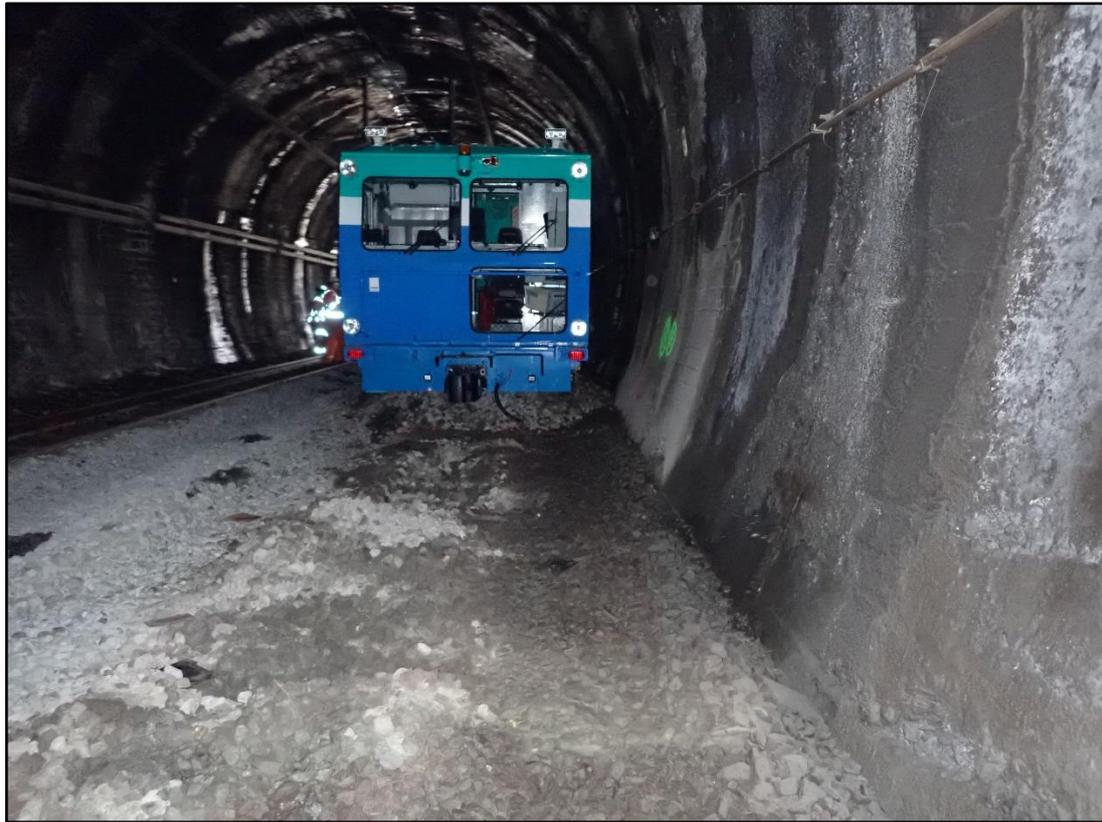
Figure 10: Track removed from tunnel 19 up main line

- 3.55. At about 1630, when they had completed the work, the work group exited the tunnel, leaving the missing track and concrete sleepers without putting in place any form of protection. They returned to the safe place to advise the SP that they had finished for the day and to complete lock-off procedures.

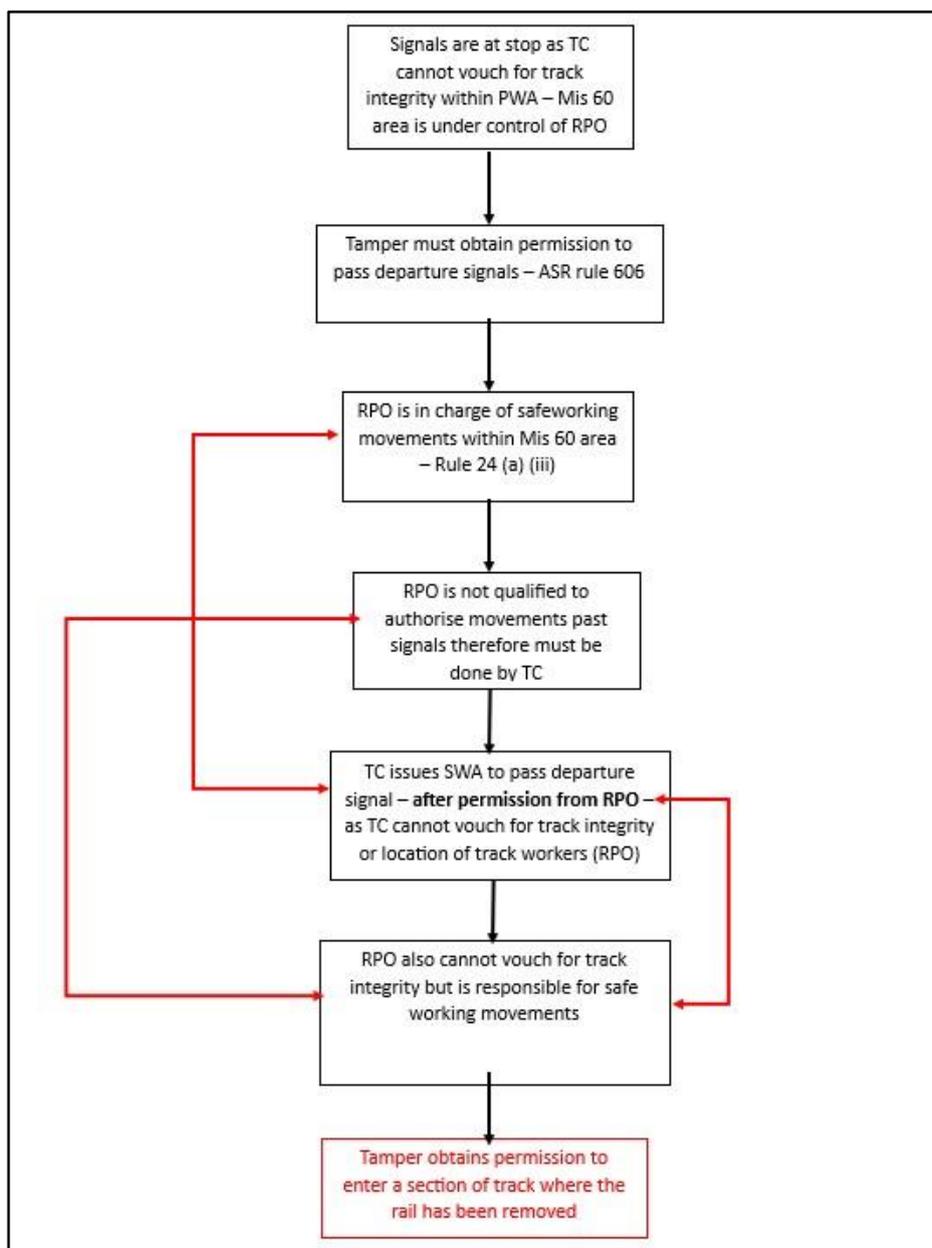
Figure 15: Logic map of SWA issuing process

- 3.87. This meant that the train controller had no way of knowing whether a section of track into which they were about to authorise a rail movement was safe for rail traffic, hence the requirement for RPO authorisation.
- 3.88. However, on this occasion the RPO authorisation was also given, even though they had no knowledge of the impassable track.
- 3.89. This meant that the operator of AV2 received permission from two authorities (train control and RPO2) to move towards a section of track that was impassable without the knowledge of either authority (see Figure 15).

- 6.3. On 28 May 2025, the Commission recommended that KiwiRail review and improve its process for authorising rail movements within worksites to ensure the safe movement of all rail traffic and personnel within protected work areas, including the verification of track integrity and the sharing of and access to safety-critical information. **[031/25]**
- 6.4. On 23 June 2025, KiwiRail replied:

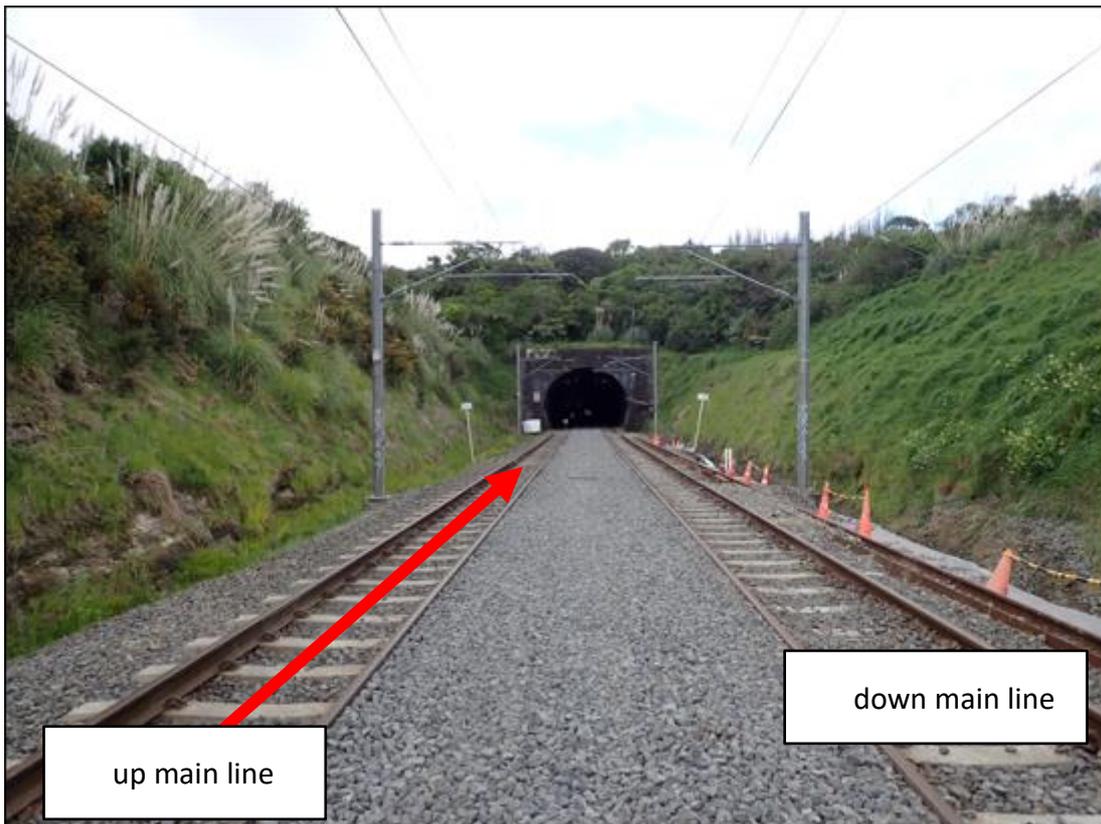
Figure 16: Direction of travel on up main line towards tunnel 19

- 3.90. Once AV2 had obtained permission to pass signal 508, it also passed signal M6728 and continued to the next signal, M6736, before stopping and contacting train control by radio.
- 3.91. Train control cancelled the SWA, as AV2 was now clear of the section protected by signal 508, before verbally authorising AV2 past signal M6736 at stop – the last signal before entry to tunnel 19 (see Figure 16).

3.95. After being authorised past signal M6736, AV2 entered the tunnel travelling at an estimated 20–30 km/h. The tamper operator saw what they thought was ballast on the track ahead before realising they could see only ballast ahead because the track was missing.
