**Report 06-009, Boeing 767-319, ZK-NCK, fuel leak and engine fire,  
Auckland International Airport, 30 December 2006**

**Boeing 767-319  
ZK-NCK**

**fuel leak and engine fire**

**Auckland International Airport**

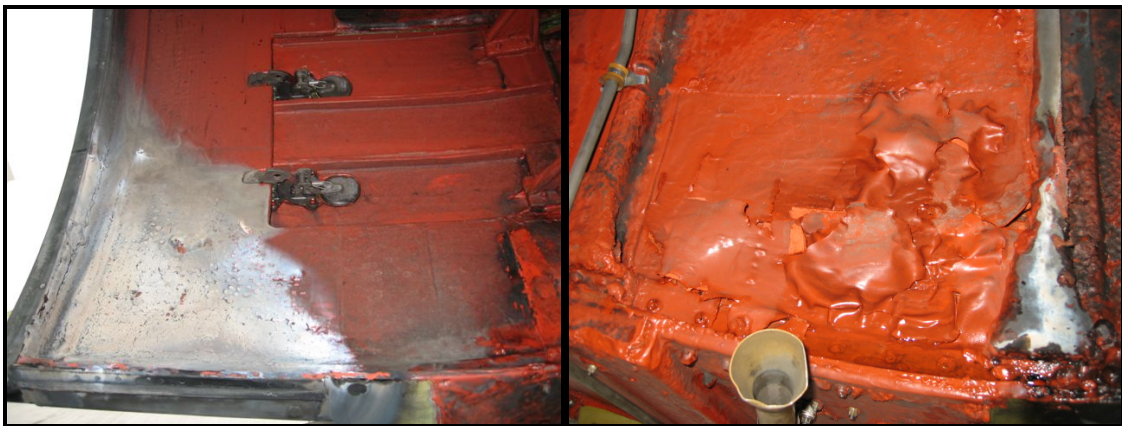
- 1.2.1 The aircraft was fitted with 2 General Electric Aircraft Engines Limited (General Electric) CF6-80C2-B6F<sup>3</sup> turbofan engines. Further engine information is in section 1.4. Damage was confined within the left engine nacelle. The rubberised thermal protective coating of the thrust reverser inner diameters had patches of heat damage from the 5 o’clock to 6 o’clock positions<sup>4</sup> below the fuel manifold (see Figure 2).

**Figure 2**  
**Damage to left engine cowls, ZK-NCK**  
Left: thrust reverser inner diameter. Right: damage at 5-6 o’clock position.

- 1.2.7 The left engine, serial number 704518, was replaced and the left engine thrust reverser halves required minor repairs before ZK-NCK was returned to service.

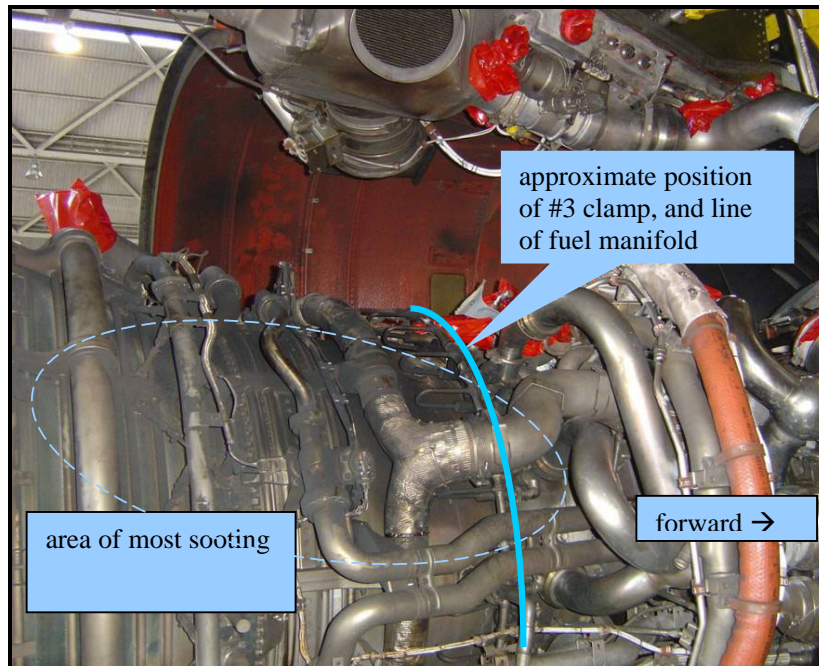
- 1.2.2 Soot was present on the compressor rear frame, except at the one o'clock position of the fuel manifold, by the #3 loop clamp (see Figure 3). General Electric advised that soot does not adhere to surfaces hotter than 700°F (370°C).
- 1.2.3 Once the engine had cooled, it was motored and a fuel leak was found at the #3 clamp location.

**Figure 3**  
**Area affected by fire, left engine of ZK-NCK**

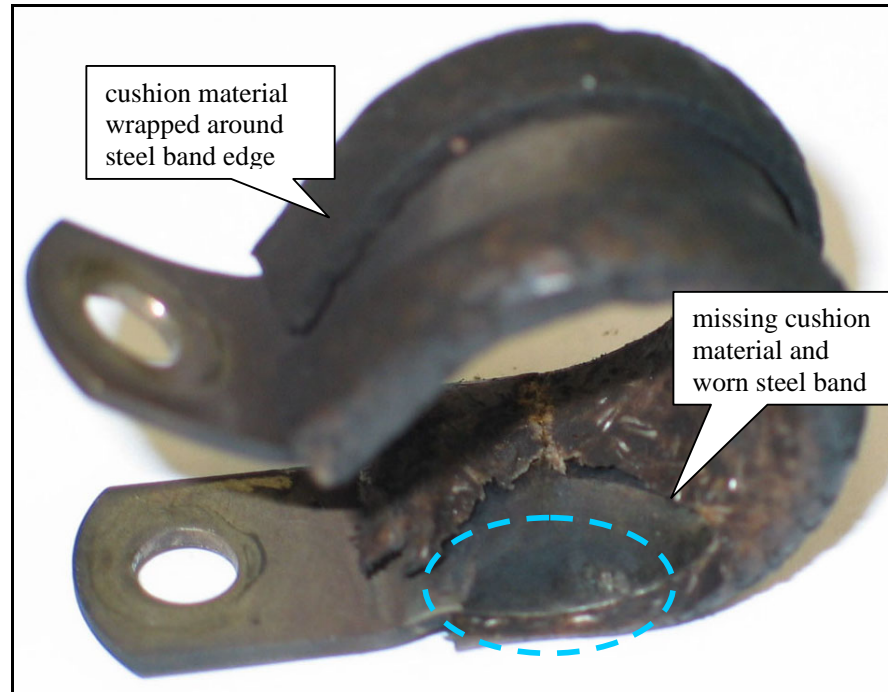
- 1.2.4 The #3 clamp was removed in the presence of the Commission's investigator. The clamp was loose on the manifold, but the attachment bolt break-out torque exceeded that specified. There was residue of a fibreglass tape, used to help achieve the required torque, under the clamp. Some cushion material was missing from inside the clamp and there were signs of metal-to-metal wear (see Figure 4). A pinhole was found in the fuel manifold where the clamp had been located.

**Figure 4**  
**#3 loop clamp from engine serial number 704518**  
Showing missing cushion material and metal wear.

- 1.9.3 The manifold pinhole was 0.014 by 0.031 inch (0.36 by 0.79 mm) in area and had originated in the region of missing cushion material on the #3 clamp. Some of the stainless steel band of the clamp had also worn away.

- 2.6 The fuel leak was in the manifold below the #3 clamp on the right manifold half, at approximately the one o'clock position on the engine. Although the clamp was properly bolted to the attachment bracket, it was missing some cushion material and metal-to-metal fretting had occurred between the manifold and the clamp.

The engine manufacturer revised the service bulletin to require the replacement of all of the manifold loop clamps at each inspection.

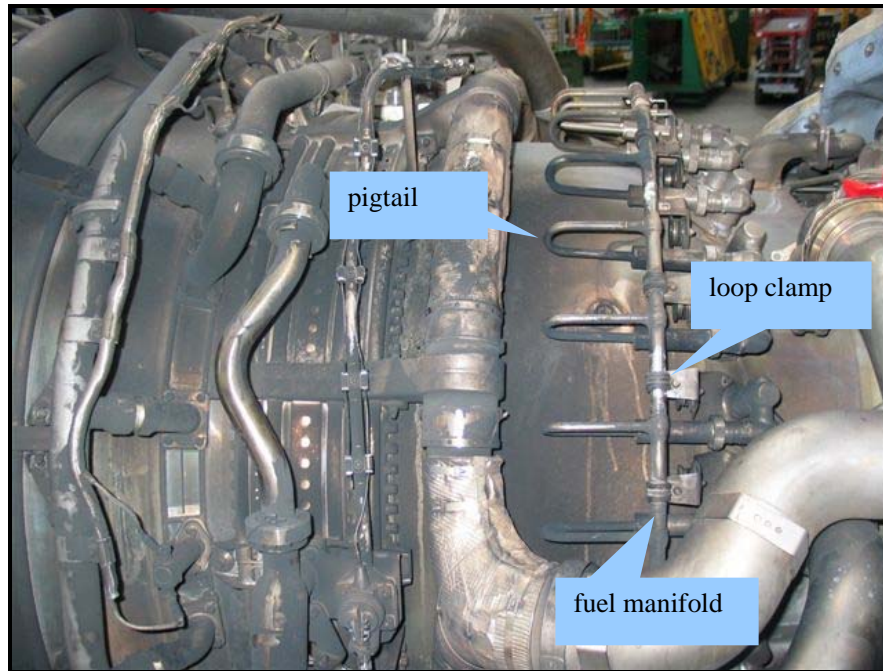
**Figure 5**  
**Fuel manifold and clamp locations, engine 704518**

- 1.2.8 Examination of the fuel manifold found 5 other clamps with excessive sideways movement, although the torque on 4 of them met the requirement. The exception had a torque value just below that specified and was the only clamp without tape under it. The tape was abraded at all loose clamp locations, and through to the manifold at 4 of these.

- 1.2.9 The cushion material was intact on all of the clamps, apart from #3, but the material was compressed and polished, although noticeably less so on the clamps from the left manifold half that had been replaced in November 2005.
