**Report 06-111, express freight Train 237, derailment, Utiku, 20 October 2006**

**Report 06-111**  
**express freight Train 237**  
**derailment**  
**Utiku**  
**20 October 2006**

At about 0640 on 20 October 2006, the sixth wagon on express freight Train 237 derailed and entered a crossing loop at Utiku, derailing 9 other wagons and bringing down a section of the overhead electric traction line as well.

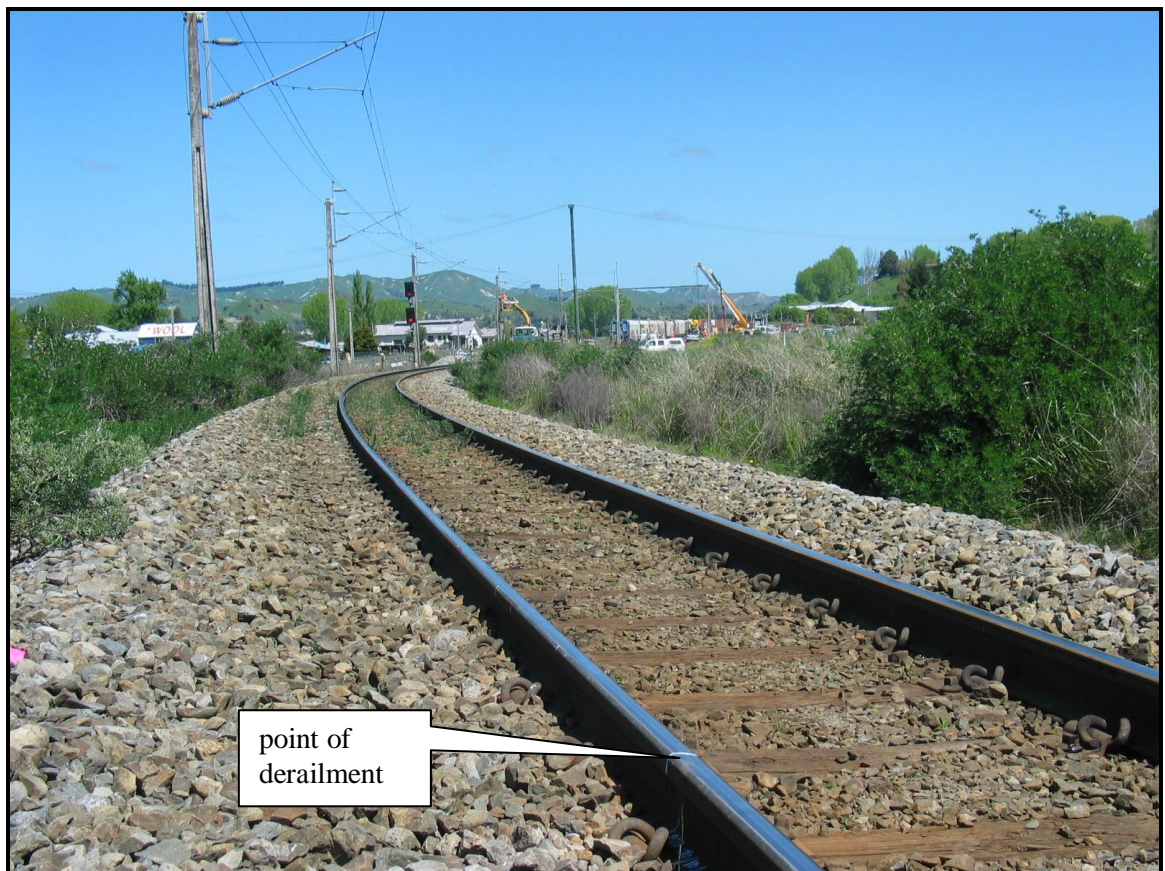
**Figure 1**  
**Track formation at the point of derailment**

- 1.2.3 The point of derailment was determined as 244.075 km NIMT, within the speed restriction, on a 500 m radius right-hand curve in the direction of travel (see Figure 1). The track within the derailment curve consisted of 50-kilogram-per-metre continuous welded rail fixed to treated *Pinus radiata* sleepers with Pandrol elastic-type fastenings. Both the rail and the sleepers were about 25 years old. The derailment curve had been tamped and lined in August 2004 and the curve had been de-stressed in 2005.

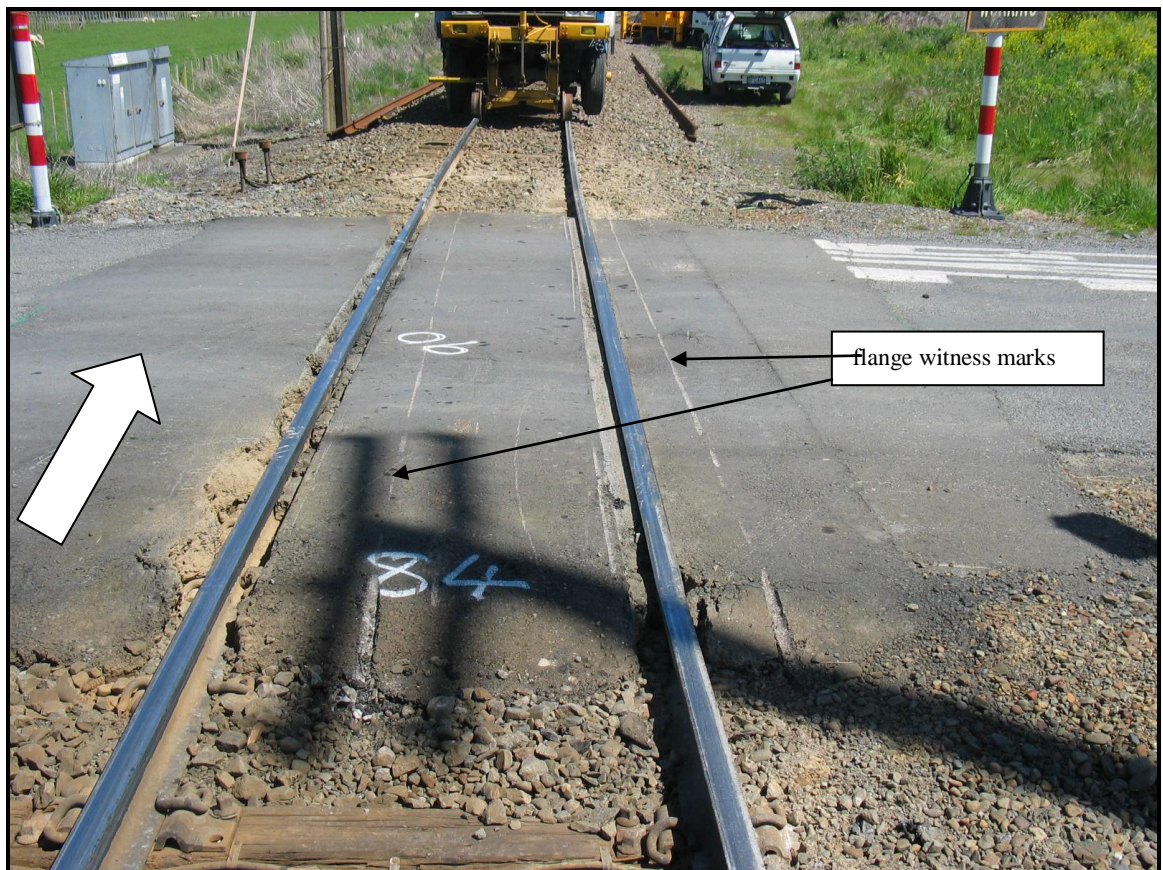
**Figure 2**  
**Wheel flange witness marks through Utiku North Road level crossing**

- 1.3.1 There were no wheel flange marks on the head of the running rail from which to determine exactly where the wheel had started its rail climb. A wheel flange witness mark was evident on the head of a screw spike on the field side<sup>4</sup> of the low leg rail in the direction of travel at 244.075 km NIMT. For track measure-up purposes, this location was taken as the point of derailment.
- 1.3.2 Forty-five metres past the point of derailment, the flange wheel witness mark moved out from the top of the screw spike onto the sleeper, 200 millimetres (mm) from the rail. Two sleepers further on there was no witness mark on the top of the screw spike, but there were 2 clearly defined wheel flange witness marks on the sleeper. The 2 witness marks on the sleeper ends continued through the level crossing (see Figure 2).

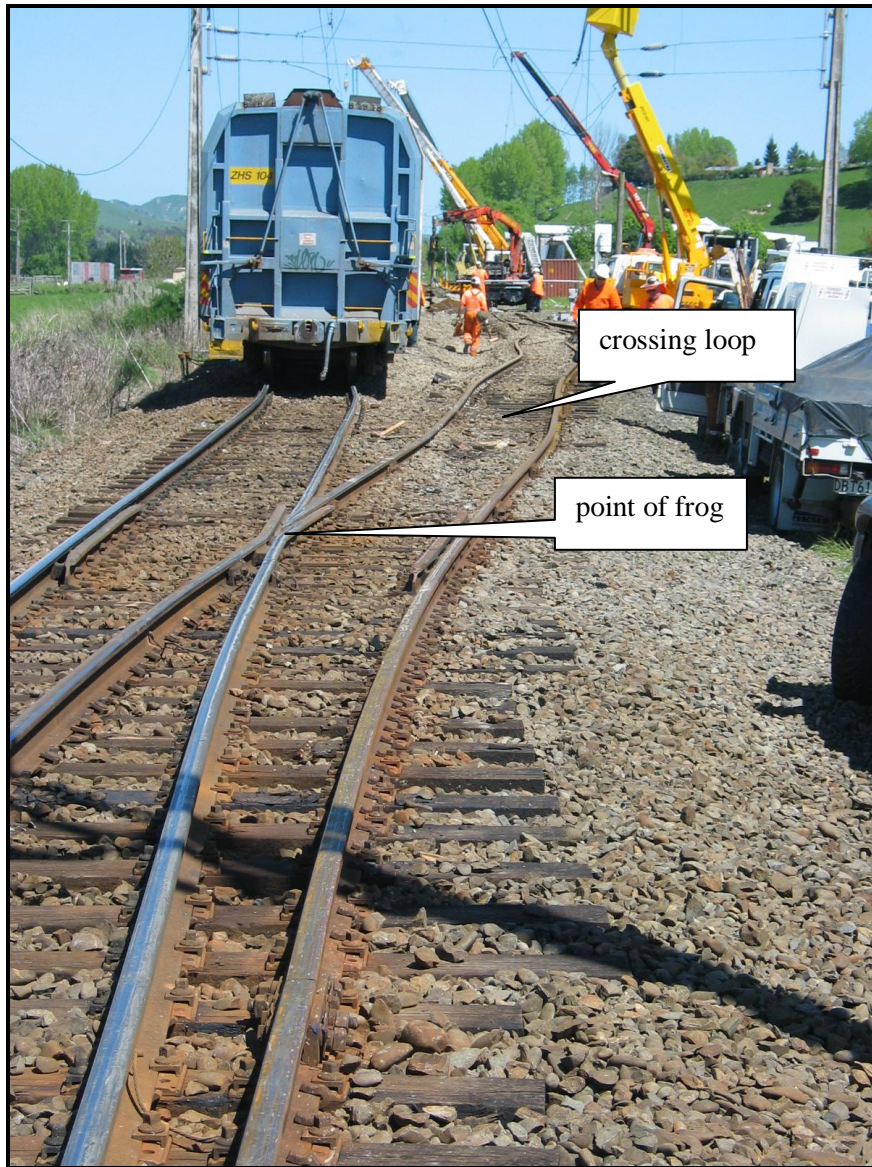
**Figure 3**  
**North-end mainline points at Utiku (in direction of travel)**

- 1.3.3 About 10 m past the crossing, there were 2 wheel flange marks on the right-hand end of the sleepers (in the direction of travel) about 300 mm from the field side of the rail. Witness marks at the north-end mainline turnout indicated that the trailing bogie of wagon PKH34 and the leading bogie of PKH21 had taken the loop road while all other wagons took the mainline (see Figure 3).

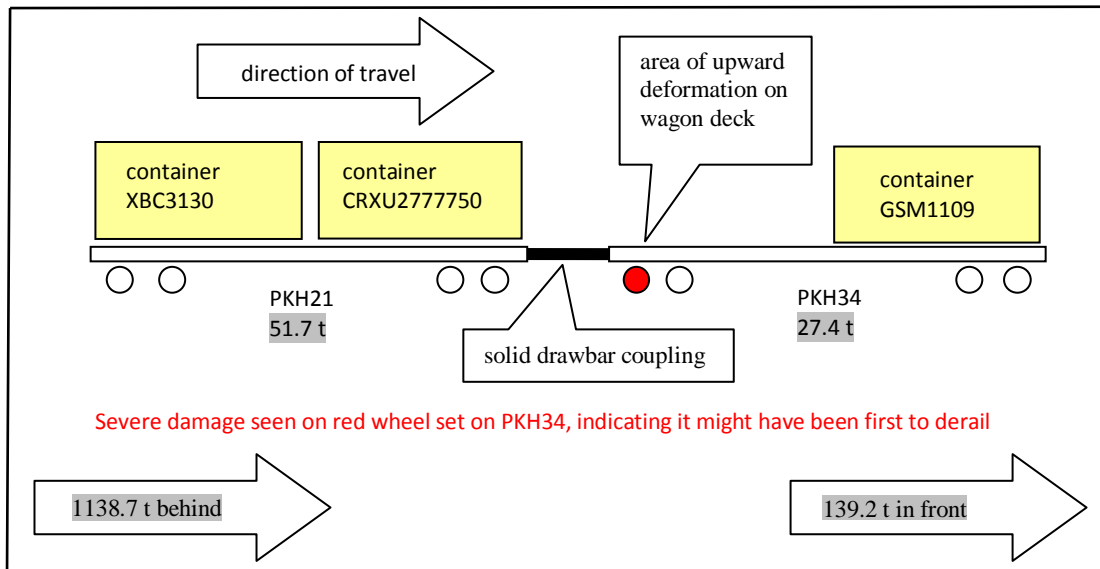
**Figure 4**  
**Loading details of PKH34 and PKH21 on Train 237**

- 1.5.1 Wagon PKH34 was the sixth wagon on Train 237 and was conveying a loaded 6.1 m container GSM1109 on the leading end of the wagon in the direction of travel. The total weight of the container was reported as 14.6 t but following the derailment it was found to weigh 18 t. The total tonnage ahead of wagon PKH34, excluding the locomotives, was recorded as 140 t. The trailing tonnage was recorded as 1137 t.
- 1.5.2 Wagon PKH21 was the seventh wagon in the train, immediately behind PKH34, and the pair was connected by the solid bar. PKH21 was conveying 2 loaded 6.1 m containers. Container CRXU2777750, weighing 10 t, was on the leading end and XBC3130, with a declared weight of 18 t but weighing 25 t, was on the trailing end (see Figure 4).

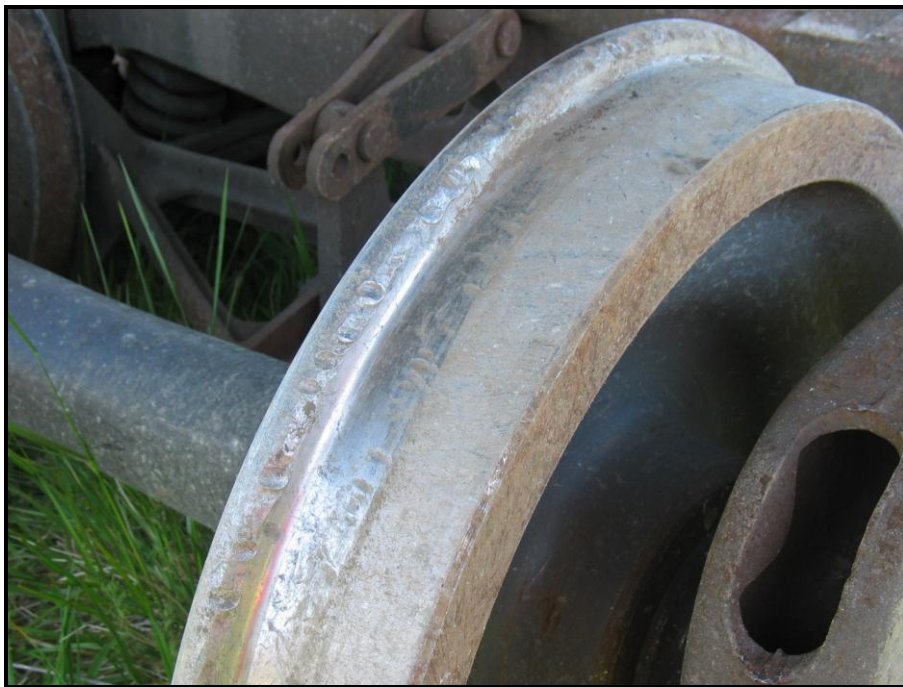
**Figure 5**  
**Derailed damage to the trailing wheel set of the trailing bogie on wagon PKH34**

- 1.5.3 An examination of the wheel sets of the derailed wagons showed that the trailing wheel set of the trailing bogie of wagon PKH34 (the closest wheel set to the solid coupler) sustained the most severe damage (see Figure 5), which indicated that this could have been the first wheel set to derail.

- 2.4 The wheel set with the most derailment damage in this case was the last one on the light end of wagon PKH34, which leads to a logical assumption that this was the first to derail, with that wheel set sustaining the most damage as it ran along the sleepers and ballast and across the level crossing before striking the mainline turnout at the north end of Utiku crossing station.

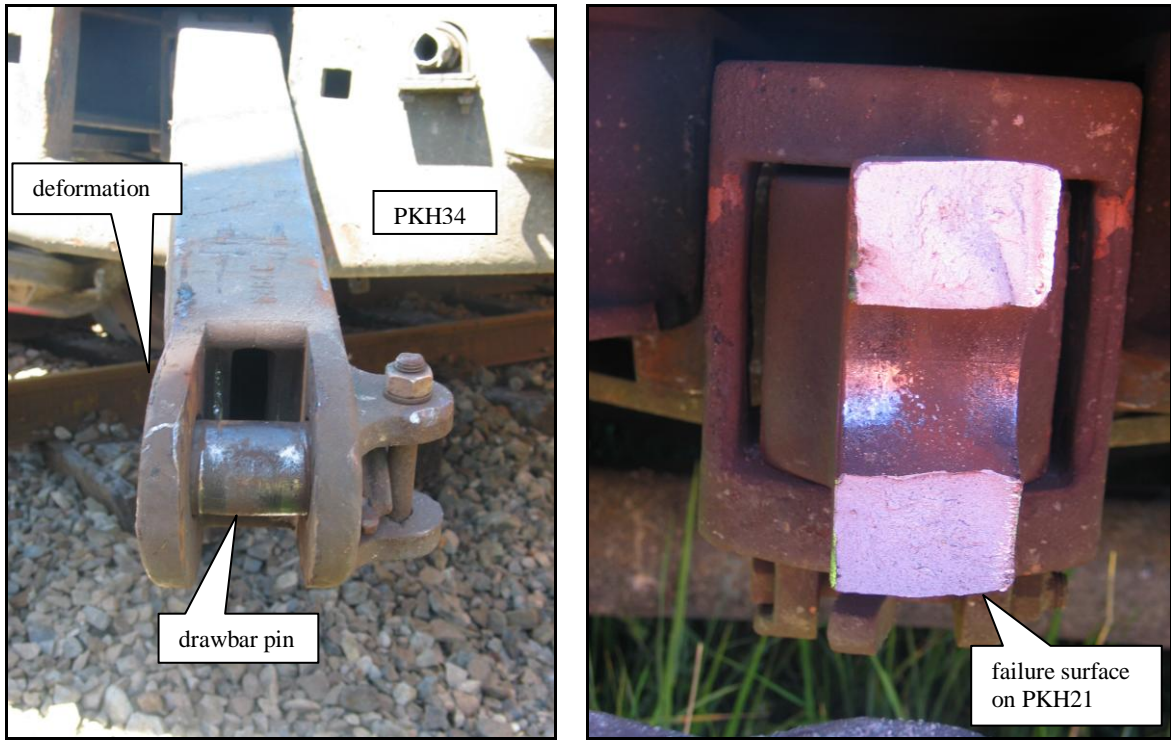
**Figure 6**  
**Left, deformed solid drawbar coupler assembly, and right, failed knuckle**

- 1.5.4 During the derailment sequence the coupler assembly connection to wagon PKH21 became deformed (see Figure 6) but the drawbar pin remained connected. The mating drawbar knuckle on wagon PKH34 fractured during the derailment (see Figure 6). An examination of the fracture surface showed it to have been a fresh overload failure with no discolouration typically present with pre-existing cracks.

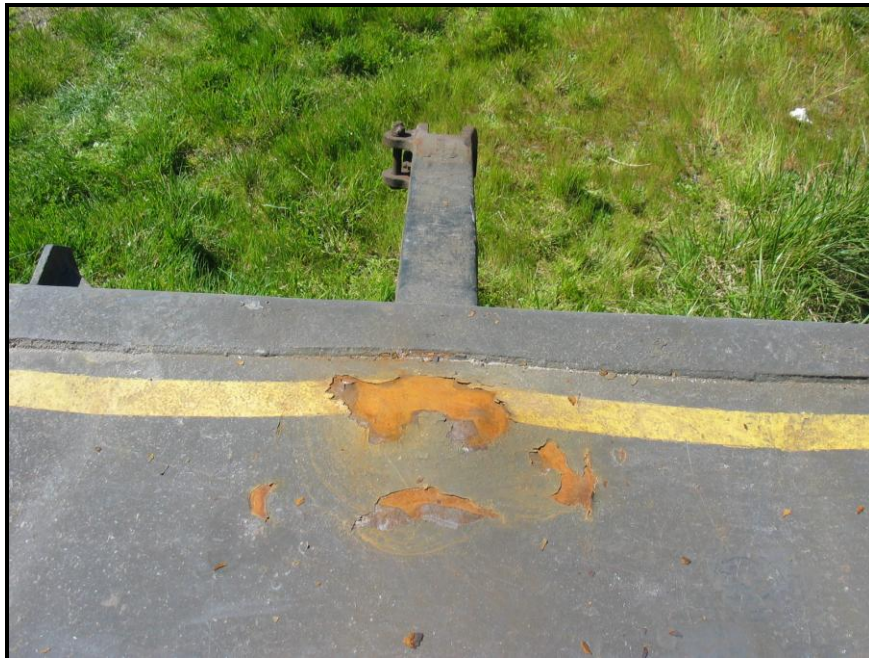
**Figure 7**  
**Deck at the trailing end of wagon PKH34**

- 1.5.5 The flat cargo deck at the rear of PKH34 was deformed upwards above where the solid drawbar attached to the chassis. Paint had fallen away from the deformed metal and corrosion was present on the metal surface under where the paint had been (see Figure 7).

- 2.7 The upward deformation of the flat container deck on the rear end of PKH34, just above where the solid drawbar was attached to the chassis, was symptomatic of the drawbar having been forced upward with some energy. This could have been as a result of the previous derailment or a cumulative deformation that had developed in normal service. The corrosion products evident on the top of the deformed plate make it unlikely that it occurred as a result of this derailment alone.
