**Report 08-002, Eurocopter AS355 F1, ZK-IAV, spherical thrust bearing failure,  
and subsequent severe vibration and forced landing,  
Mount Victoria, Wellington, 13 April 2008**

**Report 08-002**

**Eurocopter AS355 F1**

**ZK-IAV**

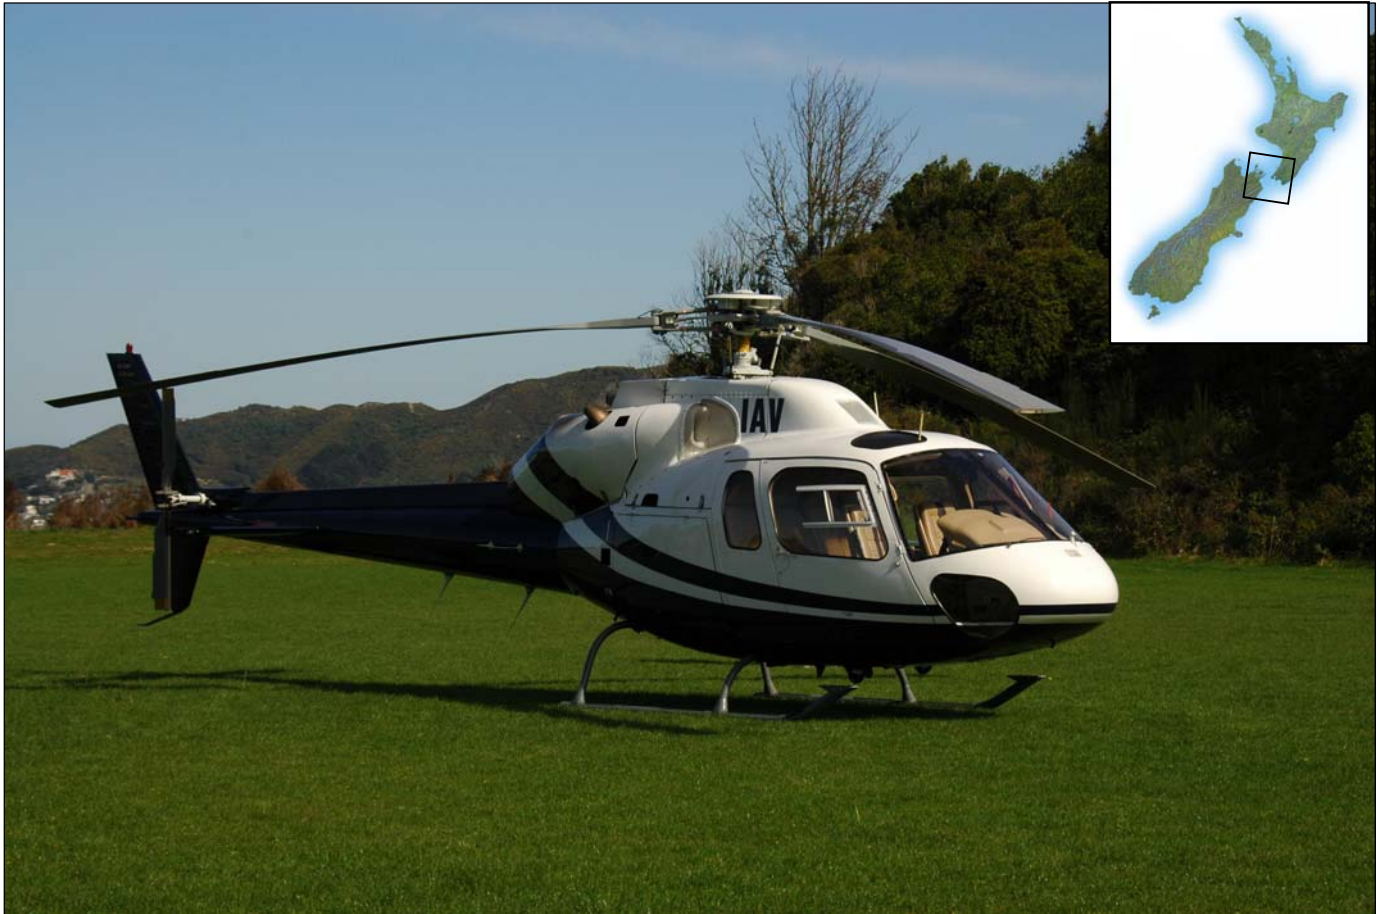
**ZK-IAV after landing near Mount Victoria, Wellington**

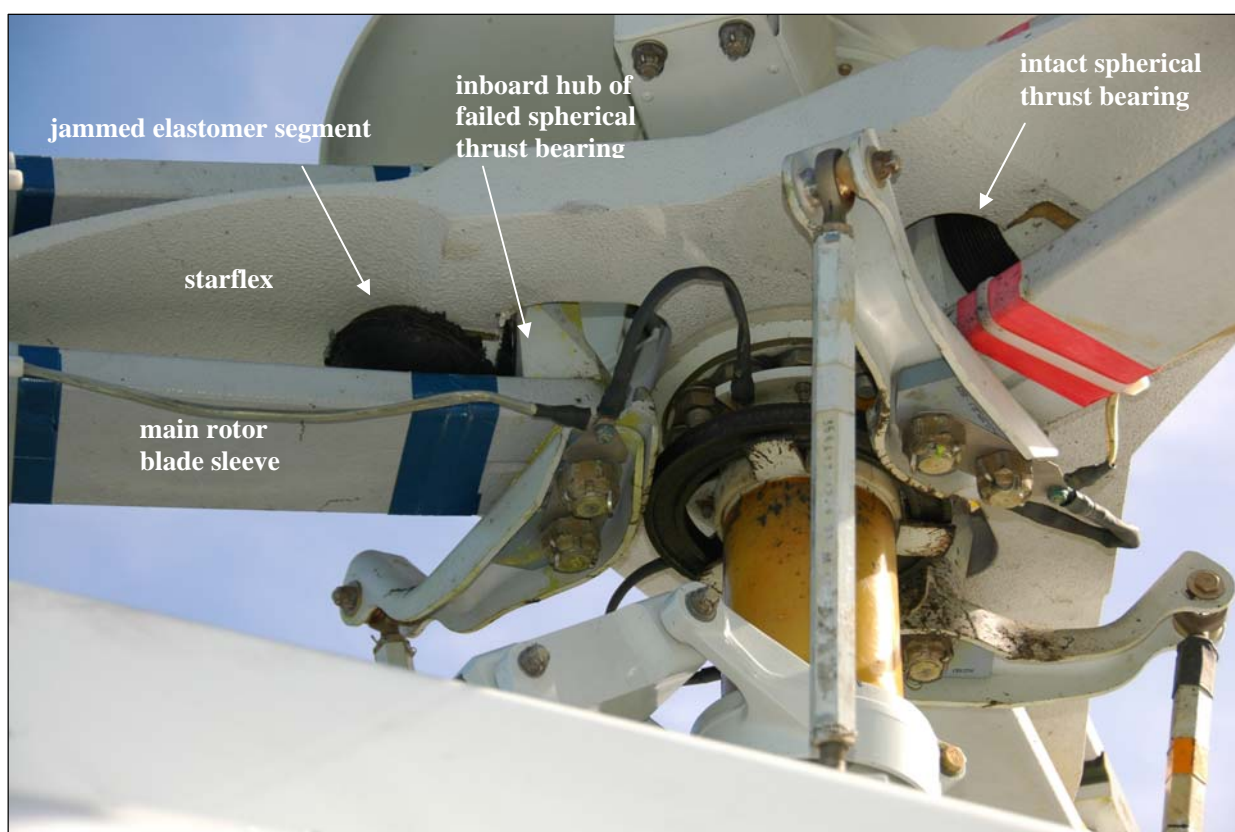
**Figure 1**  
**Rotor head assembly**

- 1.3.1 An examination of the helicopter found that the rubberised elastomer portion of one of its 3 main rotor spherical thrust bearings had separated during the flight and dislodged between the

starflex hub and its rotor blade sleeve (see Figure 1). The dislodged portion was approximately 4 centimetres thick, which allowed its main rotor blade to move outboard a corresponding distance, which created a large rotor imbalance and out-of-track situation. The failed bearing elastomer jammed between the sleeve and starflex hub and restricted cyclic pitch control of that blade.

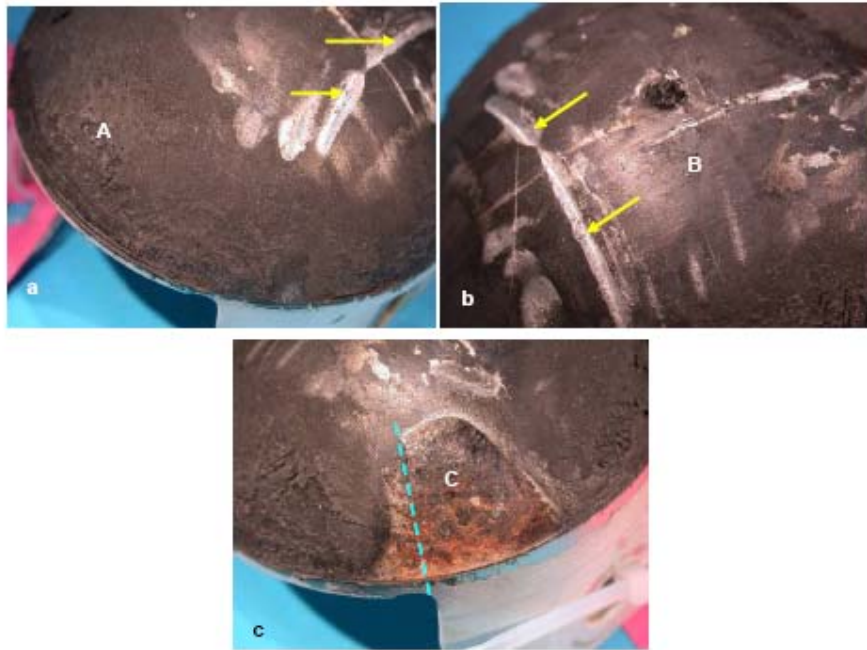
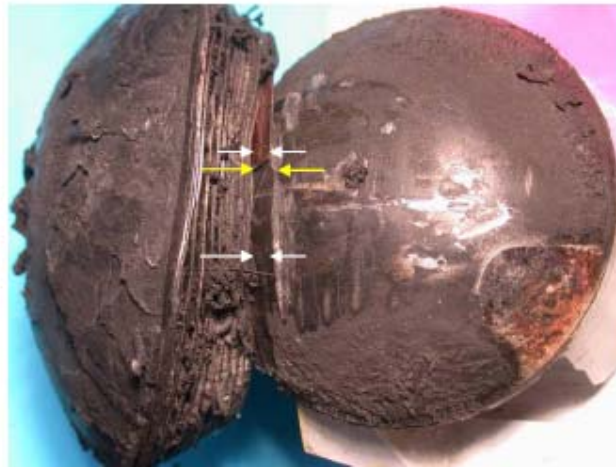
**Figure 4**  
**Area of corrosion and de-lamination**

- the bonding of the elastomer between most laminations and the condition of the elastomer were considered sound, but there was considerable de-bonding in the corroded region and the central region, and on the top lamination (see Figure 4)

- significant corrosion and de-bonding had occurred in region c (see Figures 4 and 5) on a laminate. The cause was not considered to be related to the age of the material because evidence of age-related de-bonding would have been more widespread

The convex surface of the Stop, showing (a) a large smooth area with very little rubber, (b) an area exhibiting no rubber and some corrosion product and (c) remnant rubber still adhered to the Stop.

Scratches on the Stop (right) matched with the two laminations on the Laminated Portion (left). Yellow arrows indicate the gap in the two laminations due to the missing piece of top lamination.

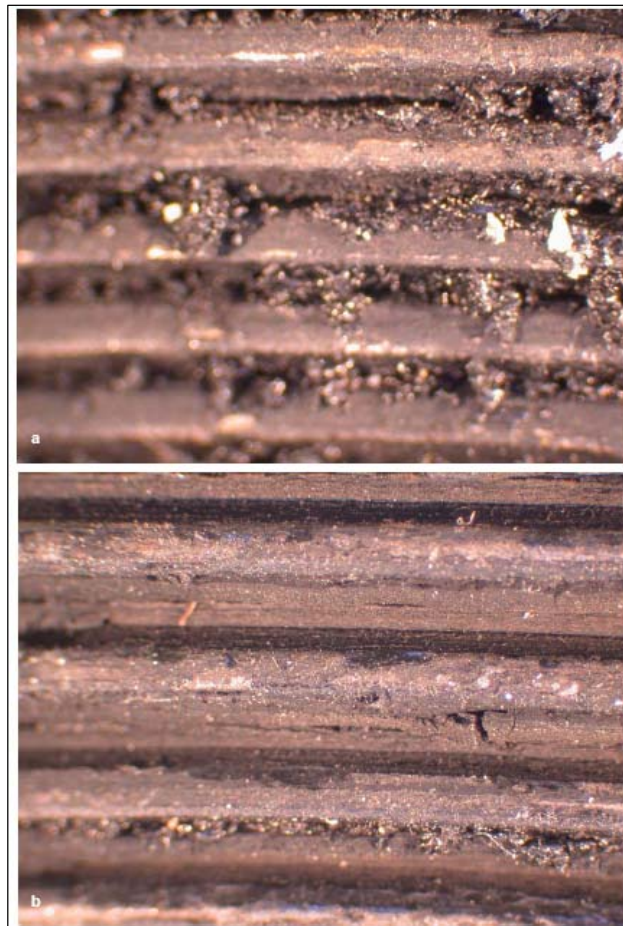
**Figure 6**  
**Elastomer surface condition of a non-failed bearing**

- the spherical thrust bearing failed because of initial de-bonding that allowed corrosion to occur. This in turn probably encouraged further de-bonding that allowed relative movement between 2 regions of the top lamination, which then led to its failure
- the final failure of the bearing was from de-bonding and overload of the top lamination
- the bearing materials were considered to have been fit for their intended purpose
- no evidence of fatigue was found
- there was no evidence that the initial de-bonding was from deterioration of the elastomer itself
- the 2 non-failed bearings showed no evidence of de-bonding or other damage of any significance. However, there was evidence of some surface degradation of the elastomer (see Figure 6).
