**Report 08-005, Kawasaki-Hughes 369D, ZK-HWE, un-commanded yaw and loss of control,
Maori Saddle, near Haast, Westland, 11 August 2008**

Report 08-005

**Kawasaki-Hughes 369D
ZK-HWE**

un-commanded yaw and loss of control

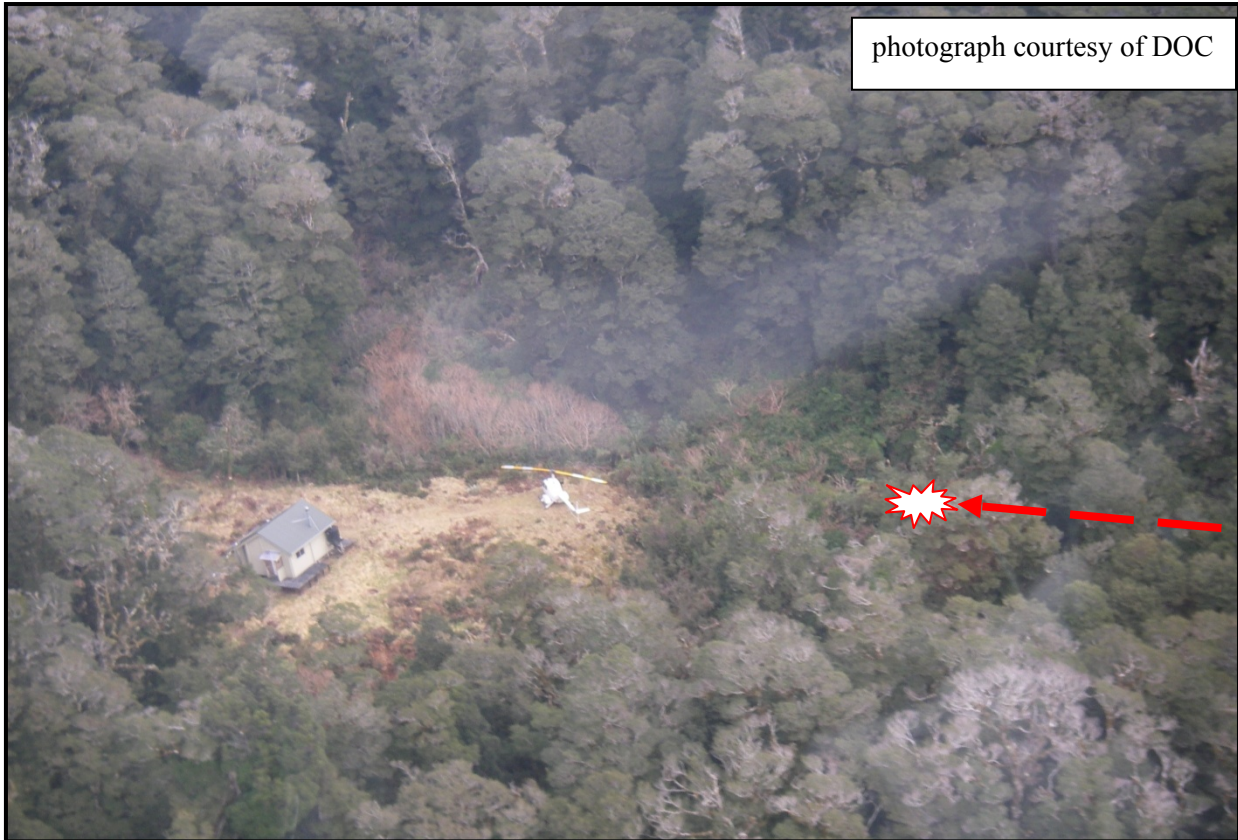
Figure 2
Maori Saddle Hut and pad, and approximate final approach path

- 1.1.7 The Maori Saddle Hut and adjacent landing pad were just north of the Saddle, in a basin with dense undergrowth and surrounding trees up to 20 metres (m) high (see Figure 2). The pilot flew overhead the Hut, with the pad on his left side so that he could assess its condition, then made a descending left turn to approach from the north-east. He said he was aware that the approach would be down wind, and that he correlated the airspeed with the GPS ground speed.

- 1.1.10 The final approach angle was shallow, such that the pilot said he did not see the Hut or pad again until he crossed the trees around the western side of the site. One front-seat passenger described the helicopter “pulling up” to slow down on the final approach. The pilot flew between some high trees and kept the helicopter pointed slightly to the right so that he could see the pad.

- 1.2.2 The hit tree was among scattered trees of similar height, and was not easily seen against the bush background. The helicopter had approached from the western side of the valley, whereas the surrounding trees were lower when approaching the pad from the centre of the valley.

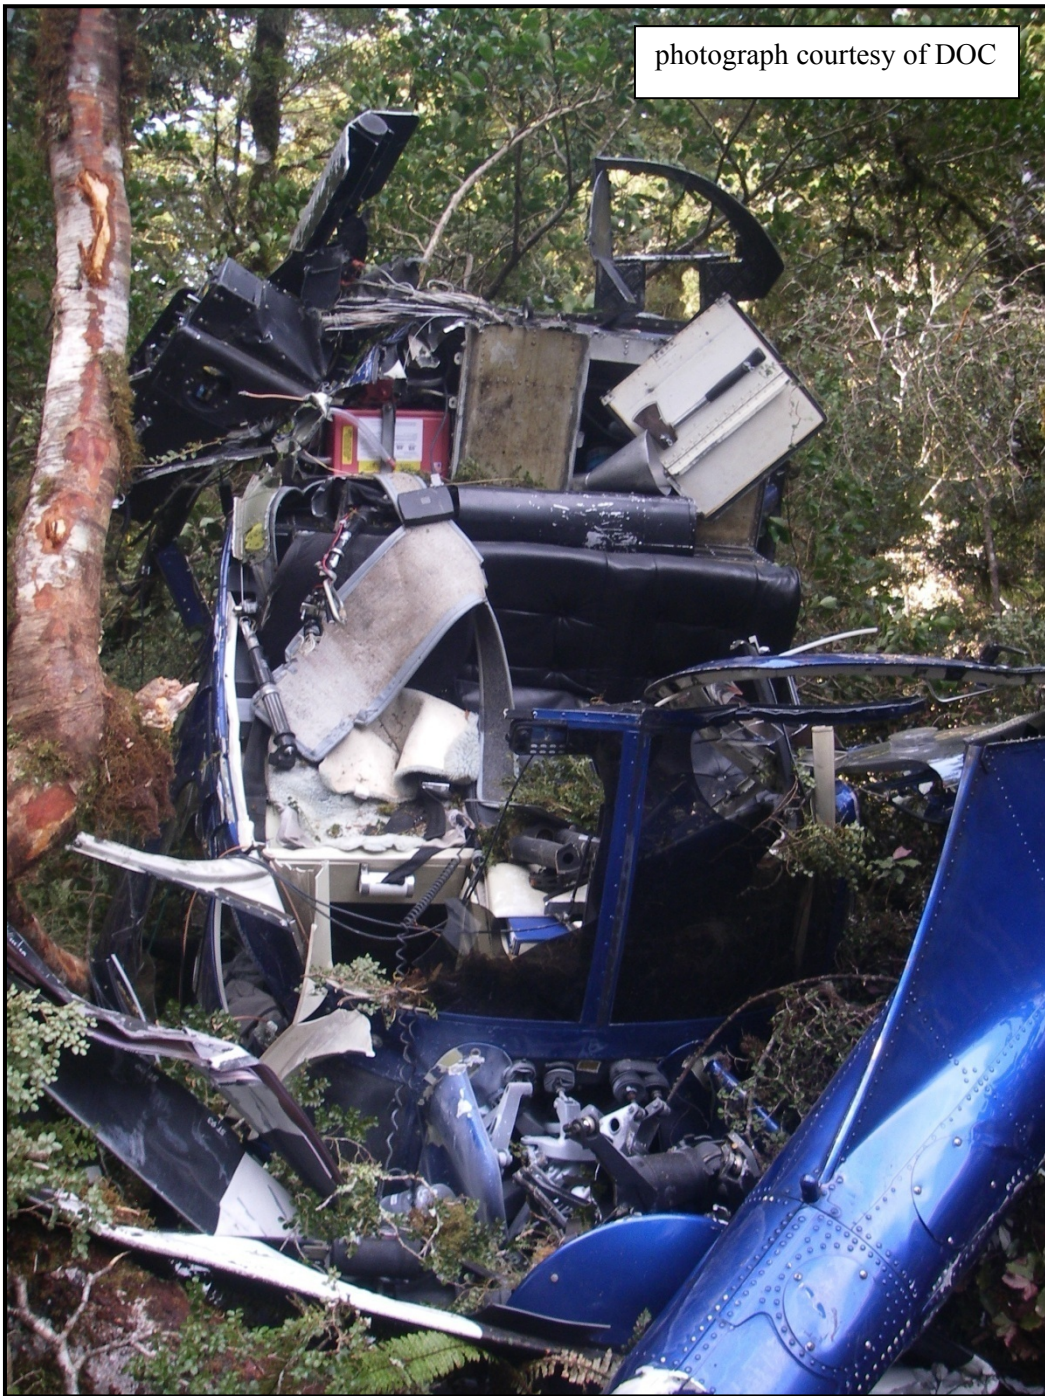
Figure 3
Wreckage of ZK-HWE

- 1.2.1 The helicopter came to rest in dense undergrowth, pointing upwards, at the base of a tree that was approximately 15 m high and had a few high branches broken (see Figure 3). All of the wreckage was located within a radius of about 8 m of this tree, which was about 35 m from the intended landing site. No evidence of prior rotor strike was found outside that area.

- 1.2.3 The forward end of the cargo pod was broken open and its contents were spilled very closely around the wreckage, which indicated that the helicopter had fallen nearly vertically through the trees. Rain since the accident had wet most of the cargo, especially personal packs.

- 1.2.4 The main rotor blades were destroyed, with 3 of the 5 blades stacked and the retention straps on some blades pulled apart. This damage was indicative of the rotor having been driven by the engine when the first blade impacted. The continuity of the main rotor controls was established.

- 1.2.5 The tail boom, which was completely detached and lying adjacent to the fuselage, had been hit multiple times by the main rotor blades. The T-tail assembly, including the tail rotor, was nearby and largely undamaged. The tail rotor turned freely and quietly, and the gearbox oil level was full. The tail rotor and stabiliser surfaces had minor damage, consistent with low-speed impacts with trees. The break in the tail rotor drive shaft had occurred while the shaft was being driven. The continuity and proper functioning of the tail rotor controls were confirmed as far as the wreckage allowed.

- 1.2.7 Although the cabin retained its protective shape, the front left of the cockpit had taken a heavy impact. The cyclic stick was broken at its base, which the pilot said he thought was caused by his pushing against the stick, during the tumble, to prevent receiving a severe chest injury.
- 1.2.8 The instrument panel was dislodged and the instrumentation offered few reliable readings. All circuit breakers were made, the emergency locator transmitter was in the armed position, and the battery and auto re-ignition switches were OFF. The altimeter sub-scale setting was 1014 hectopascal.
