**Report 08-204, 6-metre workboat *Shikari*, collision with moored vessel,  
Waikawa Bay, Queen Charlotte Sound, 20 June 2008**

Distraction by cellphone and excessive speed within a speed restricted area were the major factors contributing to the fatal collision on 20 June 2008 in Waikawa Bay, Queen Charlotte Sound, of the 6 metre aluminium workboat *Shikari* with the stern of the moored *Flightless*, a 27 metre private vessel.

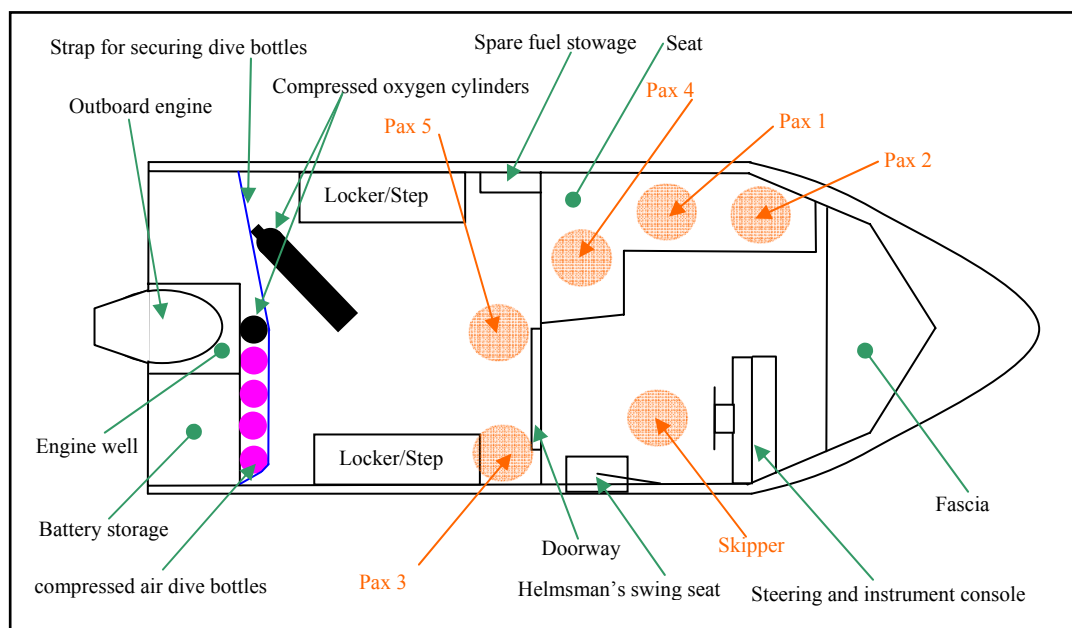
**Figure 2**

- 1.1.6 On the journey to Waikawa, Pax 3 and 5 were standing in the cockpit of the *Shikari* (see Figure 2). The skipper was standing at the helm station on the starboard side of the boat inside the cabin. Pax 4 was sitting in the aft port corner of the cabin conversing with Pax 1 who was sitting on the port side middle. Pax 2 was sitting in the port forward corner of the cabin facing aft. All were wearing life-jackets in accordance with company procedures. The dive bottles and oxygen cylinders were strapped across the transom, but one oxygen cylinder was lying on the cockpit deck.

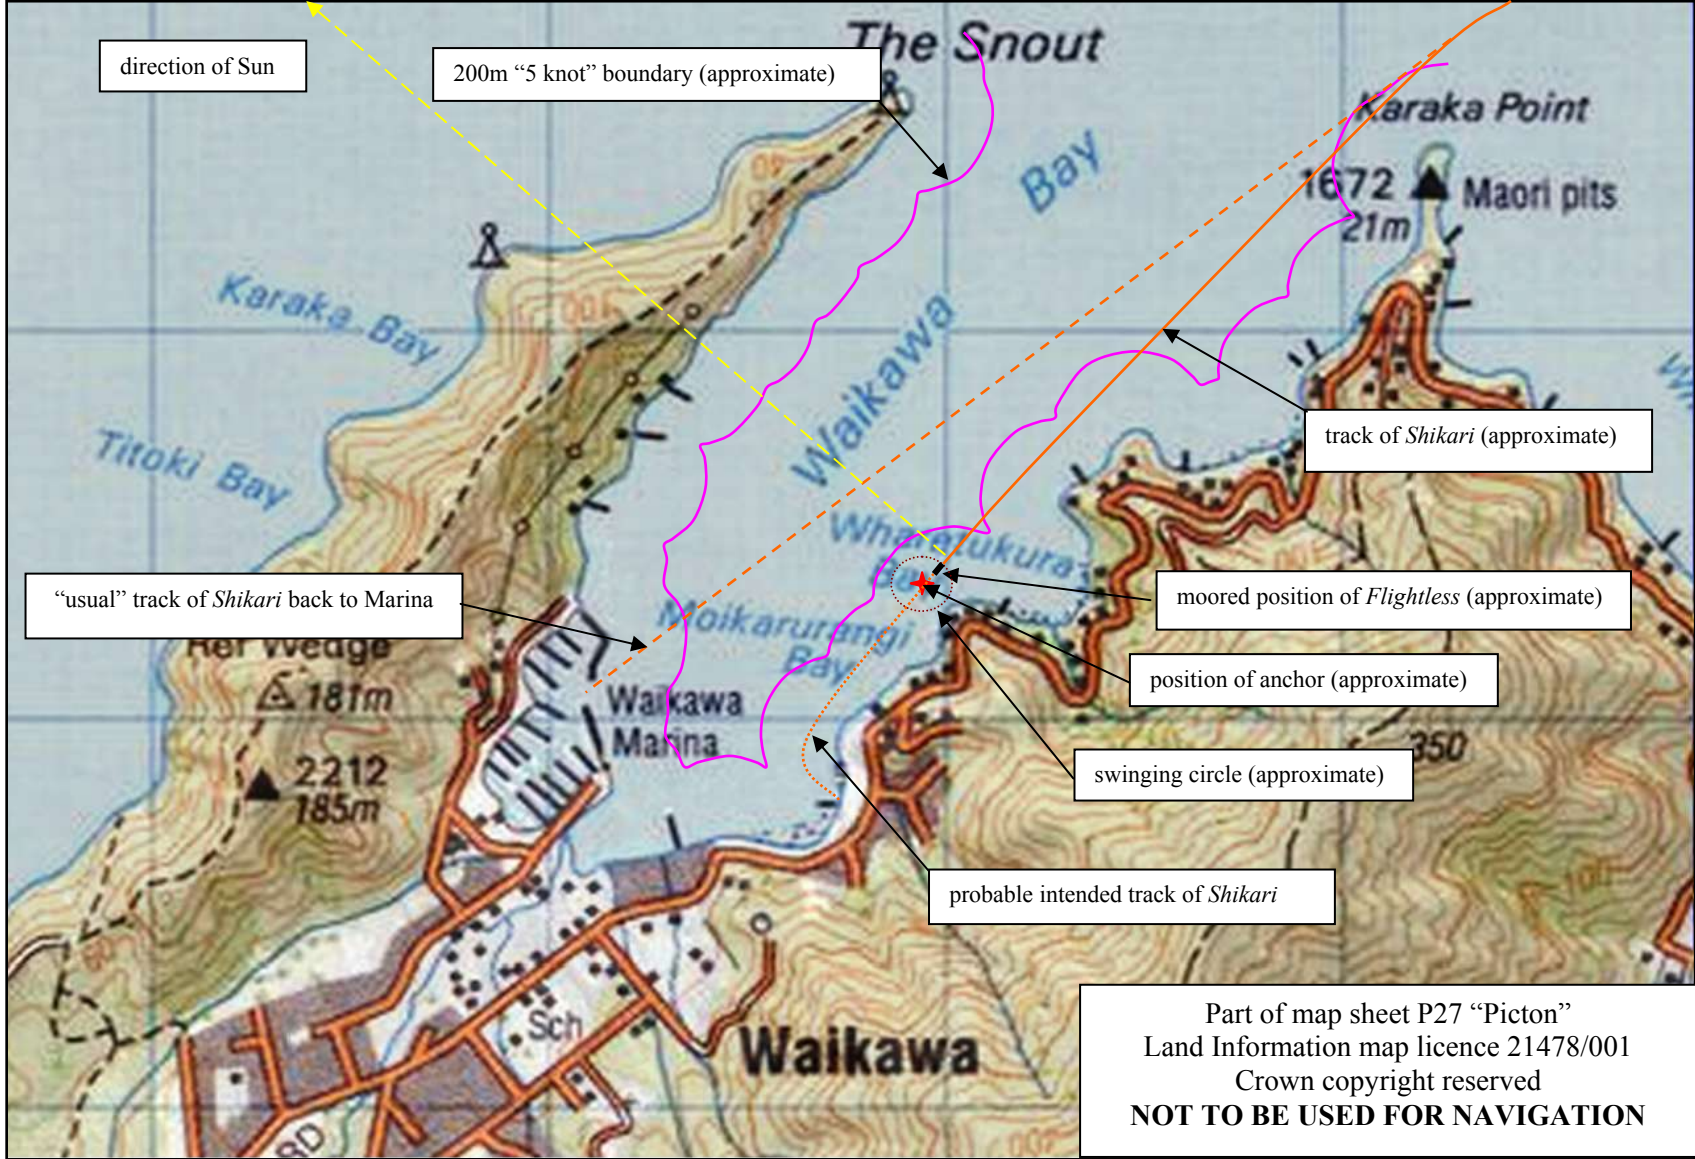
**Figure 3**  
**Waikawa Bay**

- 1.1.7 The *Shikari* followed a course into Waikawa Bay that Pax 5 estimated took the vessel about 200 m off Karaka Point (see Figure 3), then headed towards the west side of the bay where the community wharf was situated. After the incident Pax 5 commented that by looking through the cabin door they could clearly see through the forward windows.

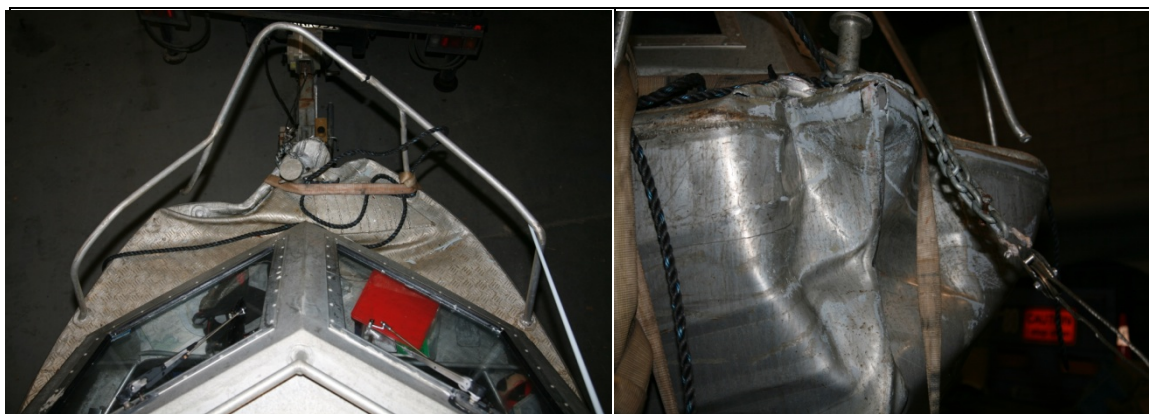
**Figure 5**  
**Damage to the *Shikari*'s bow**

- 1.5.1 The *Shikari* sustained significant impact damage to the bow section the bow was foreshortened by about 300 mm to 400 mm (see Figure 5). The helm station, associated hydraulic steering equipment and electronic instrumentation attached to the helm station were also significantly damaged.
- 1.5.2 The bulkhead between the rear of the cabin and the cockpit had been set forward about 45 mm and the aluminium bulkhead showed a distinct impact mark consistent with the shape of a compressed oxygen cylinder.

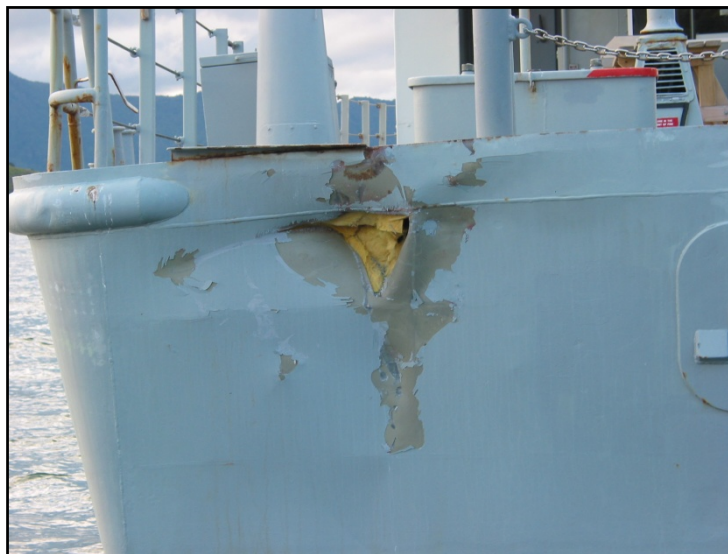
**Figure 6**  
**Damage to the stern of the *Flightless***

- 1.5.3 The *Flightless* sustained a hole in the transom of the vessel approximately 1.4 m above the waterline (see Figure 6).
