**Report 09-006, Cessna 207, ZK-DEW aircraft starting incident resulting in runway incursion,
Queenstown Aerodrome. 5 September 2009**

**Cessna 207
ZK-DEW**

aircraft starting incident resulting in runway incursion

Queenstown Aerodrome

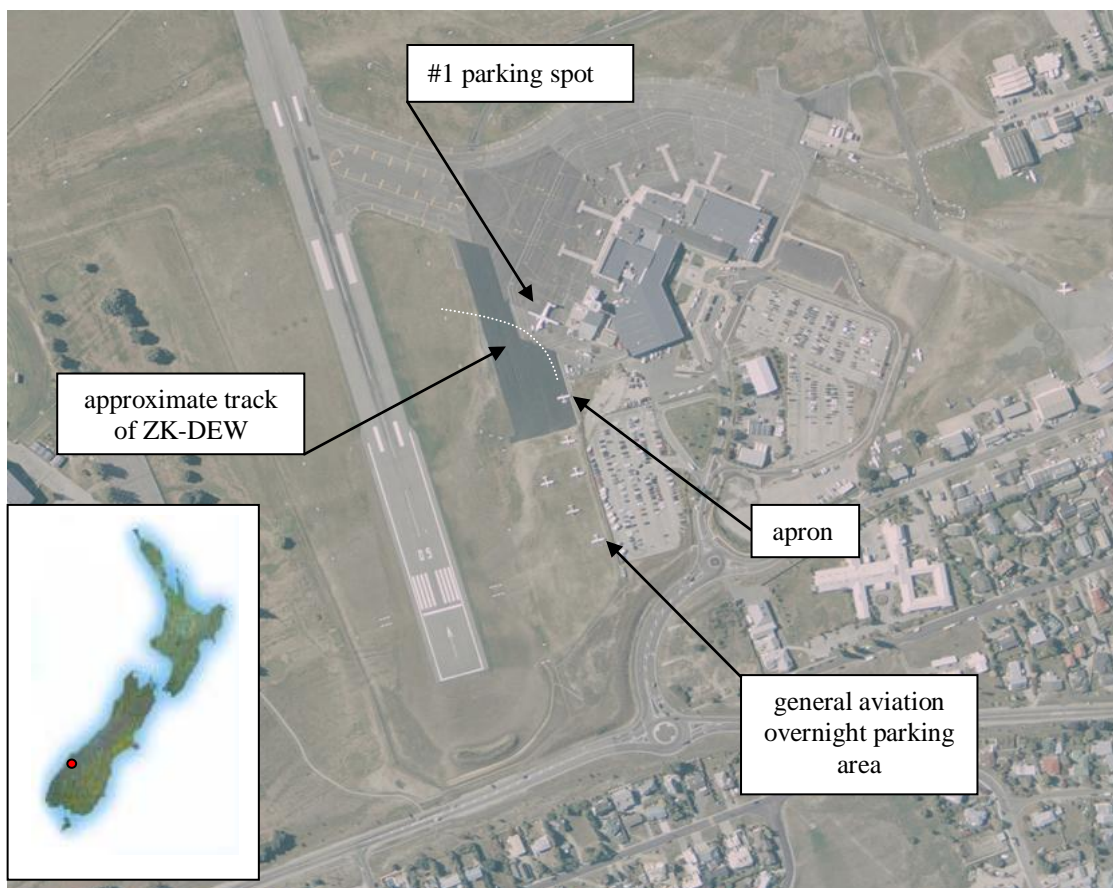
Figure 1
Queenstown Aerodrome
(courtesy of Queenstown Airport Corporation)

The aircraft left the apron area and entered the grassed Zone 2 protection area adjacent to the main runway before stopping. It was therefore classed as a runway incursion because permission from air traffic control was required before entering the Zone.

struck and damaged a marker board. The aircraft came to a halt a few metres past the marker board and about 40 m from the runway. There were no injuries.

- 1.4.4 The recording showed that ZK-DEW moved about 95 m before coming to a stop. It was estimated that ZK-DEW accelerated to a speed equivalent to a fast jogging pace and was slowing as it crossed from the apron onto the grass. During the movement the right side of the aircraft only was visible and it was not possible to see the pilot moving alongside.

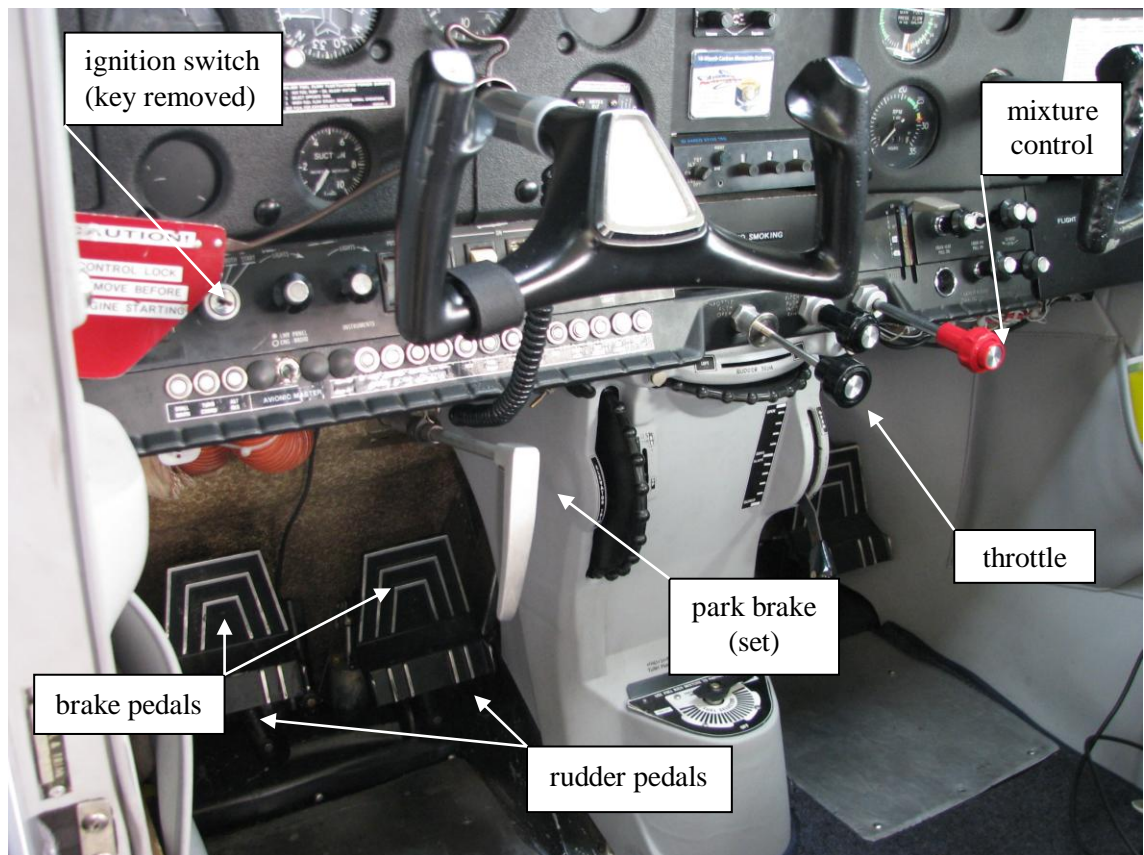
Figure 2
Aircraft controls – ZK-DEW

1.3.2 The 3 main engine controls, the throttle, propeller and mixture, were of the push-pull type. The engine would normally be started by an electric starter and usually shut down by pulling the mixer control to idle cut-off (see Figure 2). The engine could also be shut down by turning the ignition switch off and thus the engine magnetos, leaving residual fuel in the fuel line to the engine.

1.3.3 ZK-DEW was fitted with individual disc type brakes on both main wheels, operated by pressing down on the corresponding foot pedal located above the rudder pedals. The brakes could also be set by pulling and rotating a park brake lever handle mounted at the bottom of the instrument panel in front of the pilot. To release the park brake the lever handle was rotated and the lever would retract and thereby release the brakes. Tests determined that the handle needed to be rotated some 30-45 degrees before the lever would retract.

- 2.5 For the aircraft to have moved with the park brake properly set and 6 persons on board, testing showed it would have required an engine power setting higher than 1700-1900 rpm. Therefore it can be assumed that the rapid forward movement of the aircraft after starting was due to a combination of the higher rpm and the hand brake being released. The handle did not require much pressure or movement before it would release and any lateral movement of the flight coordinator’s knee making contact with the park brake handle could have knocked and released the brake.
