**Report 09-205: stern trawler *Pantas No.1*, fatality while working cargo,  
No.5 berth, Island Harbour, Bluff, 22 April 2009**

**Final report 09-205**

**stern trawler  
*Pantas No.1***

**fatality while working cargo**

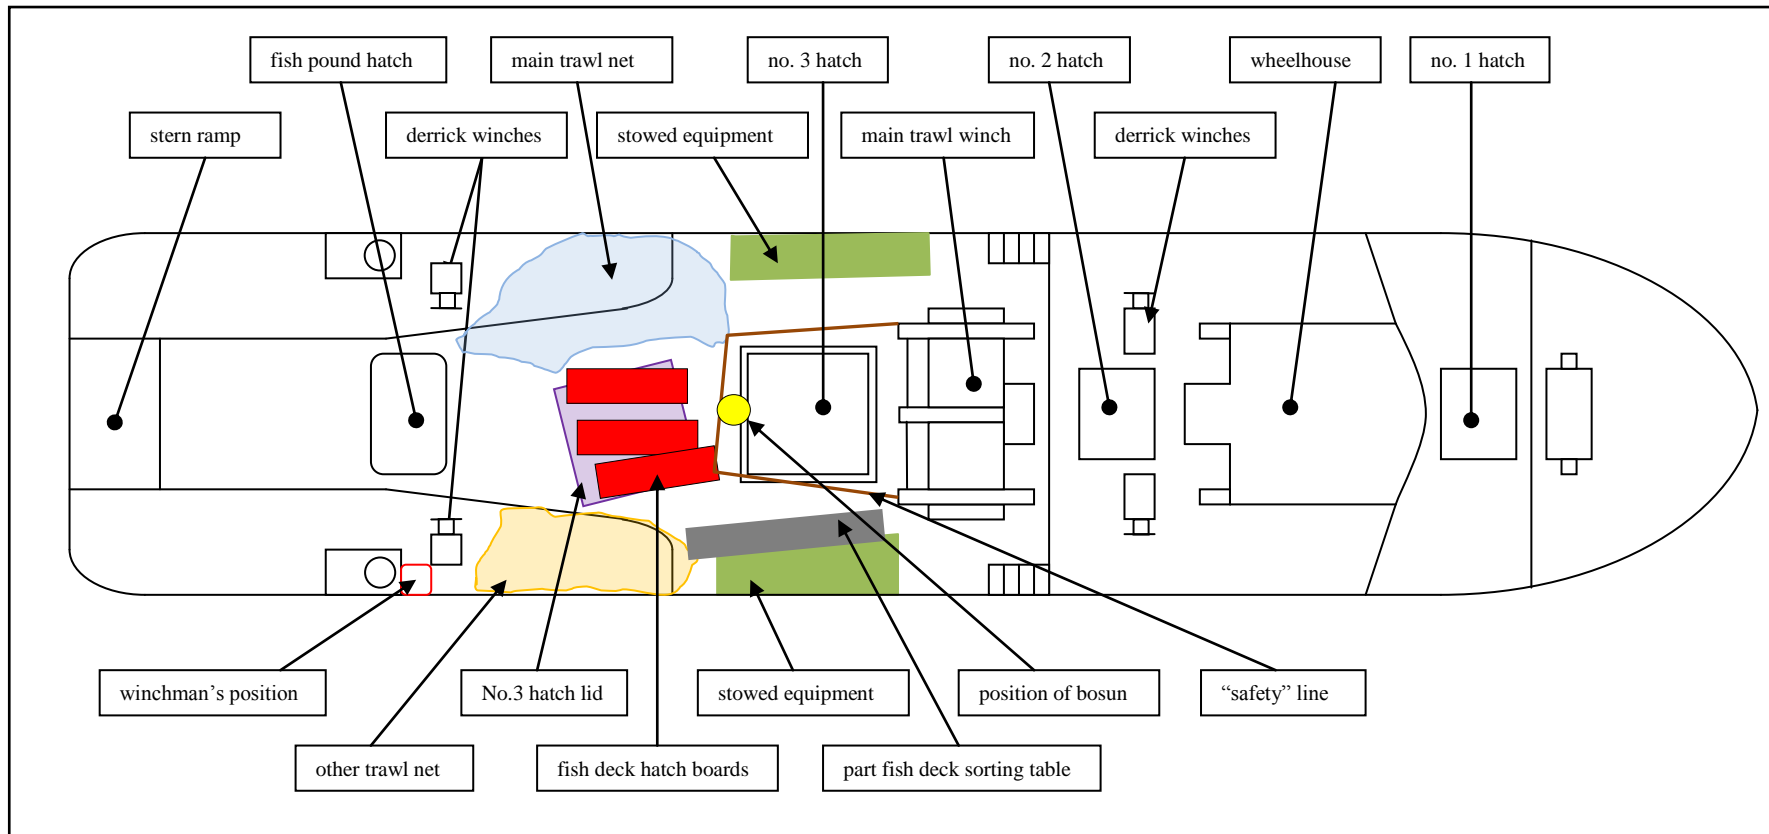
**Figure 2**  
**Diagram of the main deck of the Pantas No.1**

- 1.1.2 On 22 April 2009 at about 0730, the discharge of the cartons of frozen cargo started from hatch numbers 2 and 3. The cargo from freezer holds 1 and 2 was discharged through number 2 hatch and the cargo from freezer holds 3 and 4 was discharged through number 3 hatch.

- 1.1.3 Before discharge started a “safety” line was rigged around number 3 hatch. The safety line had been rigged from an eye pad on the main trawl winch through a loop in the main trawl net, then across to and through a loop on one of the lifting strops attached to one of the fish deck hatch boards, then back to another eye pad on the starboard aft side of the main trawl winch (see Figures 2 and 4). The safety line was a polyester right-hand or “Z” laid rope, orange in colour and about 12 millimetres (mm) in diameter. The height of the safety line varied between about 1500 mm at the 2 eye pads to about 200 mm at the after end of the hatch. There was no purpose-designed way to rig a substantial safety fence around the hatch. Number 2 hatch was constructed with a coaming of about 300 mm high which would have required a safety line when the hatch was open.

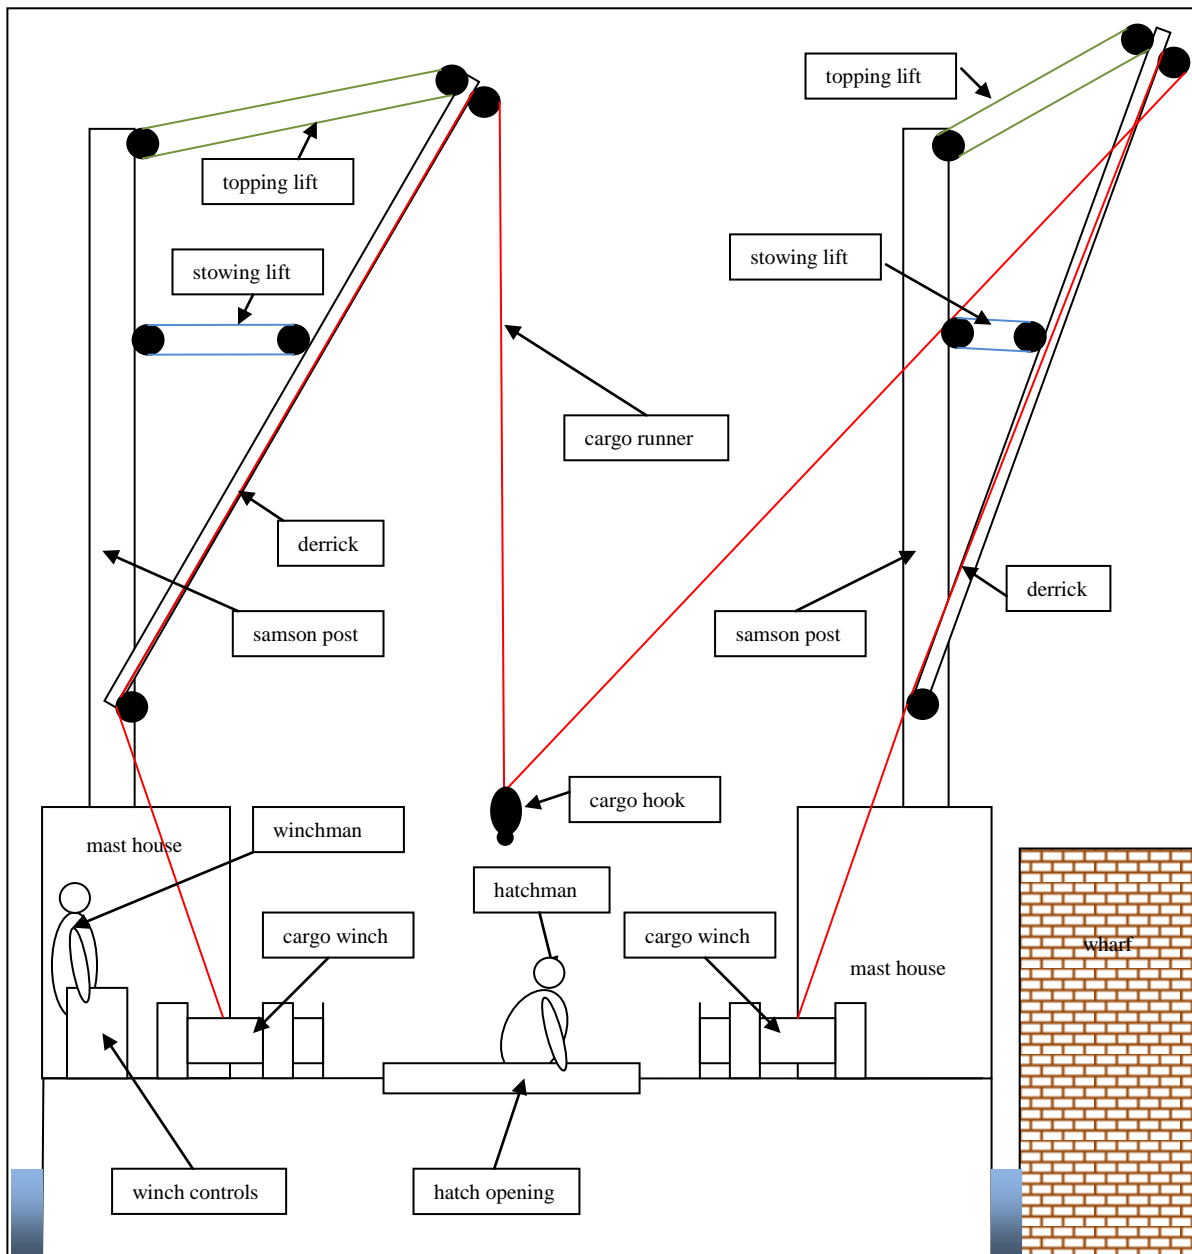
**Figure 3**  
**Elevation showing cargo gear rigging**

- 1.1.10 The winchman operated the winch controls to lift the net off the deck and over the side, and in doing so focused his attention on the position of the cargo net and where he intended to land it on the wharf. However, as he hoisted the net, the safety rope caught on the bottom of the pallet. As the load rose so did the safety line, drawing the line initially taut then pulling the line through the loop of the main trawl net. As the “safety” line was pulled upwards on the port side, the moveable hatch board was drawn towards the hatch opening, resulting in the safety line being drawn under tension over the hatch opening.

- 1.1.11 One of the stevedores on the quay noticed that the safety line had caught on the pallet and shouted a warning; however, the warning was either not heard or not understood. As the line tightened it lifted up from the deck behind the bosun, who was crouching inside it, and caught him behind the legs under the buttock area, toppling him into the freezer hold.

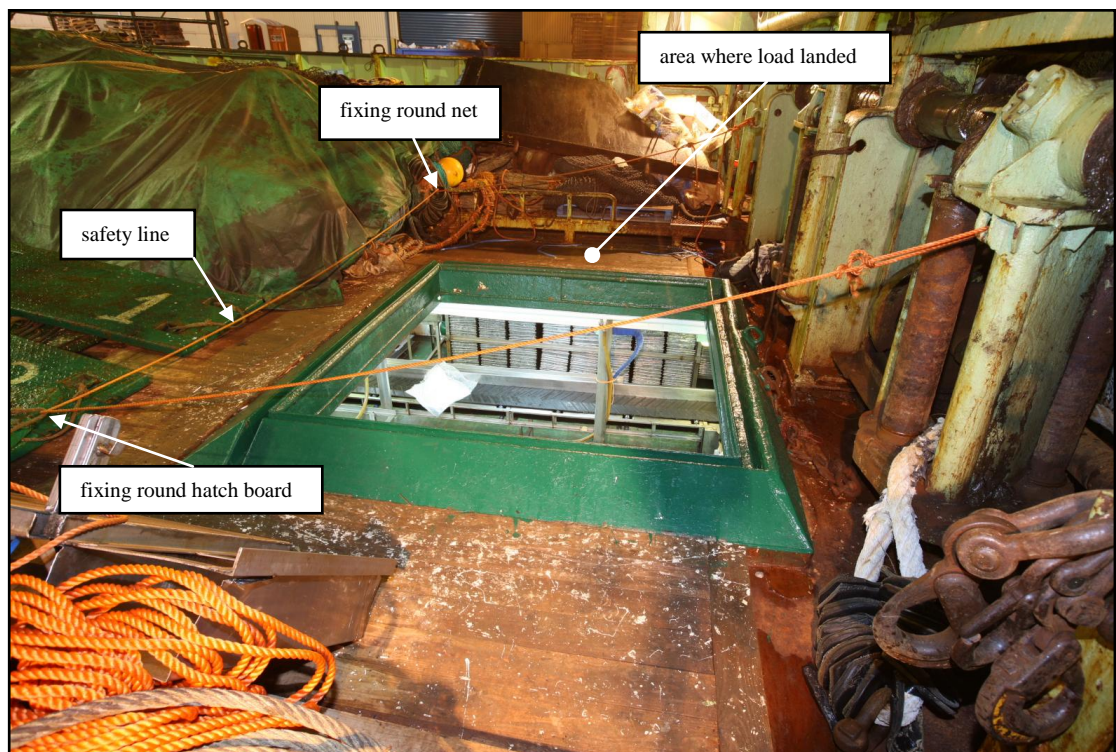
**Figure 4**  
**Scene of the accident as recreated by the New Zealand Police**

- 2.8 The bosun had probably stepped over the “safety” line to afford himself a better view into the fish hold. As the deck supervisor he should have been aware of the required procedures for safe discharge operation, and if he was, that the safety line did not comply with Code requirements and that stepping inside it was an additional violation. He probably committed violations with the rationale that he needed to do this to get the job done and this was the quickest and easiest way, thus indicating a situational violation. He had probably stepped over the safety line and entered the “unsafe space” around the hatch opening on several occasions during the day, and might well have done so on numerous occasions indicating that this had become a routine violation.

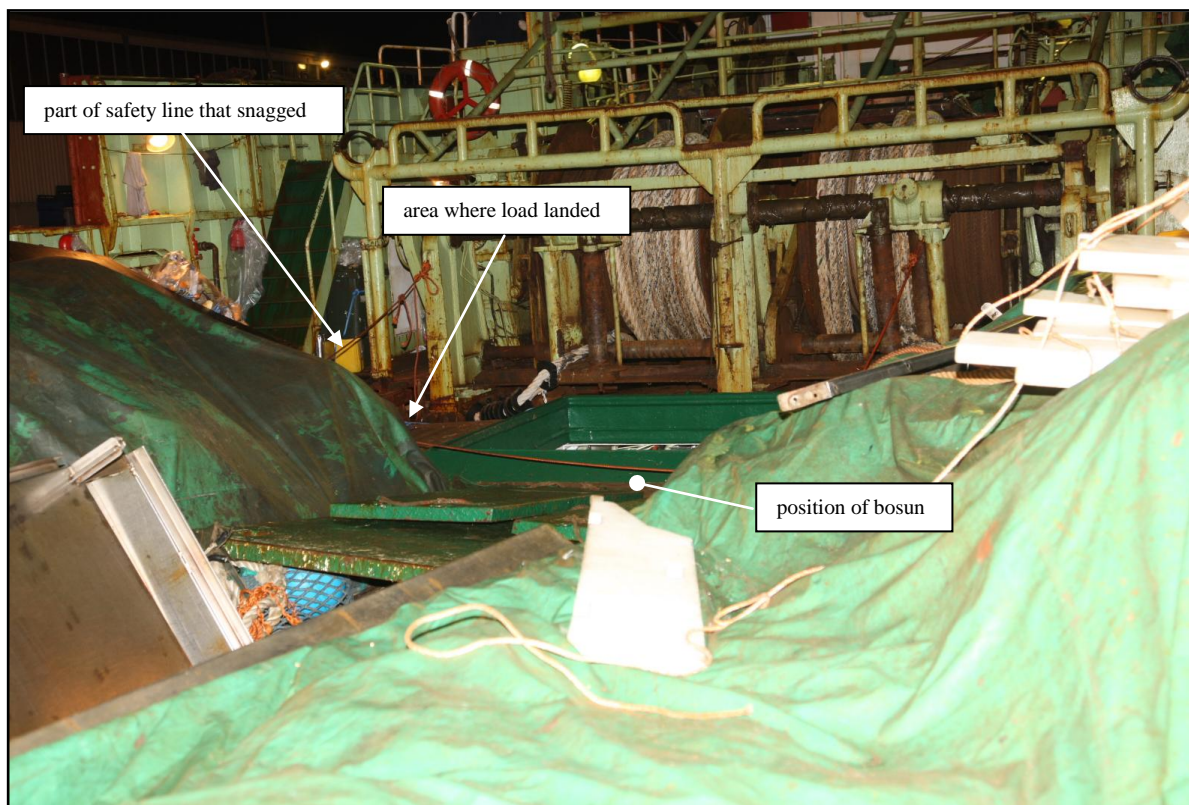
**Figure 5**  
**View from winchman's position**

- 1.1.5 The winchman was normally able to see both the hatch opening and the wharf but unable to see into the freezer hold below. In this case his vision was partially obstructed by equipment and nets stowed on the main deck between him and the hatch opening (see Figure 5). Normal practice, and used in this case, was to have a spotter or “hatchman” stationed at the hatch opening to direct the winchman using either visual or sound or a combination of both signals. The boatswain (bosun) had been acting as hatchman at number 3 hatch for the duration of the discharge.

- 2.5 The winchman, from his position on the starboard side, was about 13 m away from the position where he lowered the net to the deck. The safety line was constructed of 12 mm orange line, giving an angular resolution of about  $0.053^\circ$ . The minimum angular resolution of the eye with normal vision, in good visibility, is between  $0.02^\circ$  and  $0.03^\circ$  (Tidwell, 1995) so under good conditions the line should have been visible to the naked eye. However, although the area was adequately lit from above, the line would have been in the shadow of the net being lifted and the colour of the line would have blended into the background of other lines and equipment. The winchman therefore might not necessarily have been expected to notice it caught up on the bottom of the load he was controlling, particularly as he had been given the signal from the bosun to hoist and was then focussed on that task.
