Report 10-004: Hawker Beechcraft Corporation 1900D, ZK-EAQ
cargo door opening in flight, Auckland International Airport, 9 April 2010

Final Report

Aviation Inquiry: 10-004
Hawker Beechcraft Corporation 1900D, ZK-EAQ
cargo door opening in flight, Auckland International Airport
9 April 2010

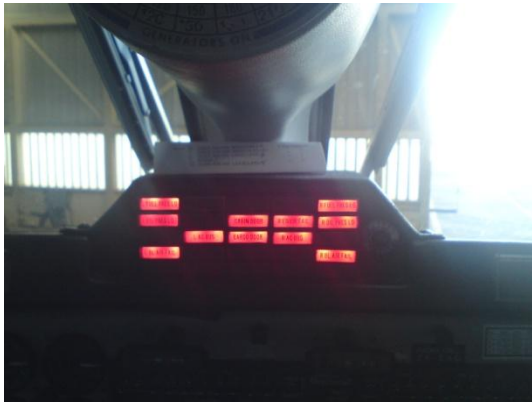
Figure 1
Annunciator light panel

- 1.2. The aeroplane was being operated with a permitted inoperative warning system that provided an indication to the crew when the cargo door was unlocked. An engineer had cleared the aeroplane to operate provided a crew member visually checked that the door was closed and locked before each departure. As the aeroplane was prepared for departure, the loader closed the cargo door but did not fully rotate the handle to lock the door. The first officer was distracted during the final pre-flight inspection of the aeroplane and did not positively check the condition of the door.

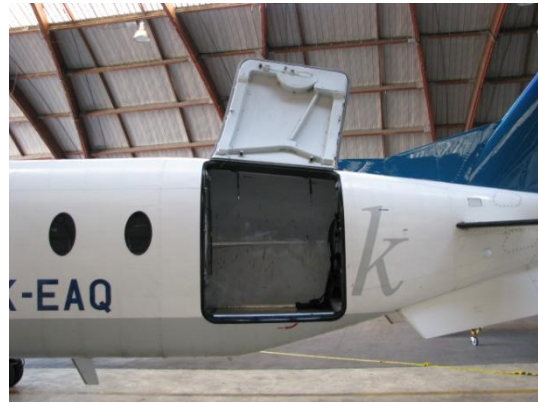
Figure 2
Cargo door ZK-EAQ – after the incident

- 3.1.7. The crew suspected the cargo door had opened, and this was confirmed shortly after by the tower controller, so they initiated a return to the aerodrome. The aeroplane was landed at about 0820 and returned to the gate to offload the passengers. There were no injuries and minor damage only to an antenna and a cargo door gas strut. No baggage was lost overboard (see Figure 2).

- 4.10. With the locks not being fully engaged, the vibration generated during the taxi to the take-off position was sufficient to cause the locks to back off. The locks finally released and the door opened at about the point of rotation during take-off. The take-off speed is lower than the speed the aeroplane normally achieves in the cruise. Had the door opened while the aeroplane was in the cruise phase of flight or descending the risk of it detaching and damaging control surfaces around the rear of the aeroplane was higher.

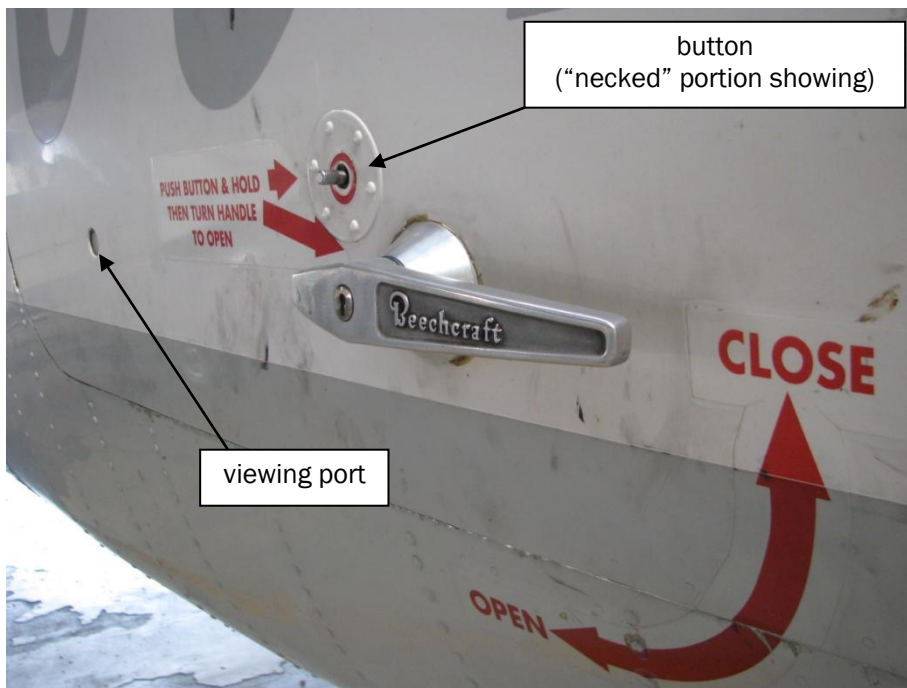
Figure 3
Cargo door ZK-EAQ

- 3.3.4. To close the door, a lanyard or strap normally stowed along the inside bottom of the door was pulled down to enable the exterior handle to be grabbed. With the door still partially open, the lanyard would be stowed. The door would then be closed and the handle rotated in an anticlockwise direction until horizontal, which would engage the camlocks and pins. The button would then pop out to indicate the locks had engaged. A viewing port located on the cargo door, about 50 centimetres forward of the handle, provided a back-up indication; the door was locked if a vertical line was visible through the viewing port, (see Figure 3).

- 3.3.5. An examination of the cargo door after the incident confirmed that there was some “play” in the door handle. The handle could be rotated until nearly horizontal, which only partly engaged the locks but not enough to lock them fully and pop the button indicator. The original bright colour of the button had faded to a bare metal colour since manufacture (see Figures 4 and 5).
- 3.3.6. The correct engagement of the locks normally extinguished a warning light on the annunciator panel on the flight deck. The previously mentioned door warning indication fault was traced to one of the 6 lock micro-switches being loose and not making contact. An adjustment of the door rigging corrected the fault.

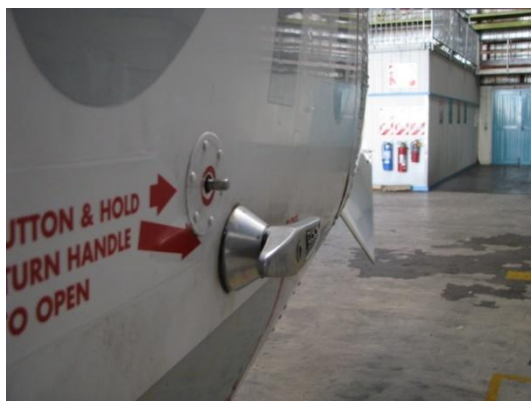
Figure 4
Cargo door locked

- 4.9. An examination of the handle confirmed that it was possible to align the handle about horizontal, but owing to the play in the handle the locks would not engage until the handle had been pushed firmly slightly past the horizontal and the button had popped. The fading of the button colour degraded its effectiveness as an indicator and as a warning to pilots that the door was possibly insecure.

- (a) *That painting of the necked portion of the door button collar is undertaken for easier visual confirmation that it has been engaged and the door is locked.*
