Watchlist

Safety for pedestrians and vehicles using level crossings

Te Komihana Tirotiro Aitua Waka
Transport Accident Investigation Commission
www.taic.org.nz

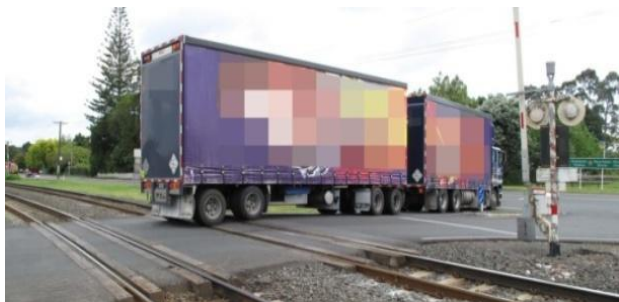
The Commission has investigated several accidents where road-legal vehicles have become stuck on rail level crossings, or have been too long to clear a rail level crossing and then stop, as required, at an adjacent road intersection with the vehicle clear of the rail crossing. There is no routine procedure for measuring the profile or vertical alignment of the road at rail level crossings, which means there could be other level crossings in New Zealand on which low-slung, but nevertheless road-legal vehicles, could become stuck.

About 31% (418) of public level crossings on New Zealand's rail network have short stacking distances, with 23% (305) rated as high risk. At level crossings with a short stacking distance, a long vehicle, even though it complies with road regulations, is unable to clear the level crossing when stopping at an adjacent road intersection. Similarly, the profile (the change of rate in gradient) of level crossings may not be compatible with vehicles that have low, albeit legal, ground clearance. A train colliding

with a heavy vehicle is a serious safety issue.

As a result of its inquiries into a train and truck collision near Rangiriri in 2014² the Commission recommended that the NZ Transport Agency work with KiwiRail and all road controlling authorities to ensure rail level crossing assessments include a measure of the road profile and compatibility with the allowable dimensions for long and low road vehicles. It was possible that a truck would be unable to complete a successful crossing after stopping at the crossing and confirming it was clear due to permitted train speed and available sight lines. We have made similar recommendations in earlier reports.³ An urgent recommendation made in relation to a crossing (at Beach Road in Paekakariki) has been closed.³
