Transport Accident  
Investigation  
Commission

# **Final report**

***Aviation inquiry AO-2025-001***  
***Airbus AS350 B3 helicopter, ZK-ITY***  
***Impact with terrain***  
***Mt Madeline, 7 km east of Milford Sound***  
***12 January 2025***

**November 2025**

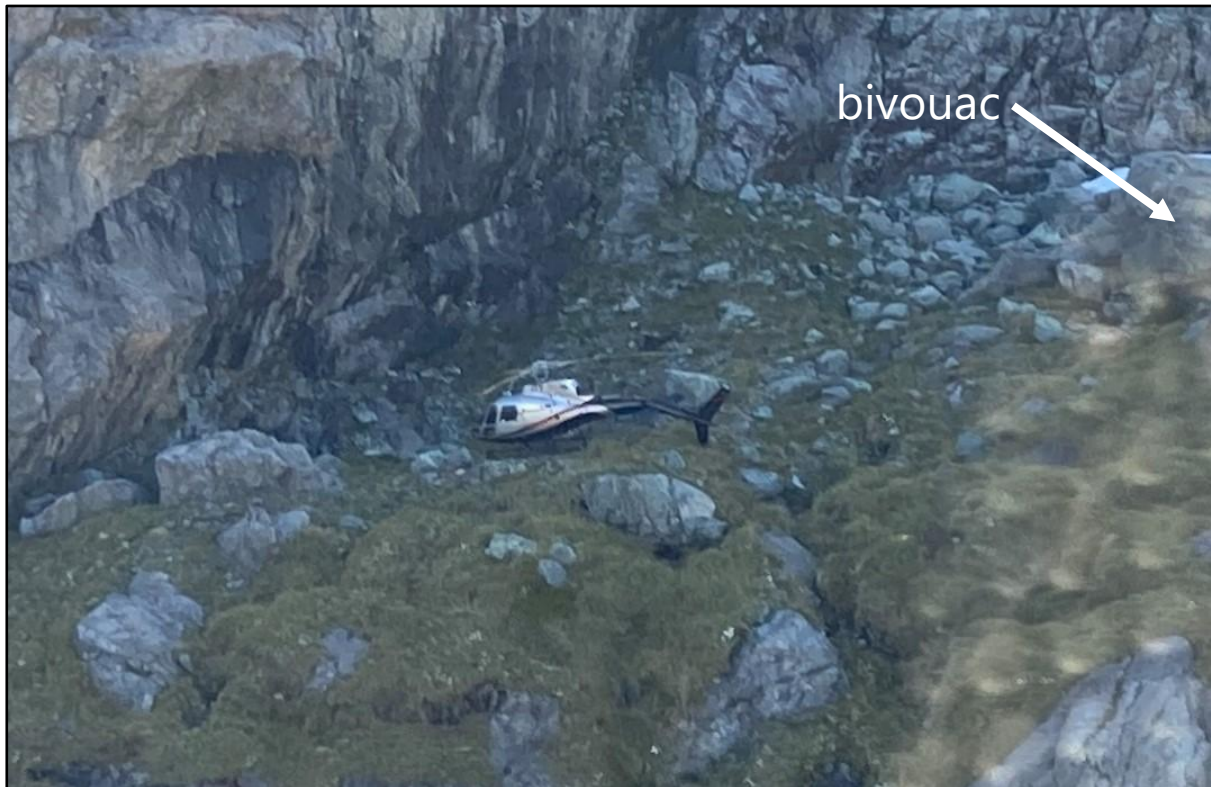
**Figure 3: Accident site**

- 2.21. Examination of the landing site identified a large flat rock that had broken in two. The rock measured about 0.5 m by 0.4 m and was about 0.15 m thick. The location of the rock on the edge of the landing site was about where the rear of the right skid would have been during a landing. Scrape marks were identified on the top surface of a boulder about 6 m out from the landing site. The boulder was below about where a tail rotor would be when a helicopter was landing at the site. Scrape marks were also found on the top of a large boulder outcrop to the right of the landing area.

- 2.23. The helicopter had come to rest about 2 m in from the edge of the landing site<sup>9</sup>, upright and on a heading of about 070° magnetic. The three main rotor blades each displayed damage, especially to the underside of the blades. The damage matched scrape marks on the flat upper surface of a large boulder outcrop on the right side of the landing area.

- 2.24. The tail boom was bent in several places and displayed numerous scrape marks. The tail rotor drive shaft displayed torsional damage.<sup>10</sup> The direction of damage was consistent with the tail rotor drive shaft continuing to drive or turn at high speed after striking an object. The vertical fin at the rear of the helicopter, including the tail strike guard located at the bottom of the vertical fin, was undamaged. However, the ends of both tail rotor blades had been eroded.

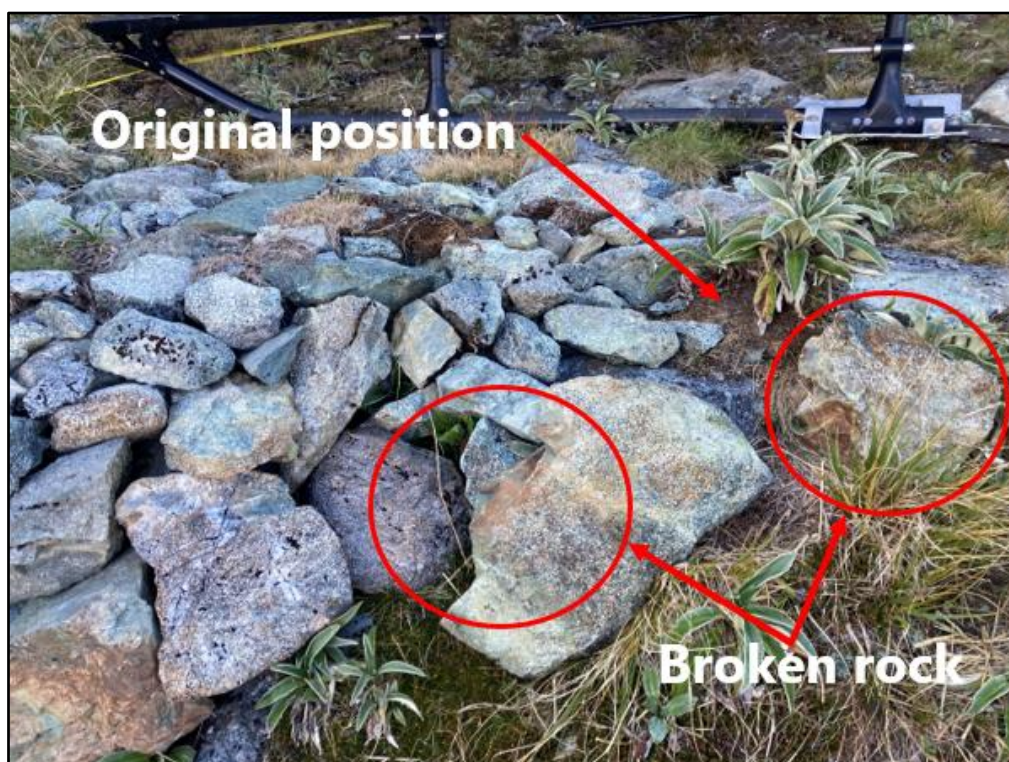
Figure 4: Front of landing site showing broken rock

- 3.2. Examination of the rocky landing area showed that a large flat rock on the edge of the elevated landing area had moved and had broken in two. The state of the earth where the rock had been and the condition of the two matching broken surfaces of the rock indicated that the break was recent (see Figure 4). There was also evidence of fresh scraping to the top surface of a boulder on the approach to the landing site and on a large boulder outcrop on the right side.

- 3.4. As the helicopter started to settle on the rough ground it is **virtually certain** that a rock under the rear of the right skid broke, causing the tail of the helicopter to suddenly drop and move right. The cockpit video camera records the front of the

helicopter pitching up and turning left. This movement resulted in the tail rotor blades striking a boulder underneath it, causing a vibration that the pilot felt through the flight controls.

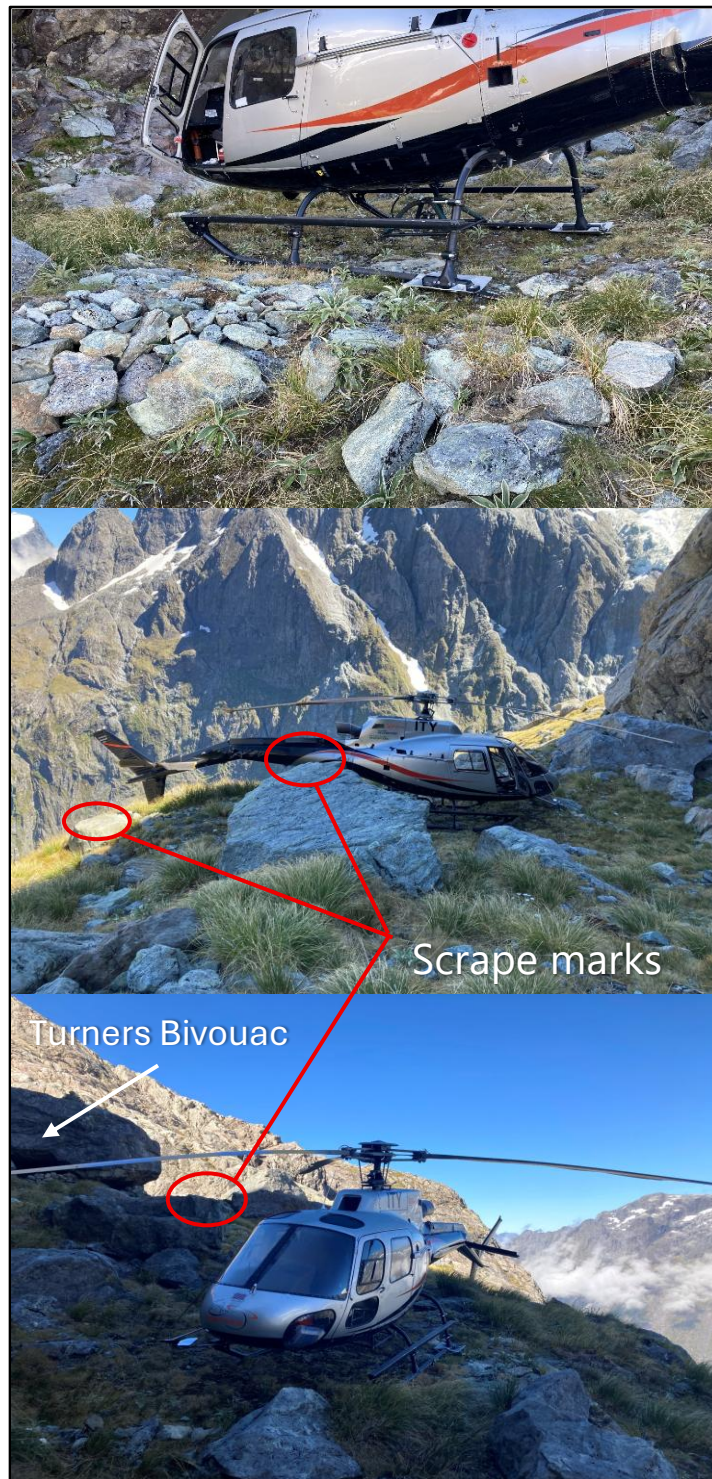
**Figure 5: ZK-ITY in situ at Turners Bivouac**

- 3.5. The pilot, concerned about possible damage to the helicopter, took what they considered to be the safest course of action by not trying to fly away, but rather committing fully to the landing and shutting down the engine. During this manoeuvring the main rotor struck the top of a large boulder outcrop on the right. This resulted in severe shaking caused by the unbalanced main rotor blades, and the helicopter rotated left through about 50° as it landed. Once the engine was shut down the shaking reduced then stopped.

- 3.6. The time between the tail rotor suddenly dropping and striking the rock and the main rotor striking the boulder outcrop was about 9 s (see Figure 5 ).

- 3.7. The damage to the tail rotor and tail boom, including the tail rotor drive and control, was significant. Had the pilot attempted to fly away after the tail rotor struck the boulder, it is **very likely** that the helicopter would have suffered an in-flight breakup.
