Transport Accident  
Investigation  
Commission

# **Final report**

***Rail inquiry RO-2025-101***  
***Train 931***  
***Safe working irregularity***  
***553.82 km Main South Line***  
***Mataura***  
***12 January 2025***

**November 2025**

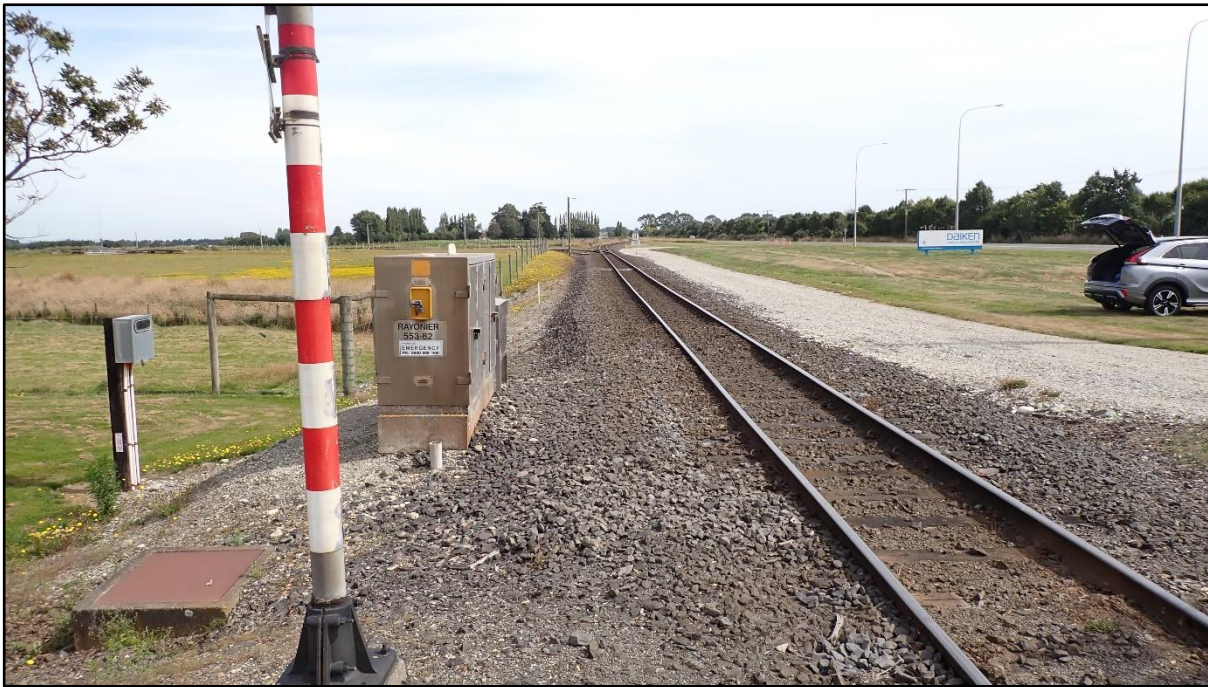
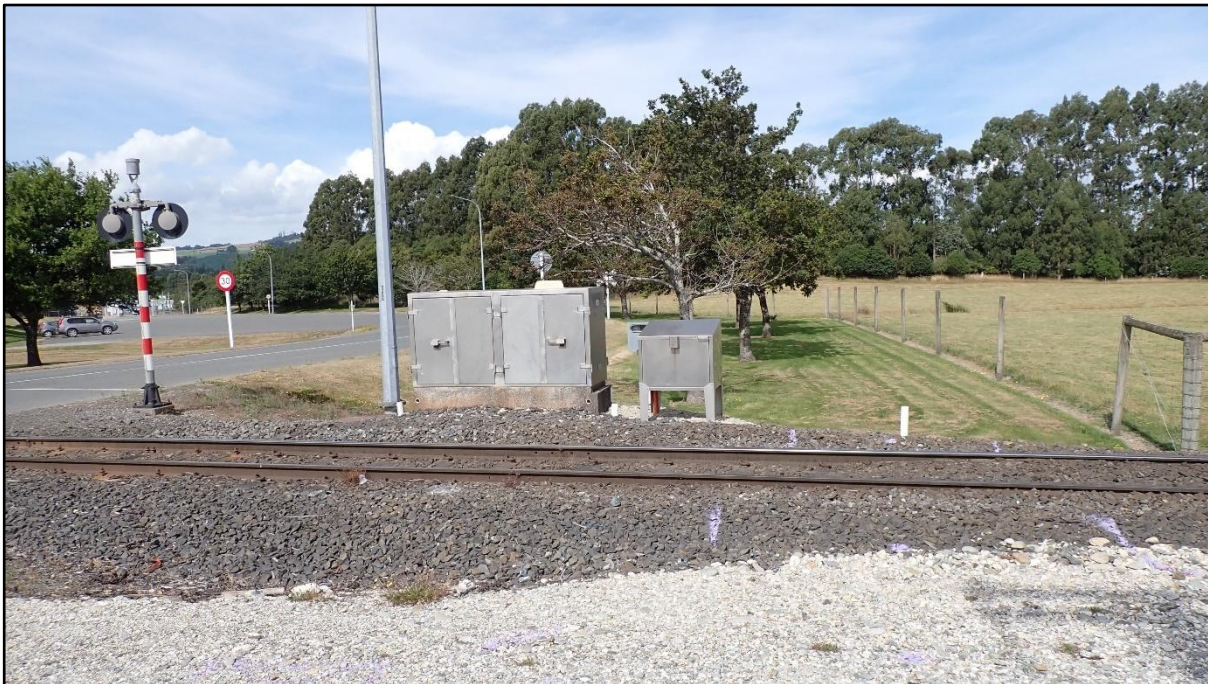
**Figure 3: Signalling cabinet located near track at the crossing**

- 1.2. The signals maintenance work included carrying out testing of bonding wires<sup>4</sup> in a cabinet close to the rail line and the crossing (see Figure 3).

- 2.29. The work being carried out was maintenance on bonding wires in the signalling cabinets close to the track. This required disconnecting batteries that provided secondary backup power to the bells and flashing lights that formed the protection at the level crossing.

- 2.30. Disconnecting the secondary backup power supply meant that if there was an interruption to the commercially supplied mains power (a power cut) the flashing lights and bells would not activate to warn road users a train was approaching the level crossing.

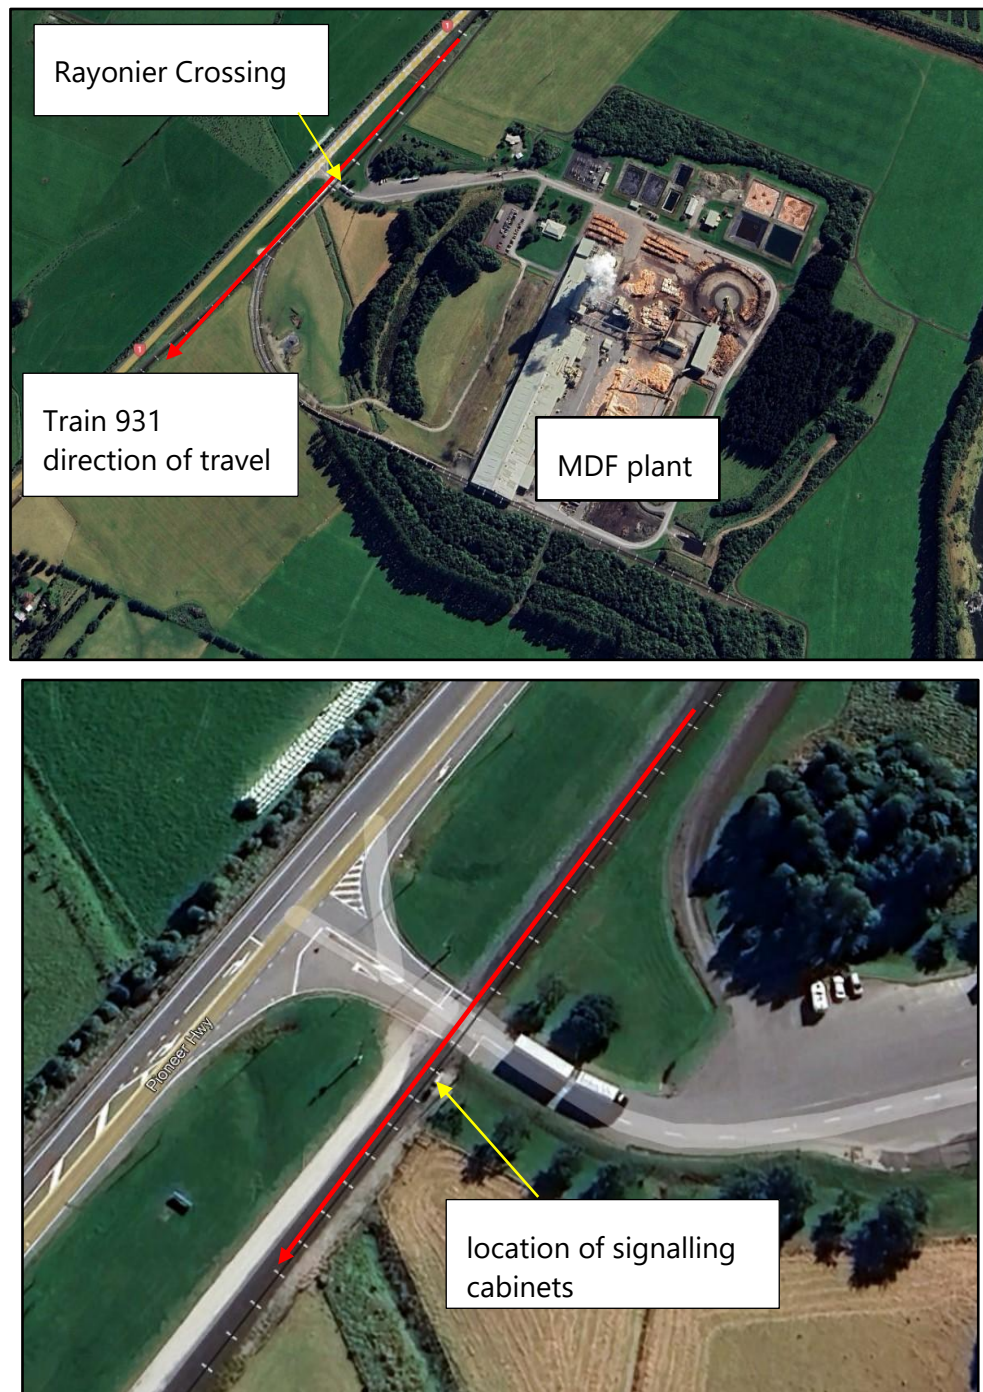
**Figure 5: Aerial view of the crossing**

- 2.7. The crossing is located along Pioneer Highway between Matura and North Edendale, 553.82 km along the MSL (see Figure 5). It is a rail crossing over a private road that provides access to a medium-density fibreboard (MDF) plant, about 2.5 km south of Matura.

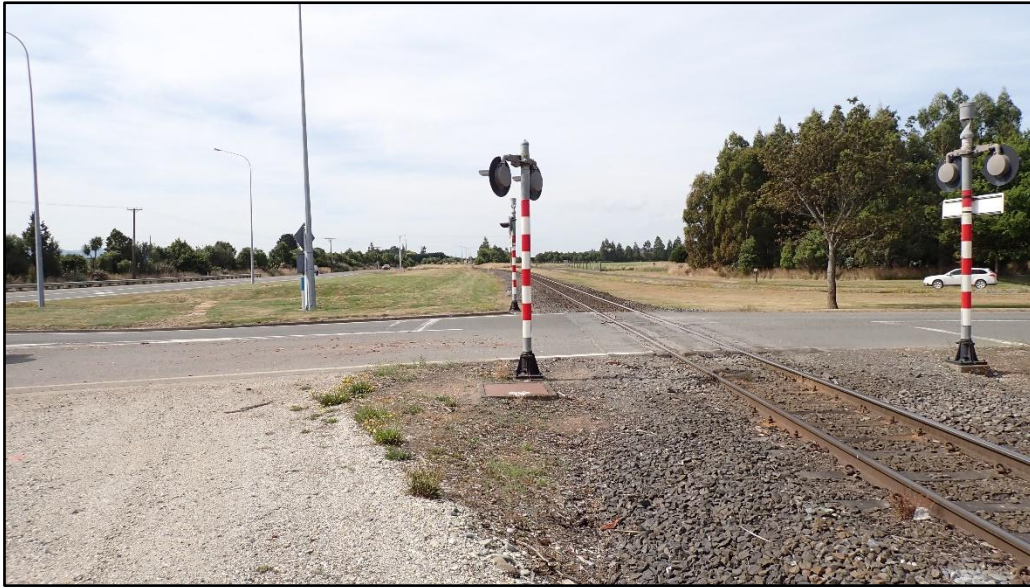
**Figure 6: Protection devices in place at the crossing**

- 2.9. The crossing is protected by flashing lights and alarm bells to provide active protection<sup>10</sup> for road users (see Figure 6).

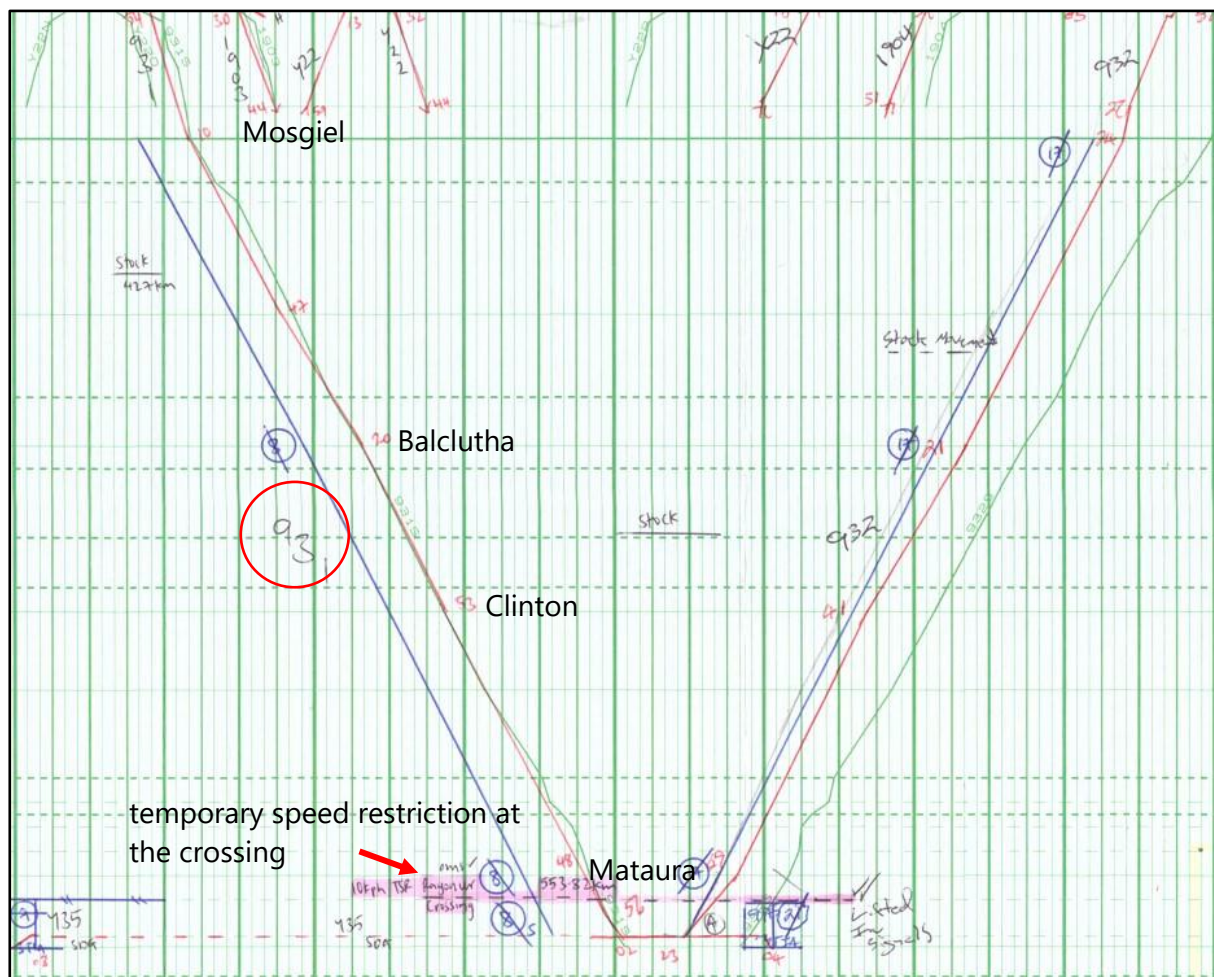
**Figure 8: Train control graph illustrating journey of Train 931**

- 2.17. Track warrant-controlled areas are considered 'dark territory' as the train controller usually has no visibility of train movements and is reliant on information from the LE to ascertain a train's location. However, because of legacy signalling arrangements on this section of the MSL (where signals remained in place after a siding at Clinton was closed down) the train controller was able to see the train pass through Clinton Station on its journey south towards North Edendale siding. The LE also made a compulsory call at Balclutha, which identified the train's location to train control (see Figure 8).

- 2.18. The train controller annotated the graph<sup>11</sup> when they became aware of Train 931 passing through locations – Mosgiel at 0910, Balclutha at 1020 and Clinton at 1053. The green lines on the graph depict a train's scheduled running time. The blue lines depict the limits of a track warrant once it has been issued, while the red line shows the actual journey time taken by that train. The red line may vary considerably from the blue and green lines because of delays en route.
