Transport Accident
Investigation
Commission

Final report

Maritime inquiry MO-2024-207
Pilot vessel, Takitimu II
Grounding
Stirling Point, Bluff, New Zealand
26 December 2024

January 2026

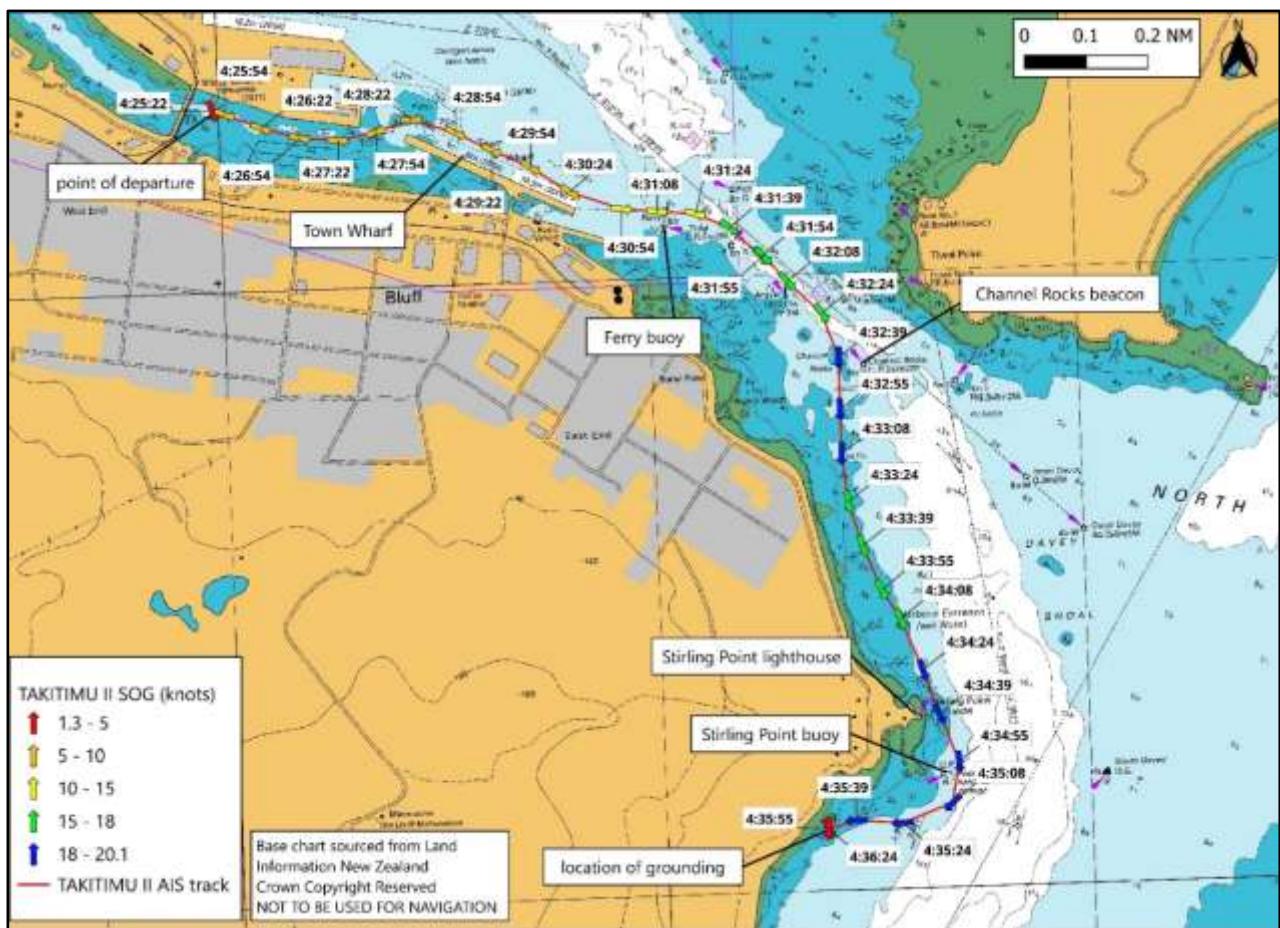
Figure 3: Outbound track of *Takitimu II* leading up to the accident

2.9. At 0432, the master steered the vessel out of the main channel and passed west of the Channel Rocks beacon (see Figure 3). The master increased speed to about 18–20 kt but realised that the vessel was closer to shore than usual, so altered course to seaward. They progressed along the coast slightly inside the five-metre depth contour, towards Stirling Point (see Figure 4).

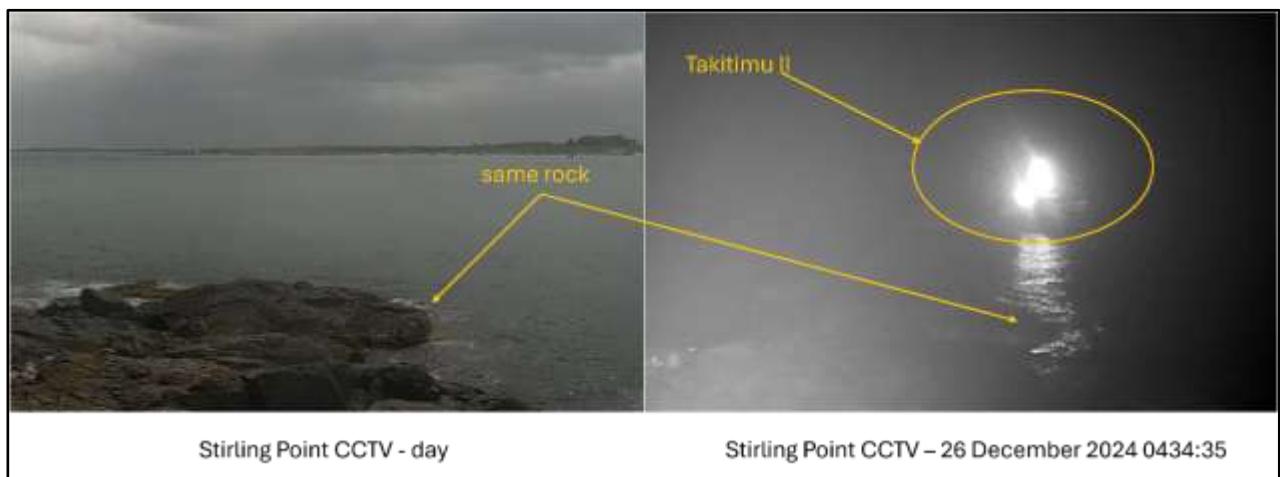
Figure 4: CCTV images from Stirling Point. The right-hand image shows *Takitimu II* passing Stirling Point at 0434:35

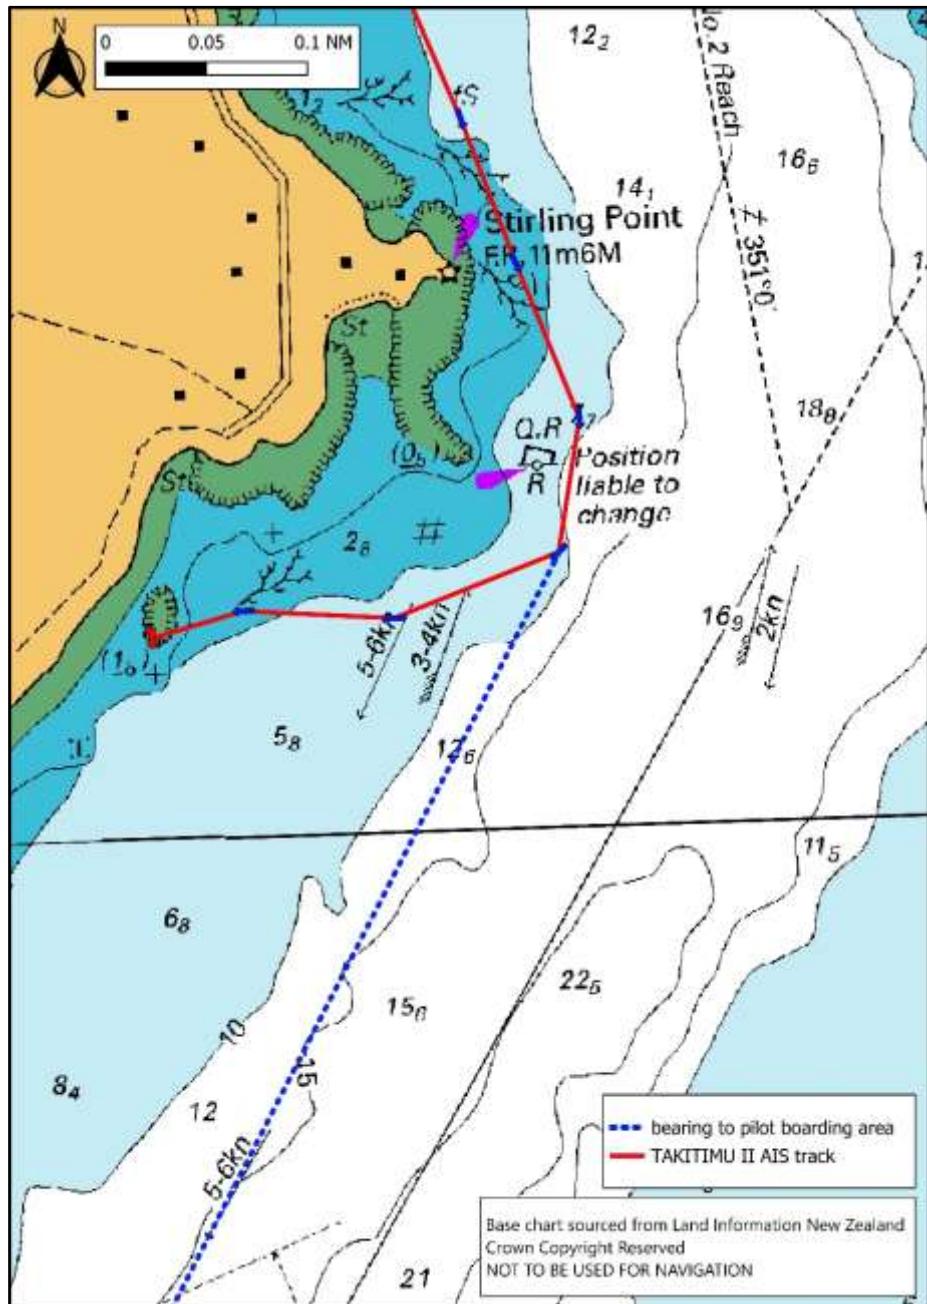
2.10. At about 0435, *Takitimu II* passed east of the Stirling Point buoy and then altered course to starboard to continue towards the pilot boarding area (see Figure 5). The

master was looking for the silhouette of Bluff Hill as their next visual reference to steer by. Shortly after the alteration of course to starboard, the deckhand noticed that the chart plotter and radar screens showed the vessel heading towards the land. The deckhand said to the master that they should be more to port. The master then looked down to check the screens and realised that the vessel was not where it should have been. A few seconds later, the vessel ran aground with both engines still running.

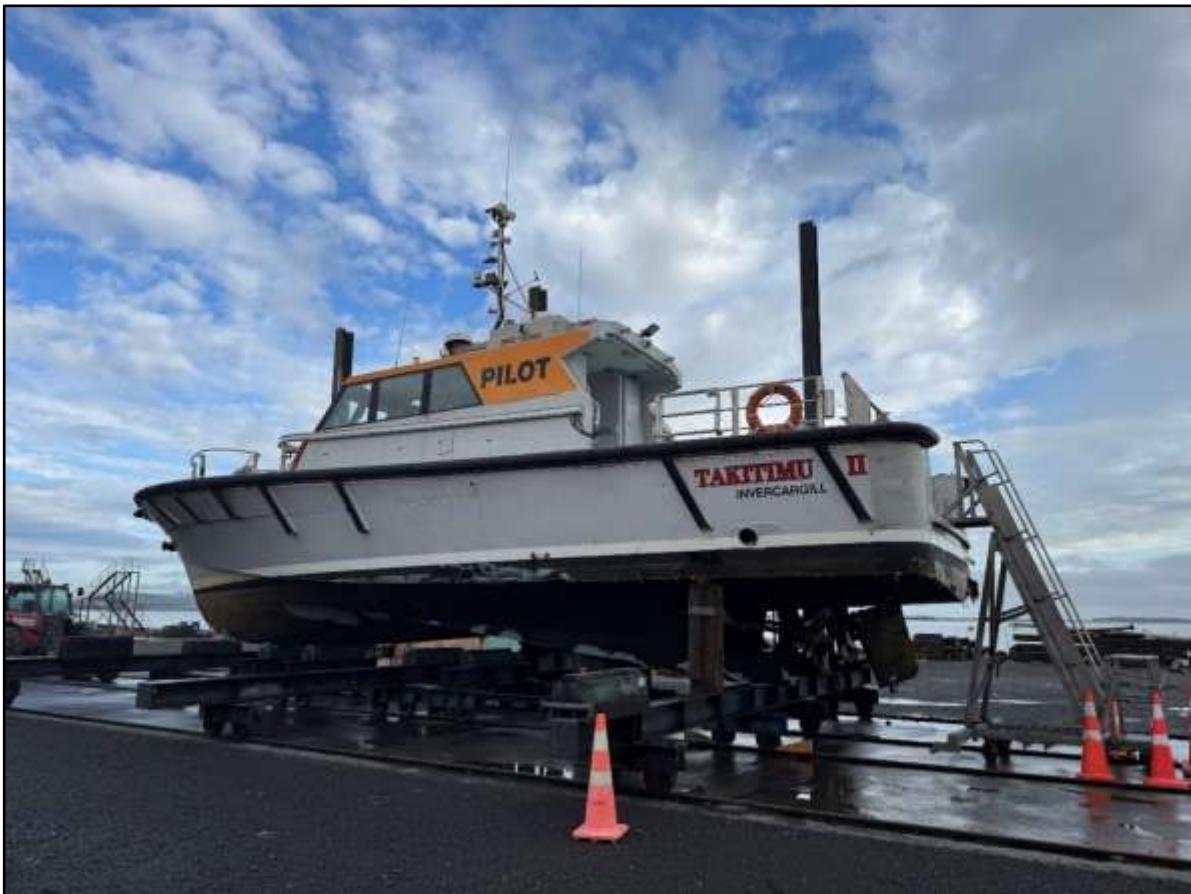
Figure 6: *Takitimu II* after the grounding

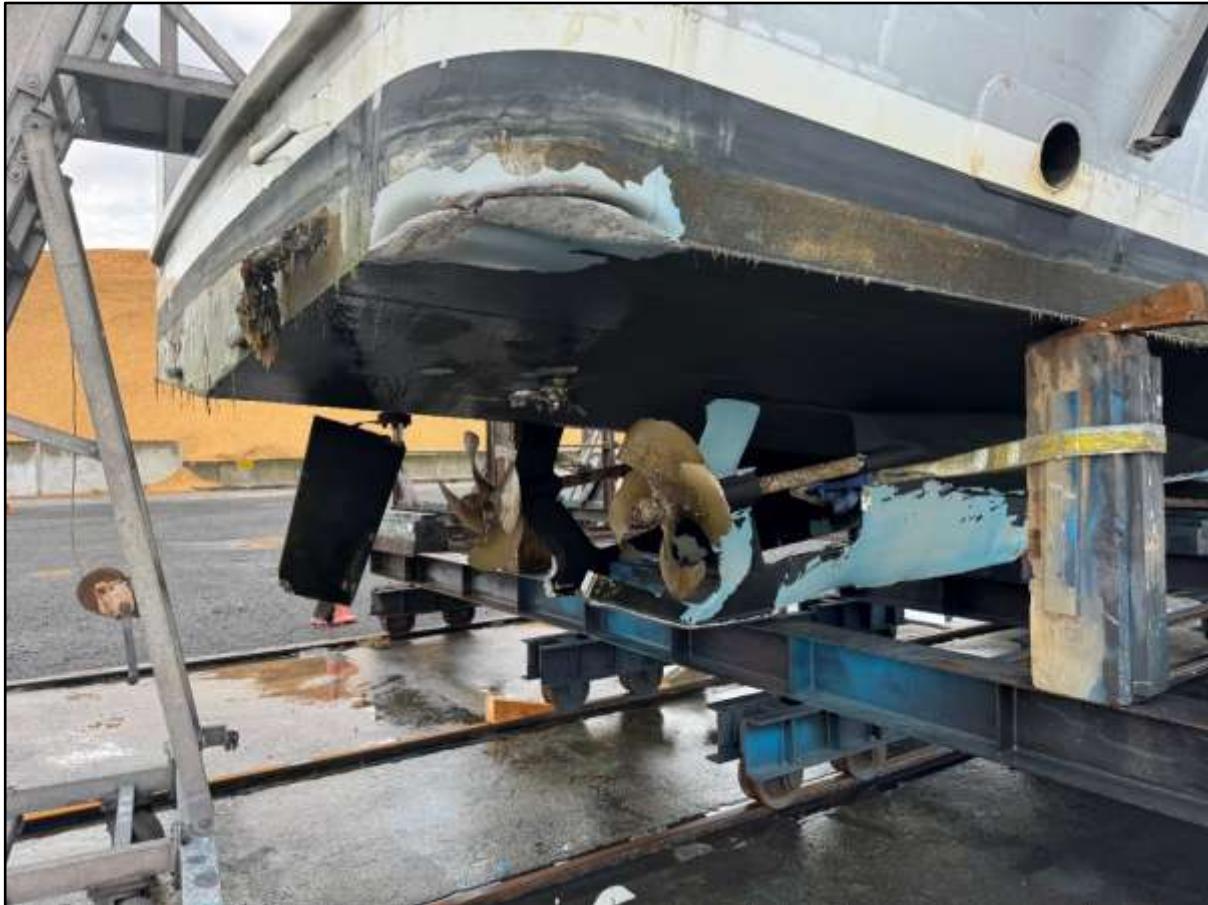
- cracking, deformation and tearing of both propellers (see Figure 7)
- cracking, deformation and tearing of the rudder blades and rudder stocks (see Figure 7)
- cracking, deformation and tearing of the tail shaft, shaft bracket and shaft bearing coupling
- cracking, deformation and tearing of the hull structure, internal framing and independent fuel tank supports.

Figure 7: Hull breach and damage to propellers and rudders

2.25. Paint scrapes on the hull (see Figure 8 and Figure 9) indicated that the vessel struck the rocks with forward momentum, whereas the damage to the rudders and propellers was more consistent with damage from the vessel moving in the seas and swell whilst stranded on the rocks.

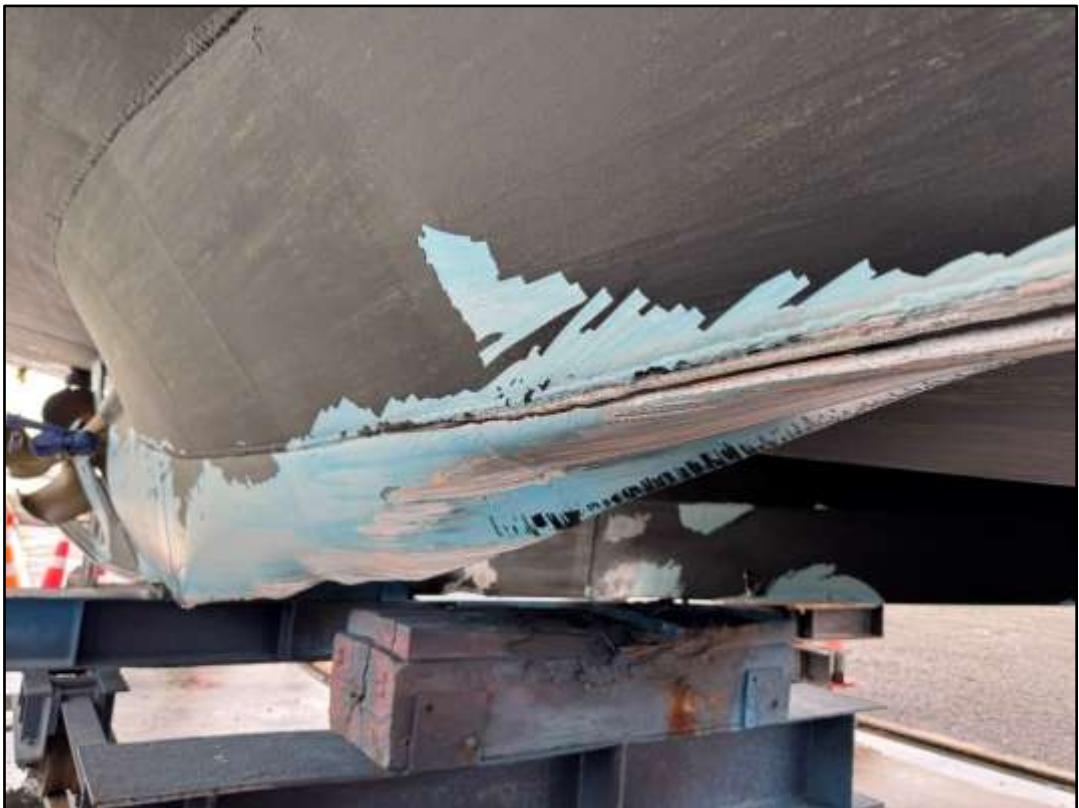
Figure 8: Paint scraped on the starboard side of the hull

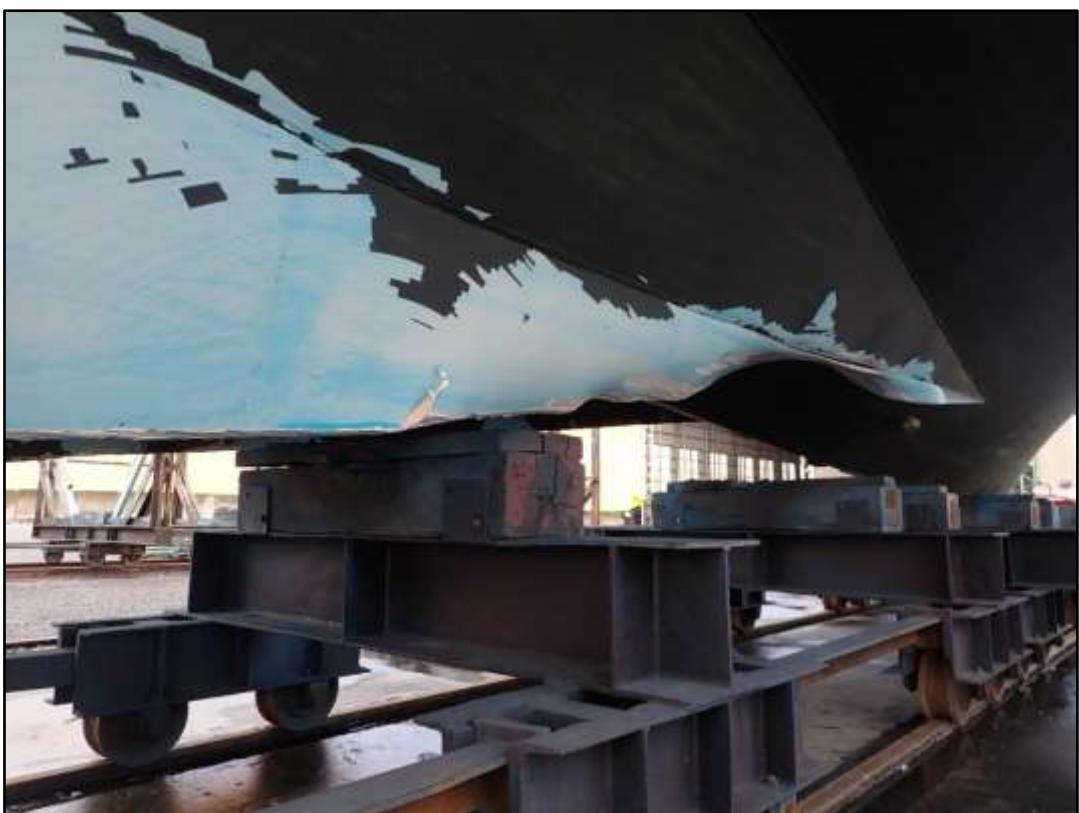
Figure 9: Damage to hull on the starboard side

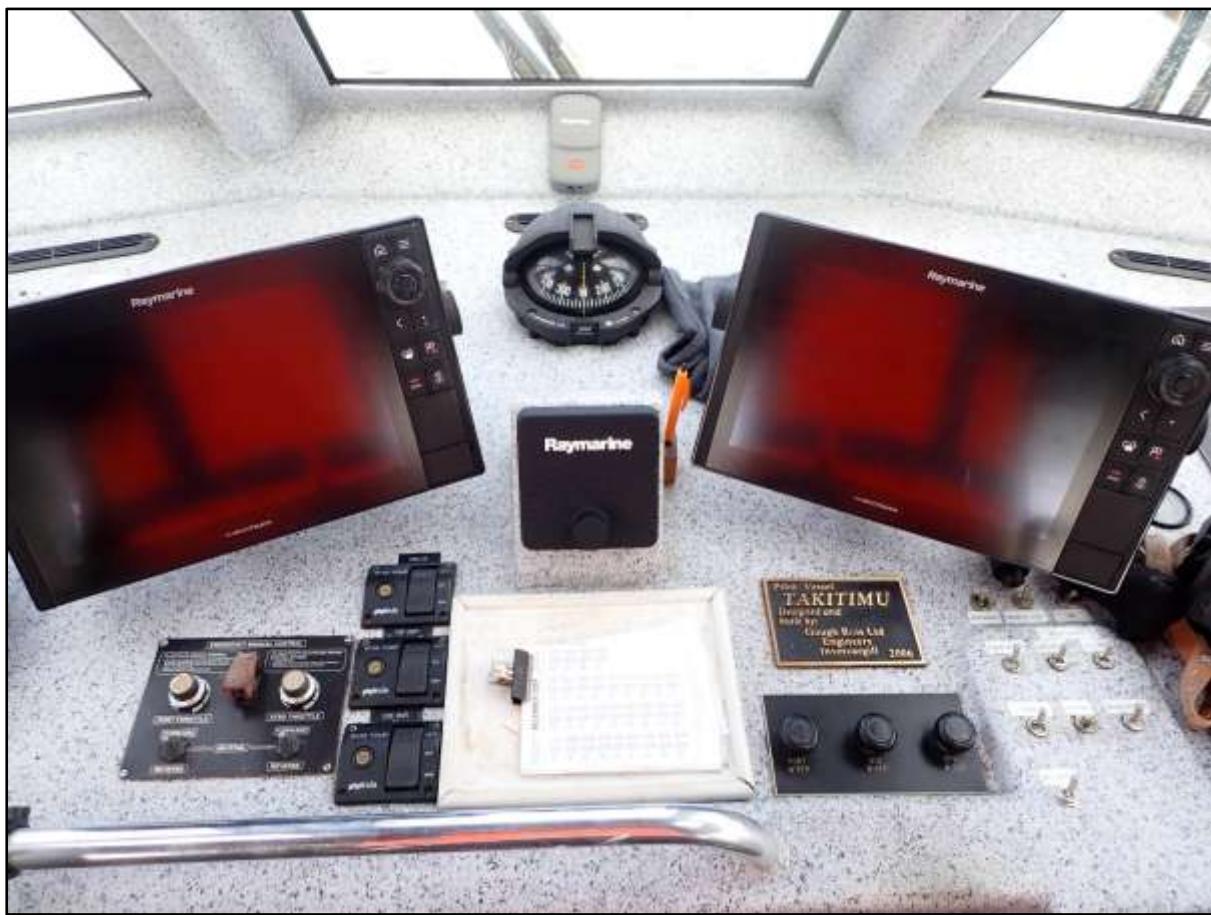
Figure 10: Raymarine multi-screens in wheelhouse of *Tikitimu II*

- 3.19. The master usually navigated by eye with the vessel's two Raymarine multi-screens (see Figure 10) displaying the GPS-fed chart plotter and the CCTV. Because of the restricted visibility conditions on the accident trip, the master set the Raymarine screens to display the GPS-fed chart plotter and the radar. However, they continued to navigate visually as navigation marks came into sight and did not regularly reference the chart plotter or radar until it was too late to avoid the rocks.

3.20. Following this accident, South Port revised its pilot-vessel training scheme. The new scheme documents the operational standards that South Port expects from its pilot-vessel masters and crews and includes a six-monthly proficiency assessment. In the Commission's view, this safety action has addressed the safety issue. Therefore, the Commission has not made a recommendation.
