Final report MO-2016-205: Fatal fall from height on bulk carrier,
New Legend Pearl, 3 November 2016

Marine inquiry MO-2016-205
Fatal fall from height on bulk carrier

New Legend Pearl

3 November 2016

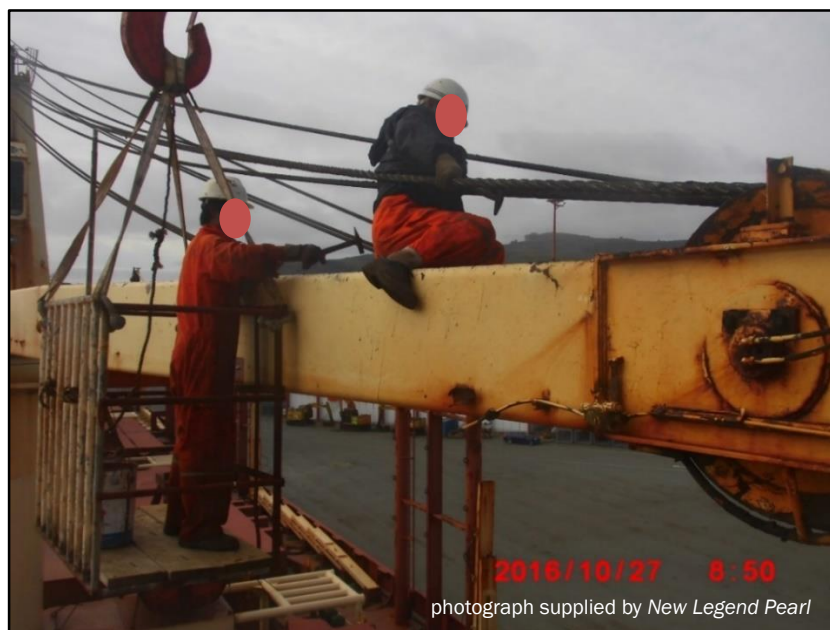
Figure 1
Crew working at height without full fall protection

- 3.1.5. At about 1015 on 27 October, the port facility's health and safety team were advised by stevedores that the crew on board the *New Legend Pearl* were not working safely. The health and safety officers boarded the vessel and witnessed the crew working at height, on the cranes, without full fall-protection equipment (see Figure 1). The ship's duty officer was informed of their concerns and work on the cranes ceased.

- 3.1.6. At about 1730 on the same day, one of the port health and safety officers witnessed the crew once again working at height on the cranes without fall protection. The health and safety officer informed the master that under no circumstances should the crew be working without the proper personal protective equipment. The health and safety officer sent an online report on the unsafe work to MNZ.

- 4.5.5 Working at height without wearing fall-protection equipment had been observed on board on two occasions when the vessel was in Bluff. The second occasion was in spite of the crew having been previously warned against the poor practice.

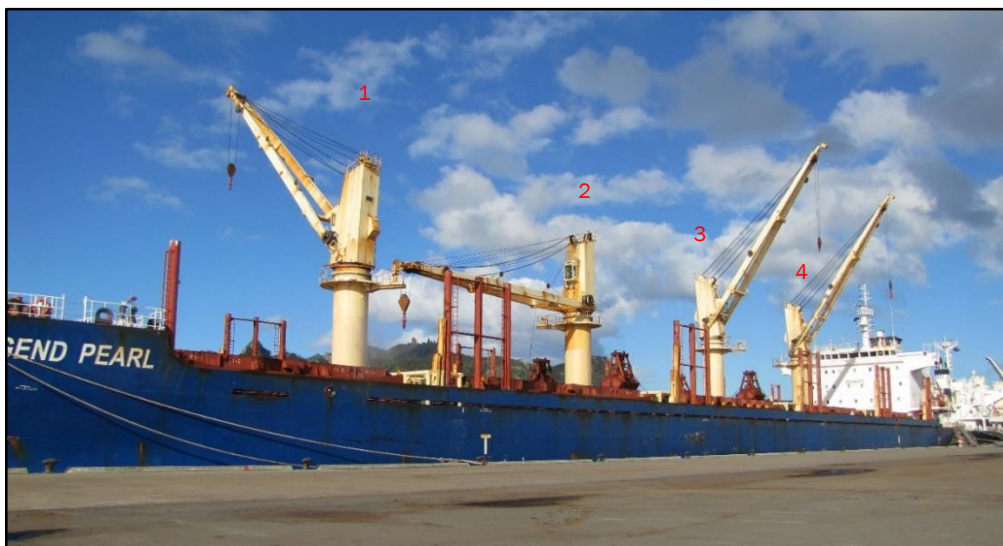
Figure 2
The *New Legend Pearl* at Marsden Point

- 3.1.10. At about 1900 on 29 October, cargo operations resumed. However, the stevedores were unhappy with the condition of the hoisting wires on numbers 2 and 4 cranes (see Figure 2).

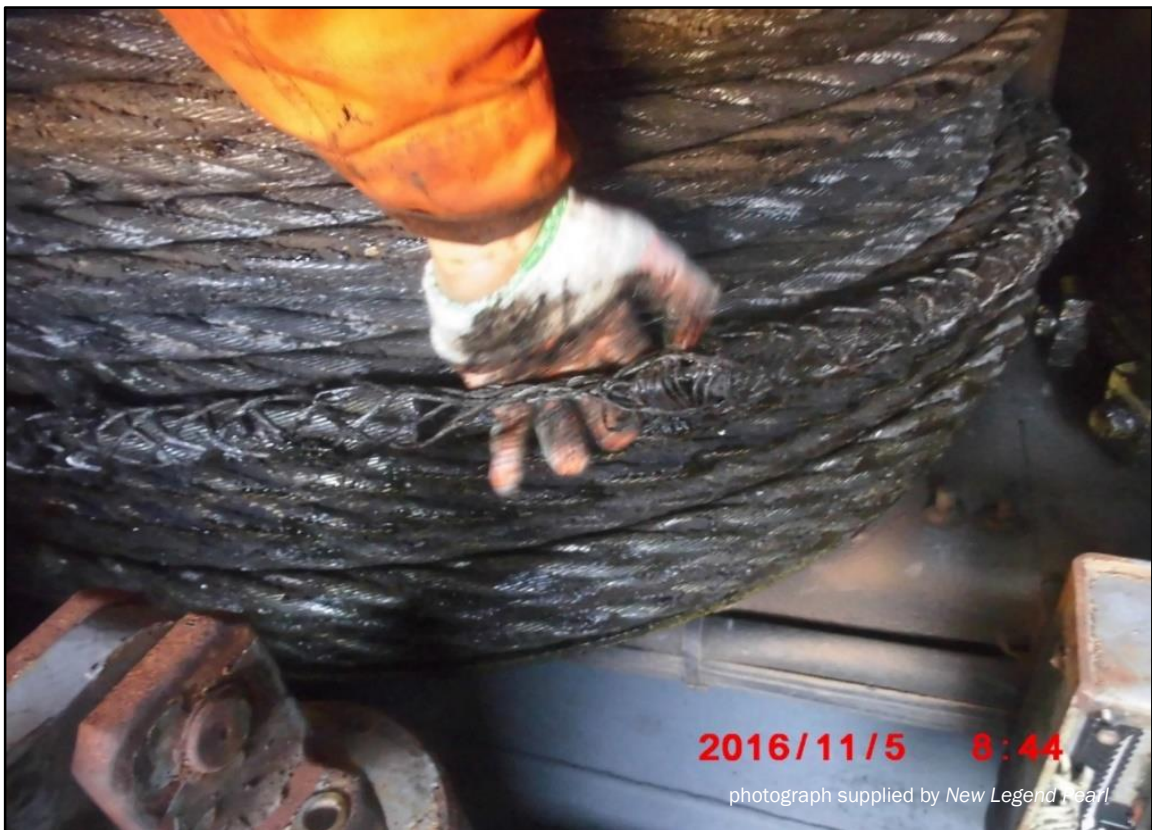
Figure 3
Cable sock joining the old wire and the replacement wire

- 3.2.4. The carpenter and two able seamen climbed onto the crane-house to release the old wire at its termination point. The wire was lowered to the deck, where the end was cut off neatly so that it could be connected to the new wire with a cable sock¹¹ (see Figure 3).

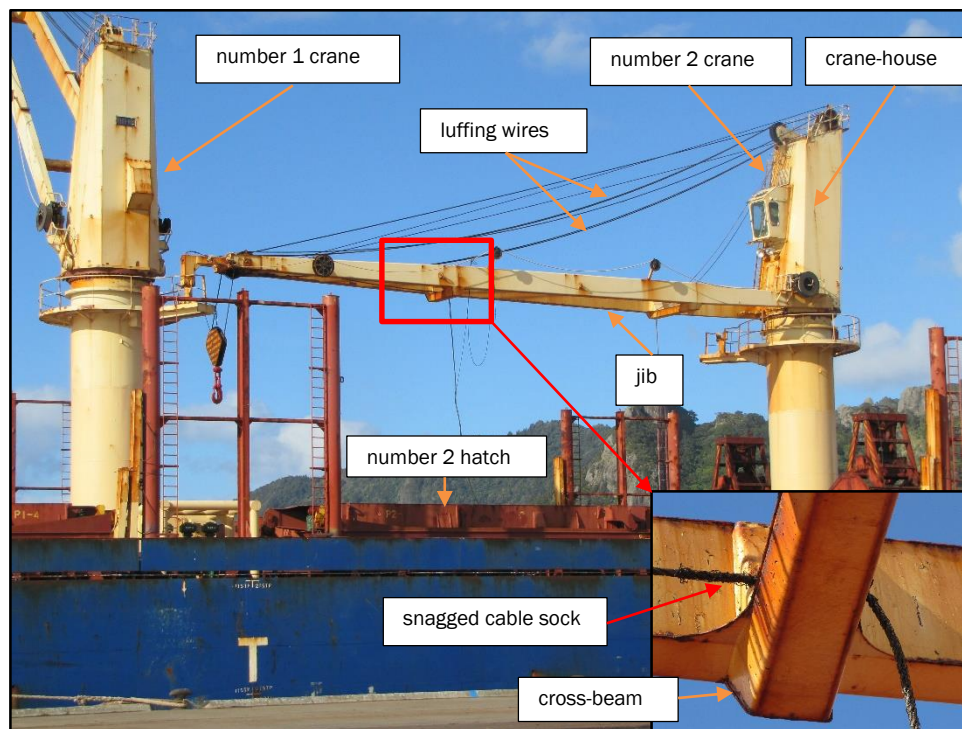
Figure 4
Number 1 and 2 cranes and the position of the snag (inset)

- 3.2.5. The crew commenced heaving the connected wires through the hoisting-wire sheaves, but stopped when the cable sock snagged on the crane-jib¹² cross-beam (see Figure 4).

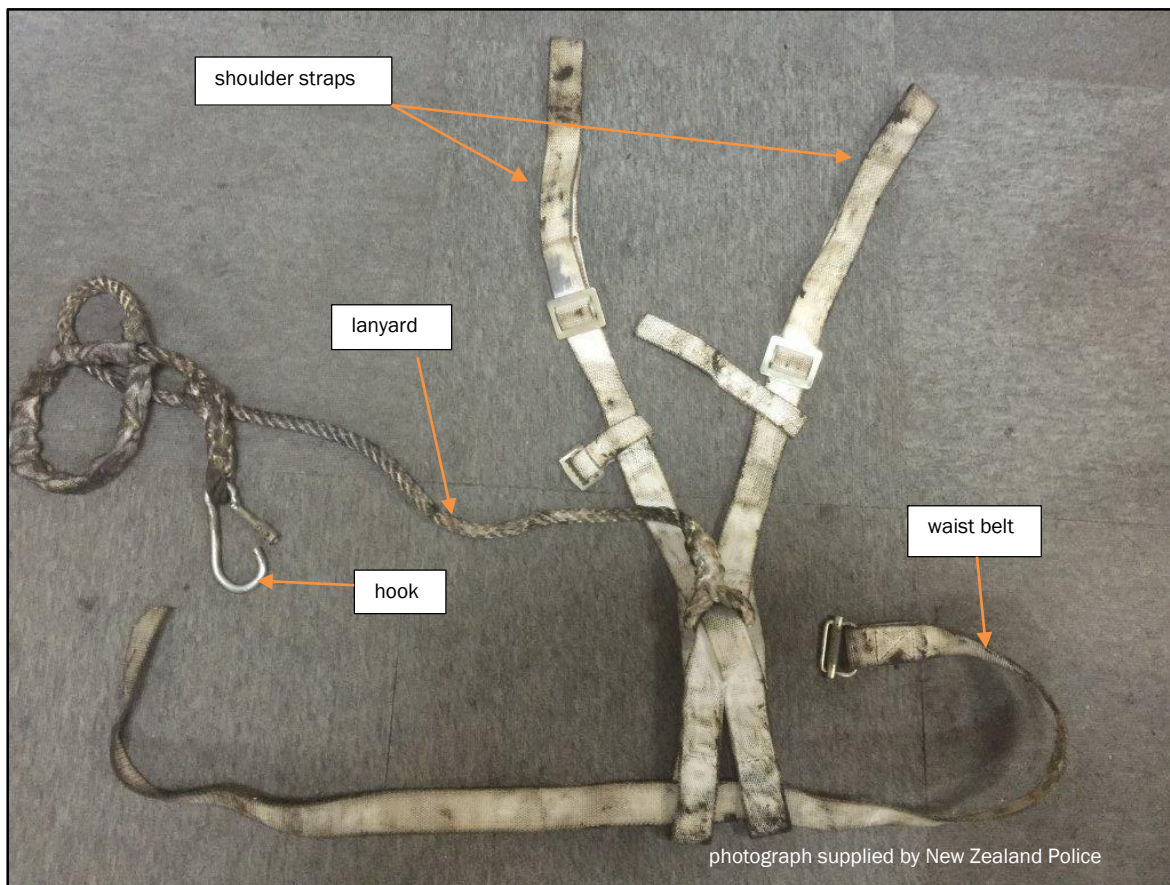
Figure 5
Safety harness worn by the bosun

3.6.1. The safety harnesses provided to the crew were half-body harnesses that conformed with the Chinese mandatory national standard for full-body harnesses. This standard specified the requirements and inspection rules of personal fall-protection systems used in working at height for a total weight of no more than 100 kilograms. The harnesses were supplied to the vessel with lanyards and hooks already attached (see Figure 5).

- 3.6.2. The lanyards were made of 14-millimetre, soft polyester, three-strand, right-hand-lay rope, eye-spliced with three tucks. There was no marking to indicate that the lanyard met the mandatory Chinese standard for lanyards used in personal fall-protection systems.

- 3.6.3. The hooks attached to the lanyards were mild-steel carbine hooks with manually lockable gates. The hooks were not stamped with any identification, safe working load or indication of meeting the recommended Chinese standard for connectors used in personal fall-protection systems.

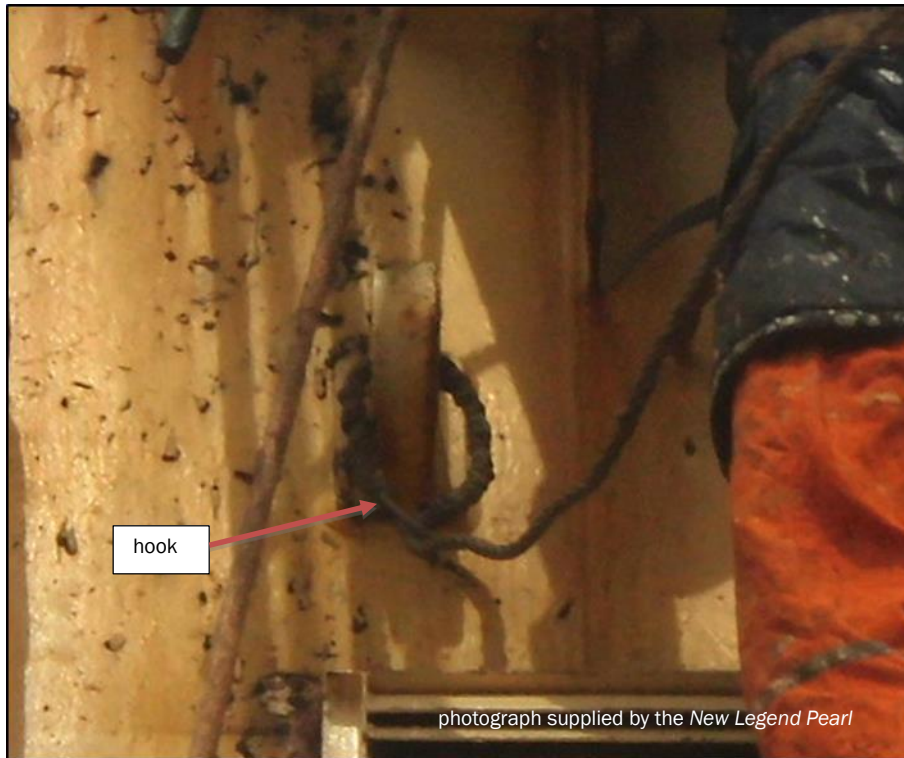
Figure 6
Safety harness lanyard hooked back onto itself

- 4.2.4 The practice of hooking a lanyard back onto itself is not recommended unless the lanyard and hook have been specifically designed for that purpose. This practice prevents the hook aligning with the force applied in the event of a fall, which means that it can also expose the gate of the hook to side-loading forces. The force required to roll out¹⁷ or burst out¹⁸ the gate of a hook is significantly less than the force the hook can withstand when pulled in direct alignment with the long axis of the hook.

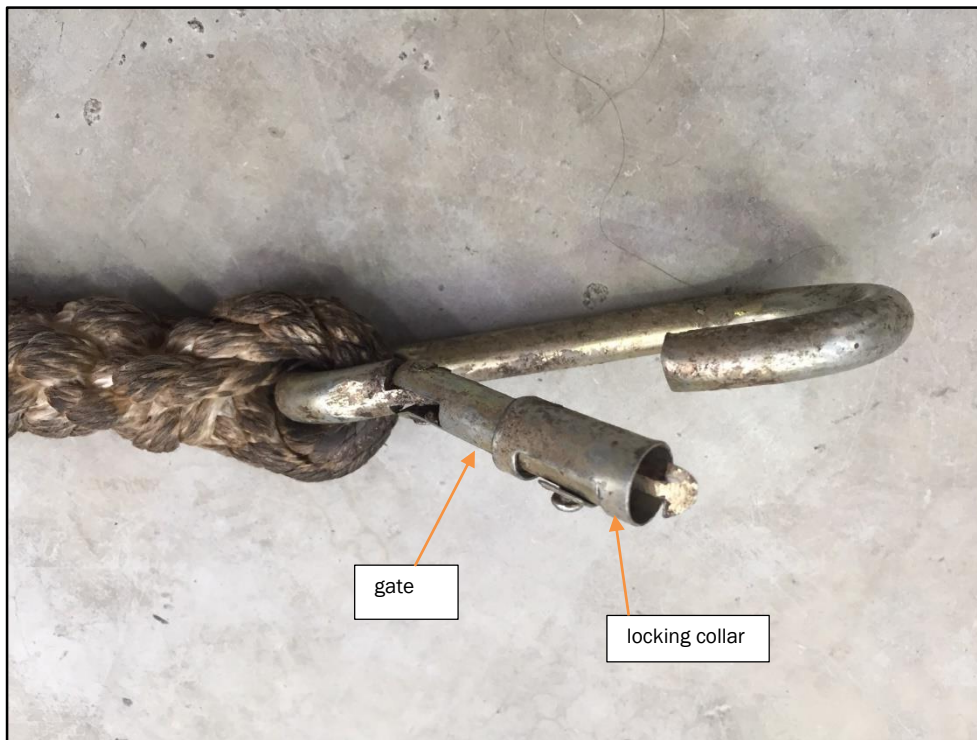
Figure 8
The damaged safety hook

- 1.3. The Transport Accident Investigation Commission (the Commission) **found** that it was about as likely as not that the locking mechanism for the safety harness hook was not engaged, which allowed the lanyard to roll or burst out of the hook when the crew member fell, and that the safety harness was not suitable for the intended task.

- 3.2.8. At some point in the process of moving the lanyard between the luffing wires, he lost his balance and fell eight metres onto number 2 hatch cover. None of the crew could say for sure whether the bosun was clipped onto a luffing wire when he fell. The safety harness was intact but the gate (see Figure 8) of the securing hook was damaged.

- 4.2.5 After the accident the gate on the bosun's safety harness hook was found bent sideways and it no longer married up with the end of the hook (see Figure 8). The crew said that the safety equipment had been checked before they started changing the wire and had been found to be in a satisfactory condition. If this damage occurred during the fall, then the locking collar¹⁹ on the end of the gate should have been damaged as the gate was pulled sideways. However, the locking collar was not damaged. Therefore it is about as likely as not that when the bosun fell he had either removed the locking collar in preparation for removing the hook from the upper luffing wire, or had clipped onto the lower luffing wire but had yet to engage the locking collar. Any sideways force on the gate as the shock-load came onto the lanyard could have caused the gate to burst out and disconnect the harness from the anchor point.
