Transport Accident
Investigation
Commission

Final report

Aviation inquiry AO-2024-004
Airbus A320, registration VH-VFF
Loss of control – ground (LOC-G)
Christchurch

31 May 2024

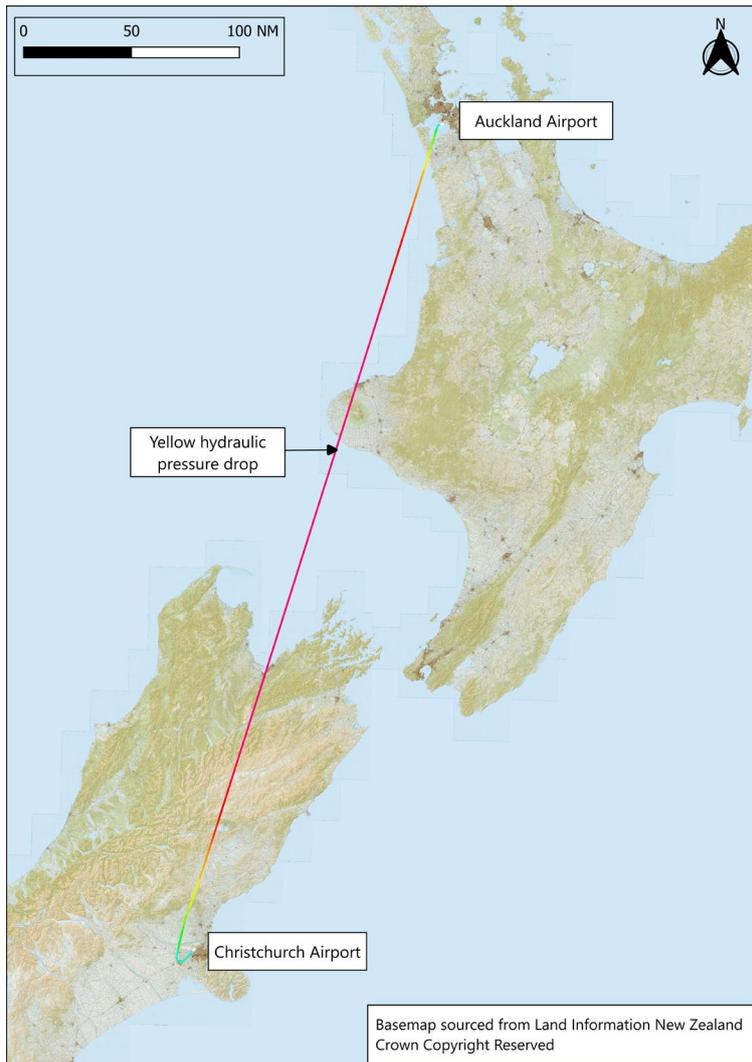
Figure 2: Aeroplane position when hydraulic failure occurred

- 1.1. On 31 May 2024, a Jetstar Airbus A320 flight from Auckland to Christchurch experienced a hydraulic failure in the cruise.¹ The failure resulted in the loss of one of the three hydraulic systems.

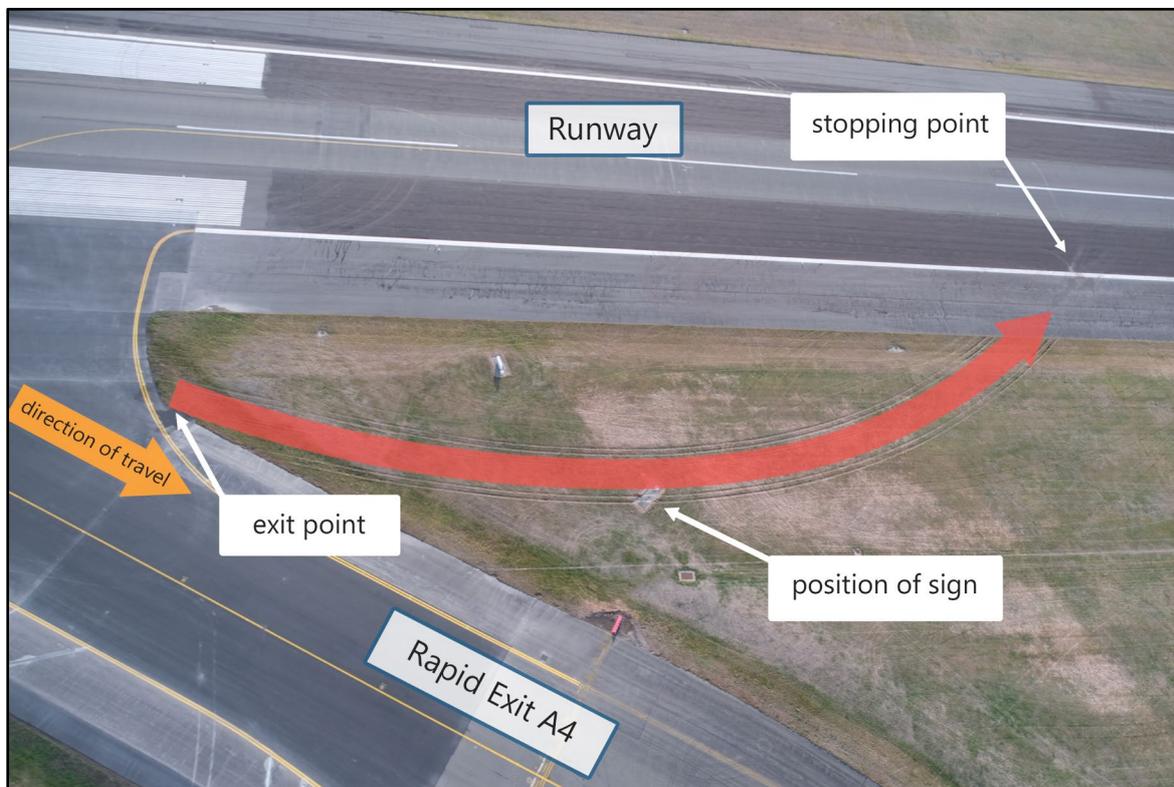
Figure 6: Path of taxiway excursion

- 2.44. The aeroplane turned off the runway and entered rapid exit A4, then left the taxiway and crossed over the grass. The No. 2 engine impacted a movement area guidance sign (MAGS) and then the aeroplane continued in a curved path back to the runway, where it came to a stop (see Figure 6).

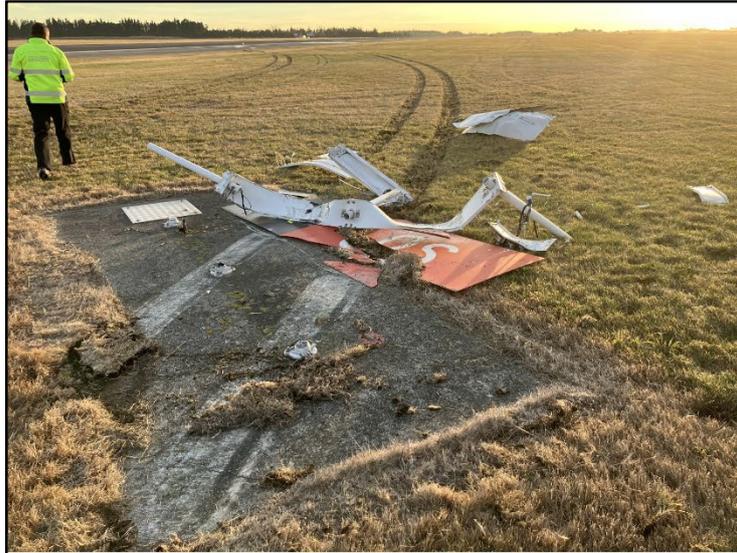
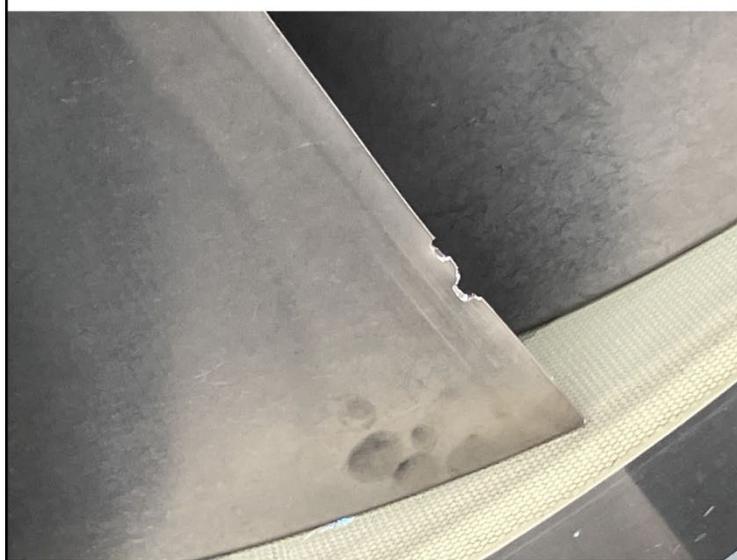
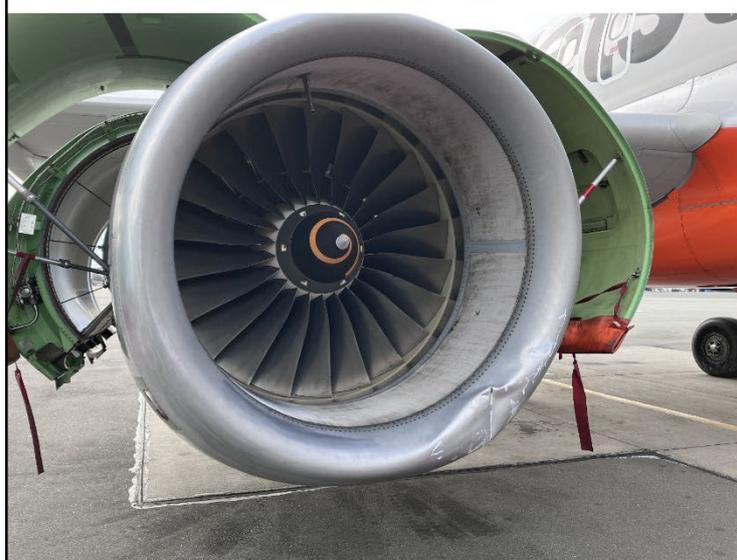
Figure 7: Engine damage from MAGS sign impact

- 2.45. Initial examination of the aeroplane found that No.2 engine had suffered significant damage to the input low-pressure fan blades and engine cowling from impact with the MAGS.
- 2.46. Further examination found that hydraulic oil had been leaking from within the right-hand main landing gear stowage bay. The leak was traced to a rupture in a hydraulic pipeline that passed through the right-hand side main landing gear bay. The pipeline was a high-pressure titanium alloy pipe. The leak resulted in hydraulic oil being sprayed around the area (see Figure 7 and Figure 8).

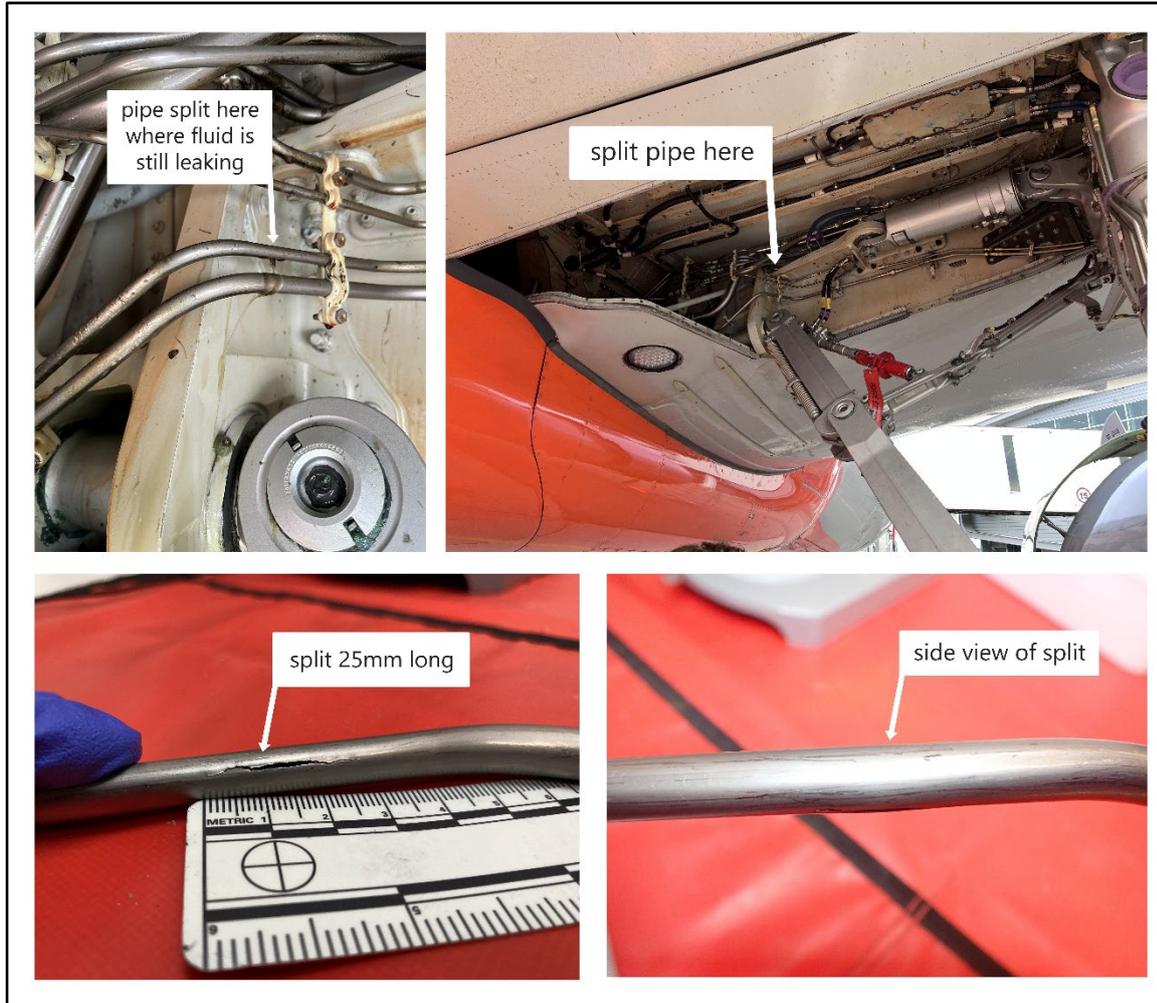
Figure 8: Hydraulic pipe failure

- 2.47. The split was 25 millimetres (mm) long and the pipe's²⁹ cross section was oval in that area. Normally the pipe was round with a 9.5 mm outside diameter, but near the split the pipe diameter was 11.5 mm across the split and 8.5 mm across the perpendicular dimension.

- 3.15. The failure had occurred in the centre of a 100 mm straight section of the 1.8 m pre-bent pipe. The pipe was oval in this area of the split rather than being round. When viewed from below, it appeared normal due to the inspection angles; the difference in width from that view angle was only 1 mm. The area was out of the way of moving parts, close to the aeroplane's internal framework in the wing and firmly supported between two pipe clamps. The pipe had no markings on the external surface that showed it had been crushed or mechanically distorted.

- 3.18. The examination confirmed that the pipe material met the Airbus specification, but found that it had been physically deformed into an oval cross section in a small area by some means that could not be determined. The mode of subsequent failure was determined to have been overload on the inner pipe wall surface.

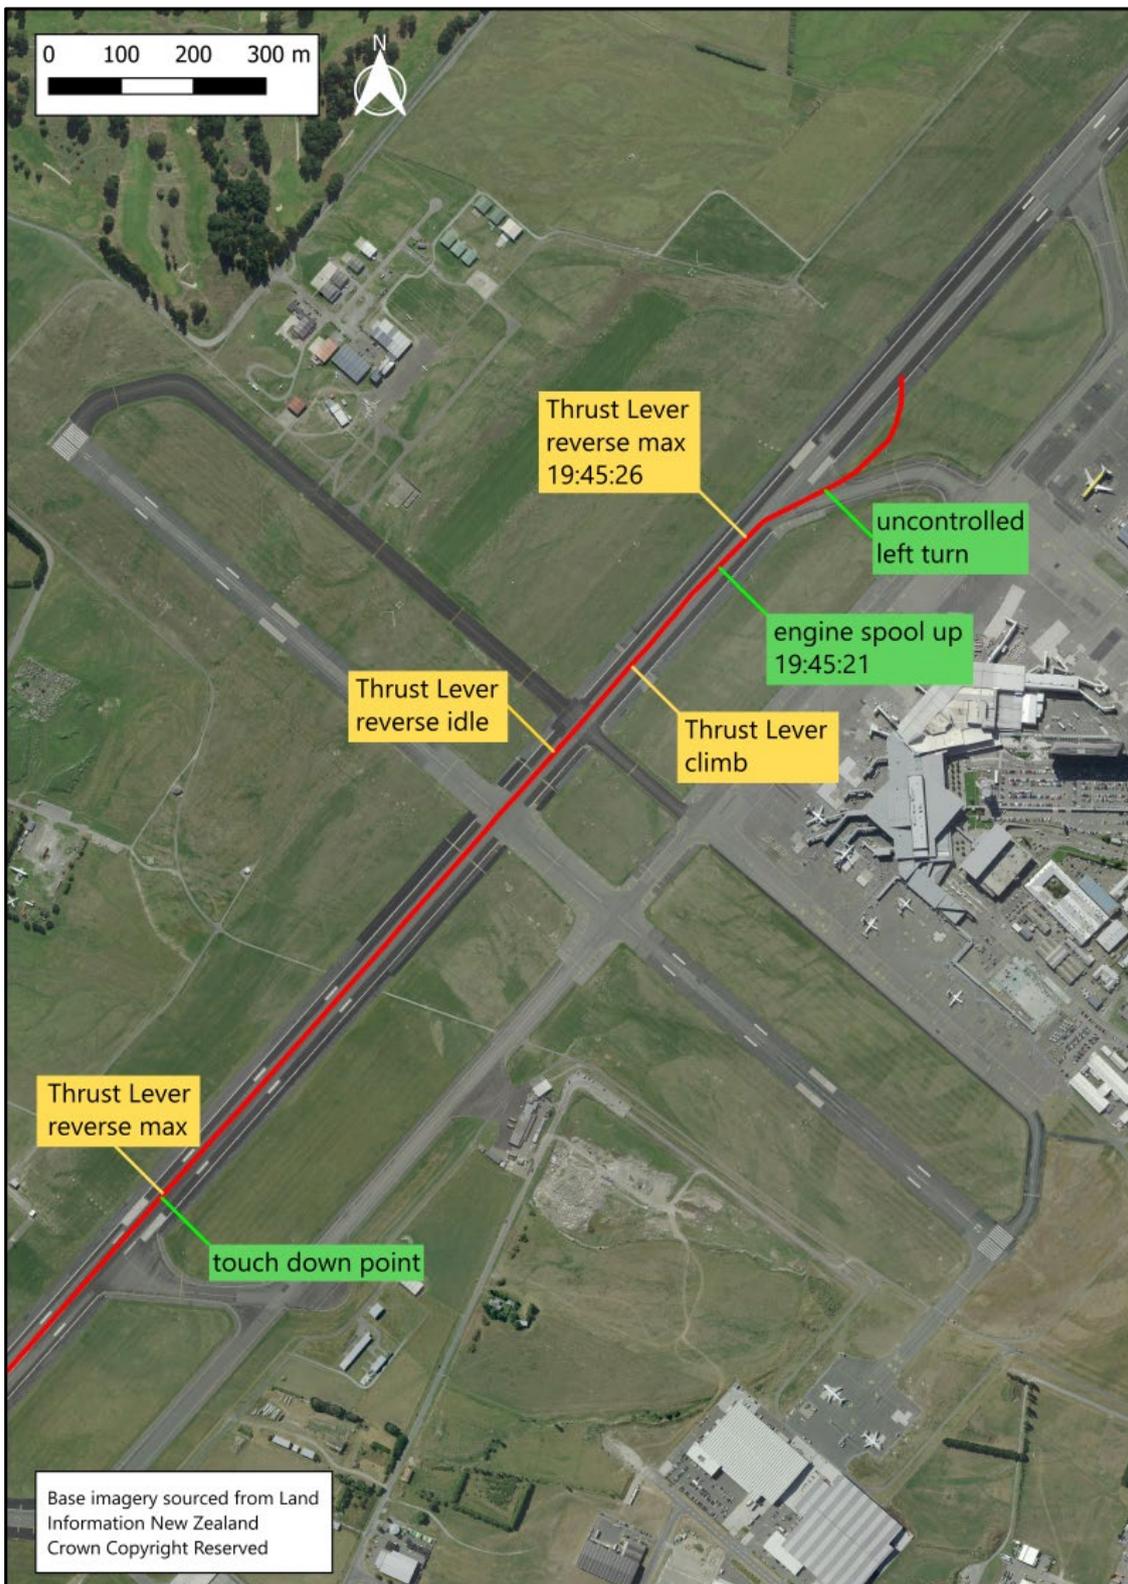
Figure 9 : Overview of landing roll
 (Note: times are in UTC)

- 3.48. The movement of the thrust levers into REV MAX after the engines spooled up led to an unexpected, uncontrolled yaw moment to the left. This was because the reverser on the No. 1 engine deployed, but the No. 2 engine reverser was disabled by the hydraulic failure and remained in the stowed position. The ECAM displayed an alert message, 'ENG 2 REVERSER FAULT', which the pilots had not expected at that time because they believed they had already stowed the reversers.

- 3.49. As both engines had previously accelerated towards CLIMB power, they were developing more thrust than they would at FWD IDLE. When REV MAX was selected, both engines slowed down. The engine's inertia prevented an immediate response to changes in thrust settings. The left engine reverser deployed, and the engine developed maximum reverse thrust while the right engine was still producing forward thrust, although it was reducing. This asymmetric thrust and pilot inputs caused the aeroplane to turn left for 60 degrees from 19:45:32.

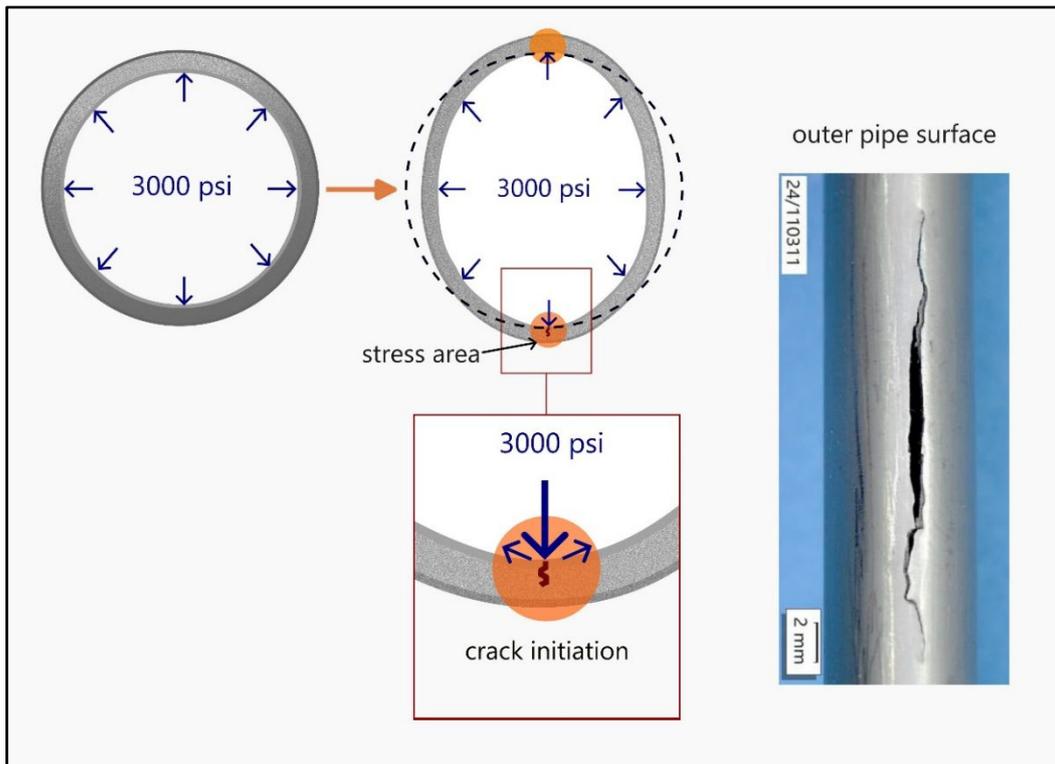
Figure 10: Mode of pipe failure

crack had reached 95% of the pipe's wall thickness when it failed from ductile overload. It then opened to a 25 mm-long split along the longitudinal axis of the pipe.

- 3.33. The hydraulic pipe failed as a result of overload stress on the inside surface at a deformed section of the pipe. The deformity was **very likely** caused when the new part's packaging was damaged in transit from the Airbus Filton warehouse in Bristol to the Airbus Fuhlsbüttel warehouse in Hamburg. However, the part was not subsequently inspected for damage and remained labelled as a serviceable item. The damage was not detected before installation or while it was in service.
- 3.34. Airbus has acknowledged the source and timing of the initial damage and recorded the case in its safety management system. Airbus informed the Commission that it will use this incident as an example in refresher training for its warehouse operators to prevent a recurrence.

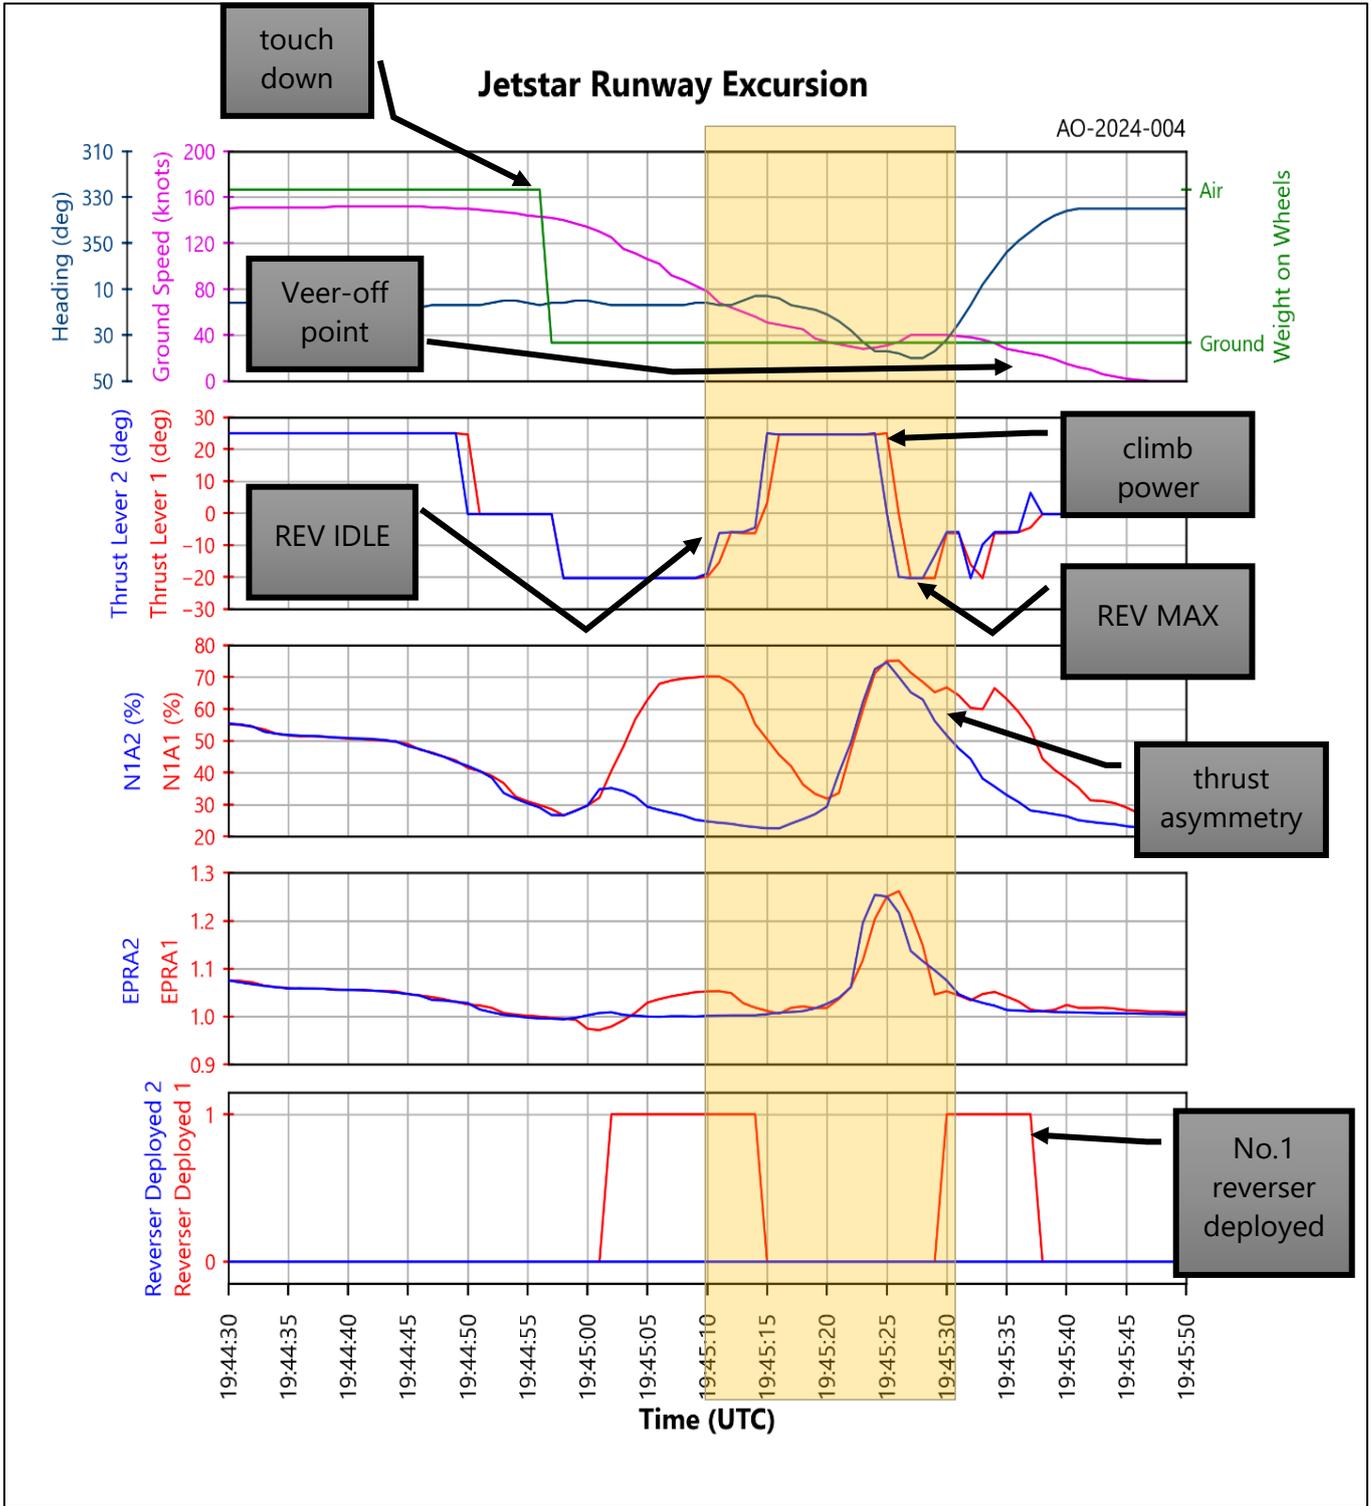
- A6.1 The data from the DFDR, presented in Figure 15: DFDR data graph shows the aeroplane movements from landing to the time of the veer-off from the rapid exit A4. The highlighted band is the excursion from the taxi exit.

- A6.6 The fourth row shows the EPRA. This is the parameter that the engine FADEC controls to maintain engine power as set by the thrust levers. The ratio is calculated from the engine low-pressure turbine exhaust pressure divided by the engine inlet pressure (see Appendix 4 for the arrangement of the engine and approximate pressure sensing points). The graph shows that both engines powered up evenly about eight seconds after the thrust levers were placed in CLIMB power, then reduced to a low setting corresponding to the REV MAX power setting, immediately after the thrust levers were placed in REV MAX.

- A6.7 The fifth row shows when the reversers were deployed. It takes about two seconds for the reversers to move from closed to open or the other way. The reverser tabs can only be lifted when the thrust levers are at FWD IDLE. No. 2 reverser did not deploy, but the thrust lever was in the reverse segment and both thrust levers were moved together.
