Transport Accident  
Investigation  
Commission

# **Final Report**

***Maritime inquiry MO-2022-206***  
***Charter fishing vessel, i-Catcher***  
***Capsize***  
***Goose Bay, New Zealand***  
***10 September 2022***

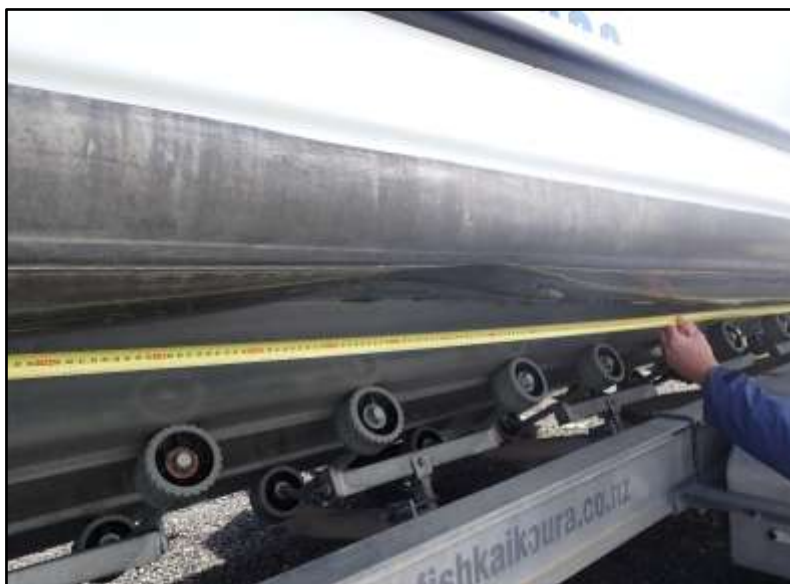
- 1.57. During its initial examination of the vessel, the Commission identified a significant smooth indentation underneath the port pontoon, measuring approximately 2.47 m in length. The depth of the indentation was greatest in the forward portion measuring 8 cm deep, tapering in depth further aft (see Figure 8).

**Figure 8: Indentation under port pontoon**

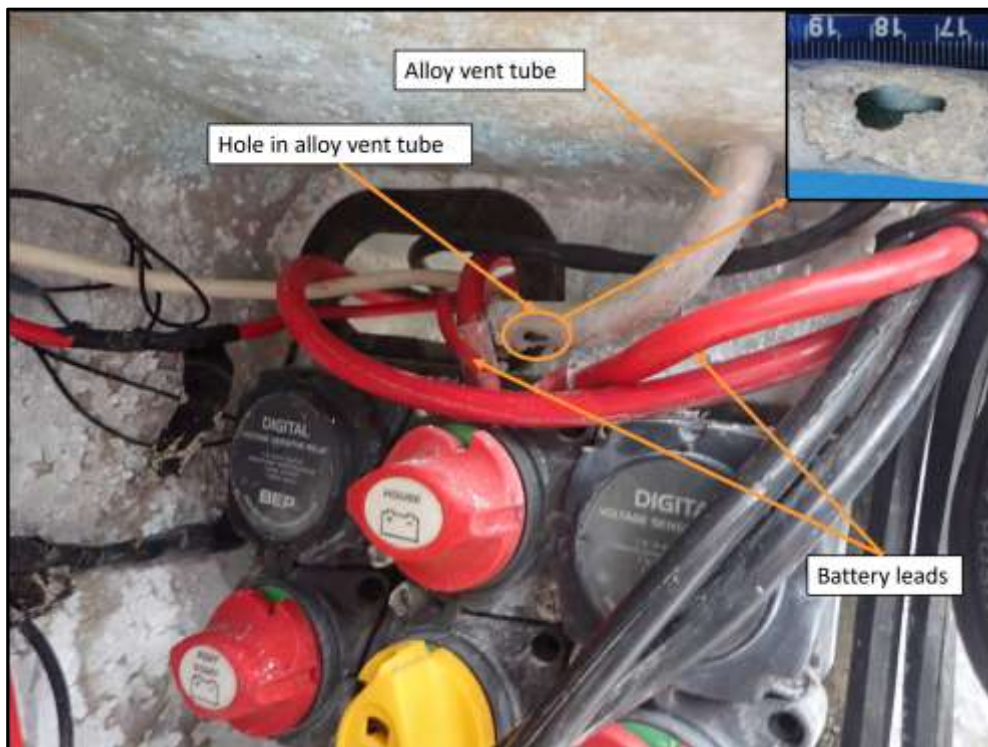
- 1.60. Initial inspection of the fuel system revealed a hole measuring approximately 12 mm x 6 mm in the alloy vent tube used as a secondary fuel vent (see Figure 11). The alloy vent tube was situated above the battery cluster switch located within the interior of the stern of the vessel (see Figure 12).

**Figure 11: Hole in alloy vent tube (batteries removed for access after accident)**

*the most likely cause of the hole was an accelerated external corrosion that occurred locally in-service, before the capsizing. The accelerated corrosion was likely because of crevice corrosion conditions caused by contact of the electrical cables with the pipe and/or accumulation of debris.*<sup>34</sup>

- 2.18. The Commission found that the hole in the alloy vent tube was **very likely** a result of crevice corrosion over time, because of one or a combination of the following factors:

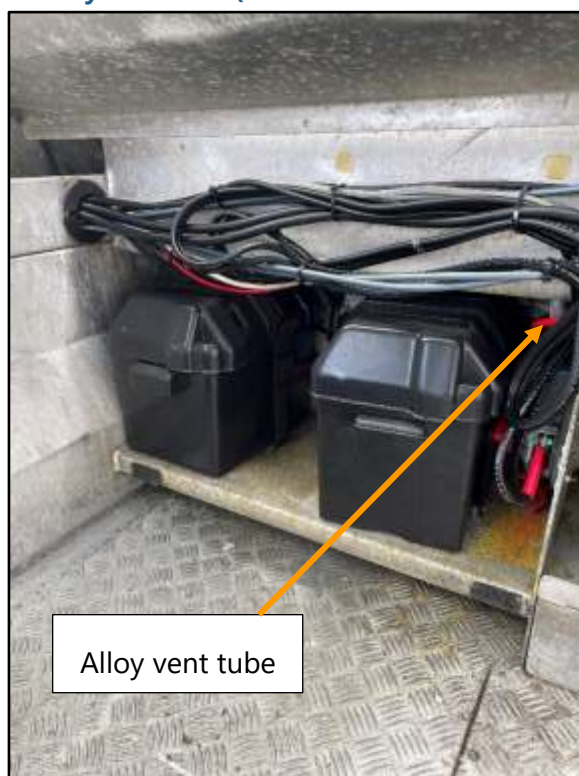
**Figure 12: Location of alloy vent (after accident)**

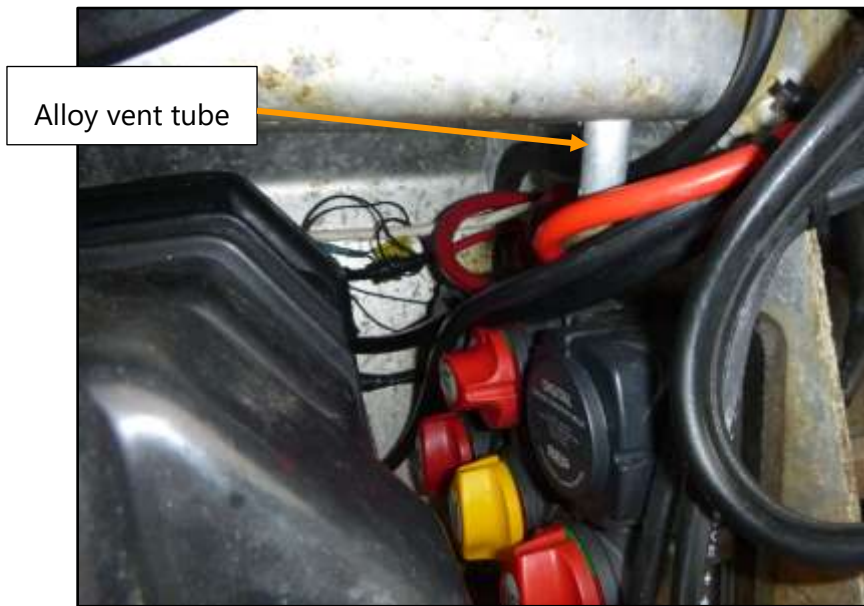
- 1.61. Identification of the hole in the alloy vent tube required a thorough examination of the venting arrangement. The alloy tube was partially restricted from view by a battery box and surrounding wiring (see Figure 13). The hole was a potential path for fuel to escape when filling the fuel tank or if the vessel overturned. It was also close to the battery leads and contact points, which presented a significant fire or explosion hazard.

**Figure 13: 2021 survey photo demonstrating restricted view of alloy vent tube with batteries in place.**

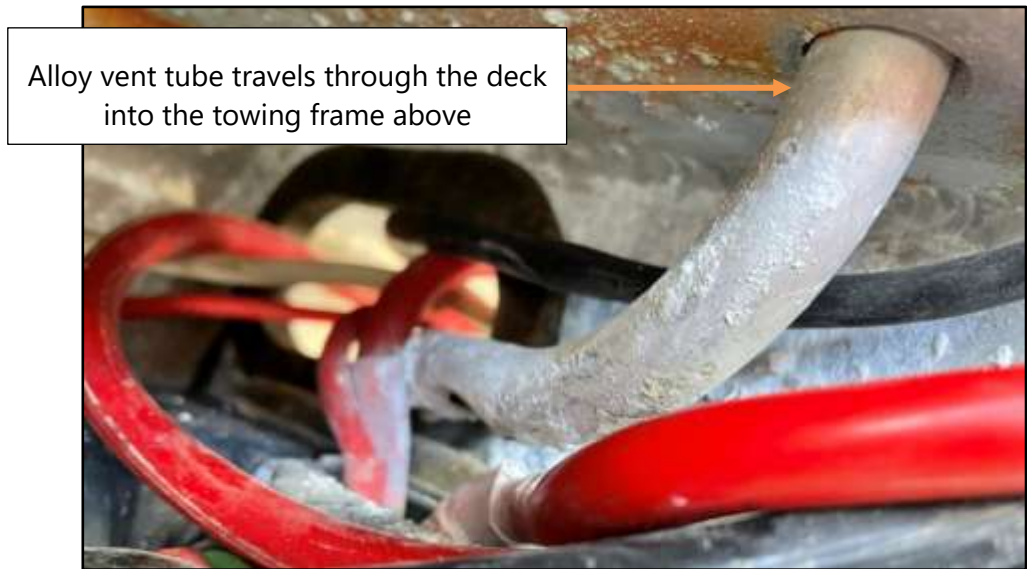
- 1.62. The alloy vent tube terminated inside an alloy towing frame on the transom just forward of the swim platform (see Figure 14 and Figure 15). A pressure test of the alloy frame revealed that it was closed off from the atmosphere, preventing fuel vapours from venting to open air and rendering it ineffective as a fuel-tank vent.

**Figure 14: Alloy vent tube joining towing frame**

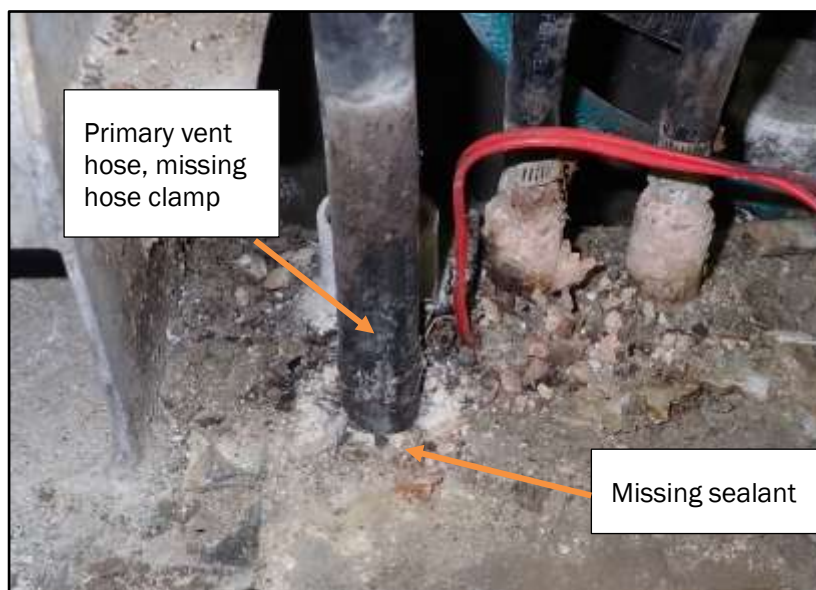
- 1.64. To enable inspection of the fuel tank and its connections, investigators removed the cover plate and the deck plate and partially disassembled the fuel system. Upon disassembly, investigators found the primary vent hose was not secured with a hose clamp, a critical component to ensure a secure connection to the fuel tank (see Figure 17).
- 1.65. A sealant had been applied around the plating where the fuel and vent hoses connected to the fuel tank. It was observed that a portion of the sealant had broken away, leaving a section of the primary vent hose connection exposed. The fuel tank and its fuel hoses were pressure-tested by Commission investigators, which revealed a leak from the base of the primary vent hose.

**Figure 17: Primary vent hose connection to fuel tank (underneath the deck plate)**

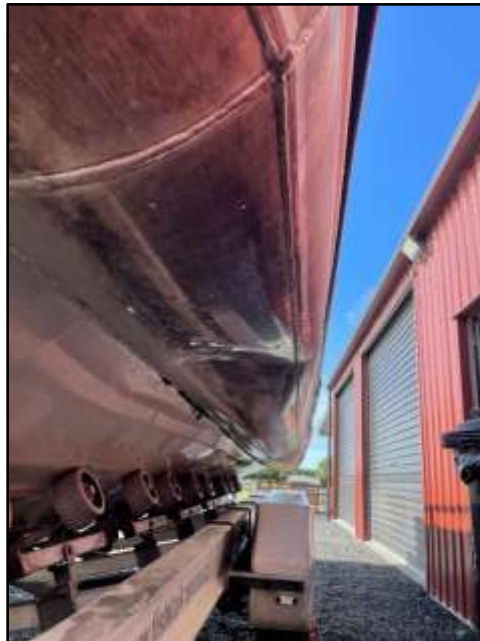
- 2.9. The indentation underneath the vessel's port pontoon was smooth and of significant size (see Figure 23), indicating that it was caused by a soft but dense material rather than a hard object. Contact with hard objects usually result in significant abrasions, definitive markings, transfer of material and possible holing in the hull.

**Figure 23: Indentation under port pontoon**

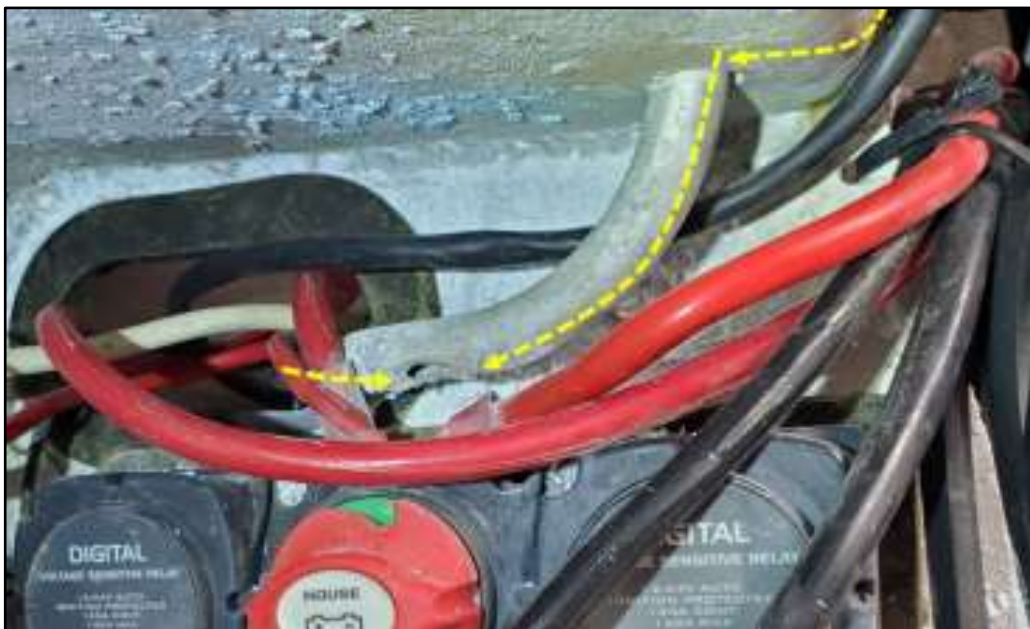
- 2.14. The corroded hole was located at a low point in the system, which would allow water and dirt to run and collect (see Figure 24). When the alloy tube was removed from the system it was evident that there was further abrasion and corrosion where the battery leads had been in contact with the alloy tube (see Figure 25). With time it can be expected that these areas would also develop into holes.

**Figure 24: Low point of alloy vent tube**  
(Credit: Quest Integrity)

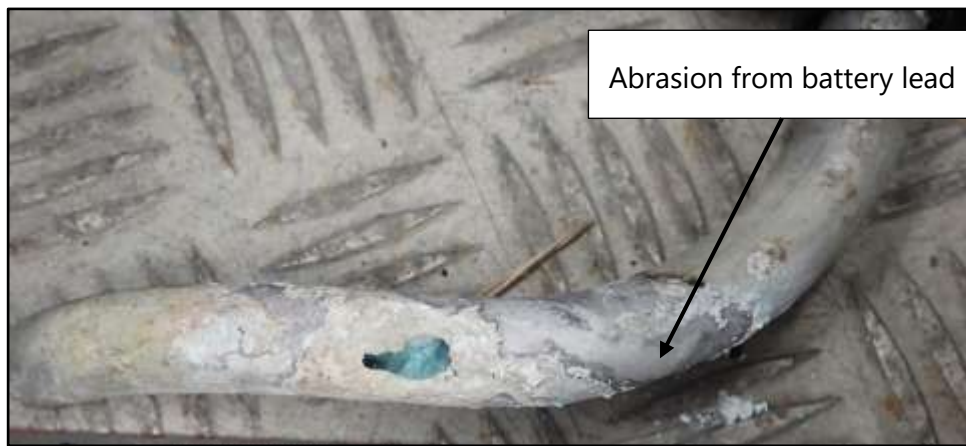
**Figure 25: Abrasion from battery lead**

- 2.16. At the time the battery selector switch was replaced, the alloy vent tube may have been subject to abrasion and the hole may not yet have formed. With the aluminium's natural passive layer damaged or removed by the battery leads, it would just be a matter of time before a hole developed.

- 2.17. It is **likely** that before the battery selector switch was replaced, the battery leads had been in contact with the alloy vent tube contributing to the corrosion that later developed into a hole.

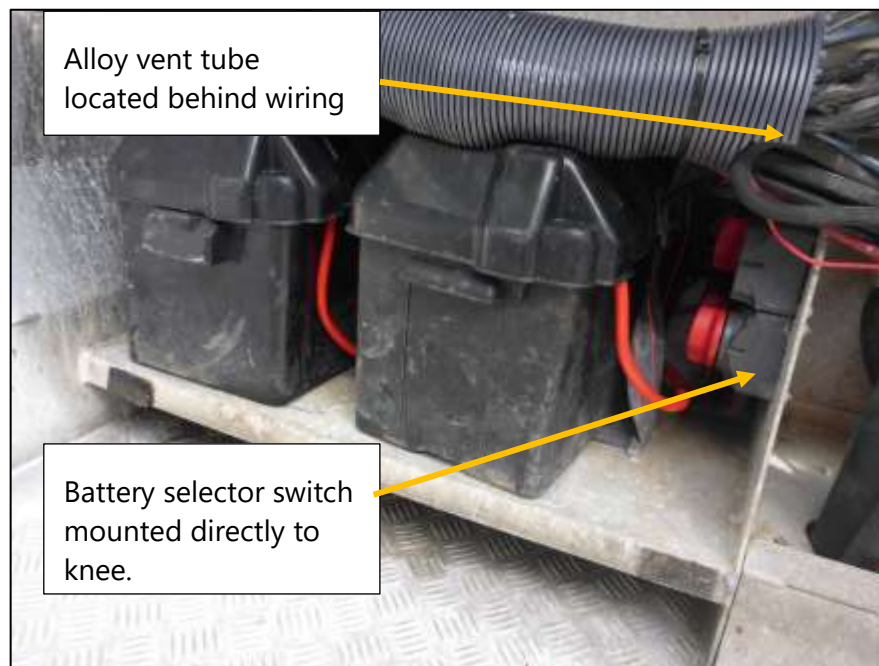
- 2.15. The *i-Catcher's* battery selector switch was replaced in 2019. The original battery selector switch was mounted directly to the knee of the transom (see Figure 26). When the new battery selector switch was installed, an insulator pad was added to absorb vibrations between the knee and the switch. This would have changed where the battery leads contacted the alloy tube.

**Figure 26: Original battery selector switch arrangement (2016)**

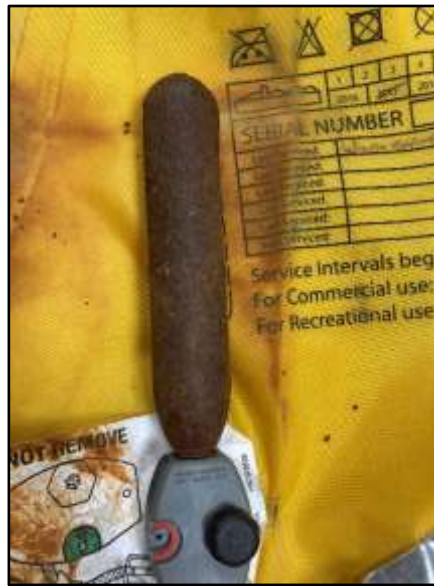
**Figure 30: Corroded lifejacket cylinder**

- 2.78. The CO<sub>2</sub> cylinder had corroded to a point where the cylinder wall had significant pitting (see Figure 30). This level of corrosion posed a significant risk to the wearer as the canister was at risk of failing while pressurised, which could have led to the lifejacket not inflating, or the canister exploding.

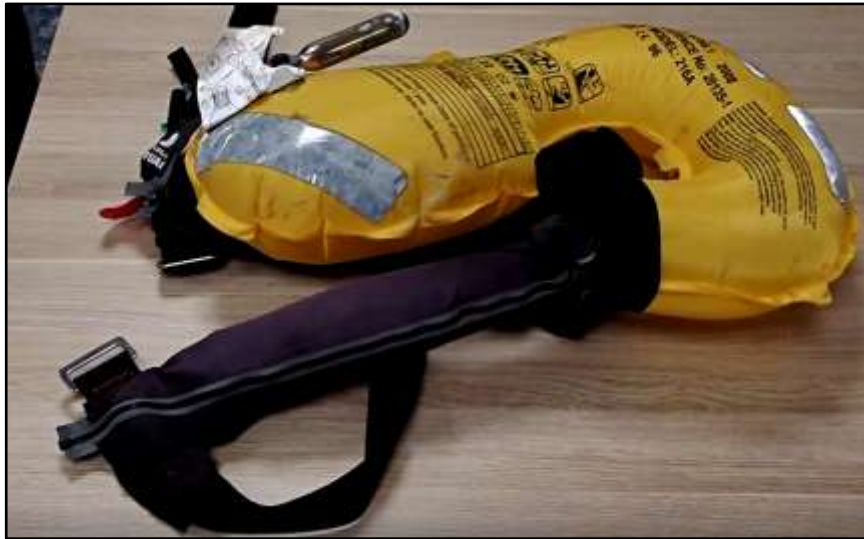
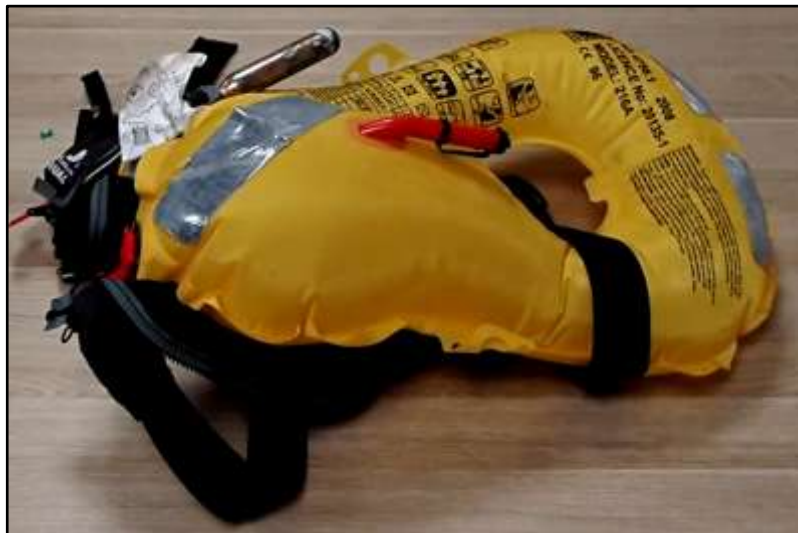
- 2.80. An injured passenger on the *i-Catcher* attempted to inflate their lifejacket to assist with keeping afloat as one of their arms was ineffective. Only one side of the bladder initially inflated, further complicating their swimming ability for a moment until the second portion suddenly inflated. The Commission tested another lifejacket that was not inflated during the accident and found a similar inflation sequence where the bladder inflated to a point where it appeared pinched and, after a significant build-up of air pressure, a subsequent sudden violent burst of inflation occurred (see Figure 31 and Figure 32).

**Figure 31: Lifejacket bladder pinched for several seconds**

**Figure 32: Bladder fully inflated after sudden violent burst of inflation**
