Transport Accident
Investigation
Commission

Final report

Maritime inquiry MO-2025-202
Jet boat Discovery 2
Allision with canyon wall
Skippers Canyon, near Queenstown
25 February 2025

April 2026

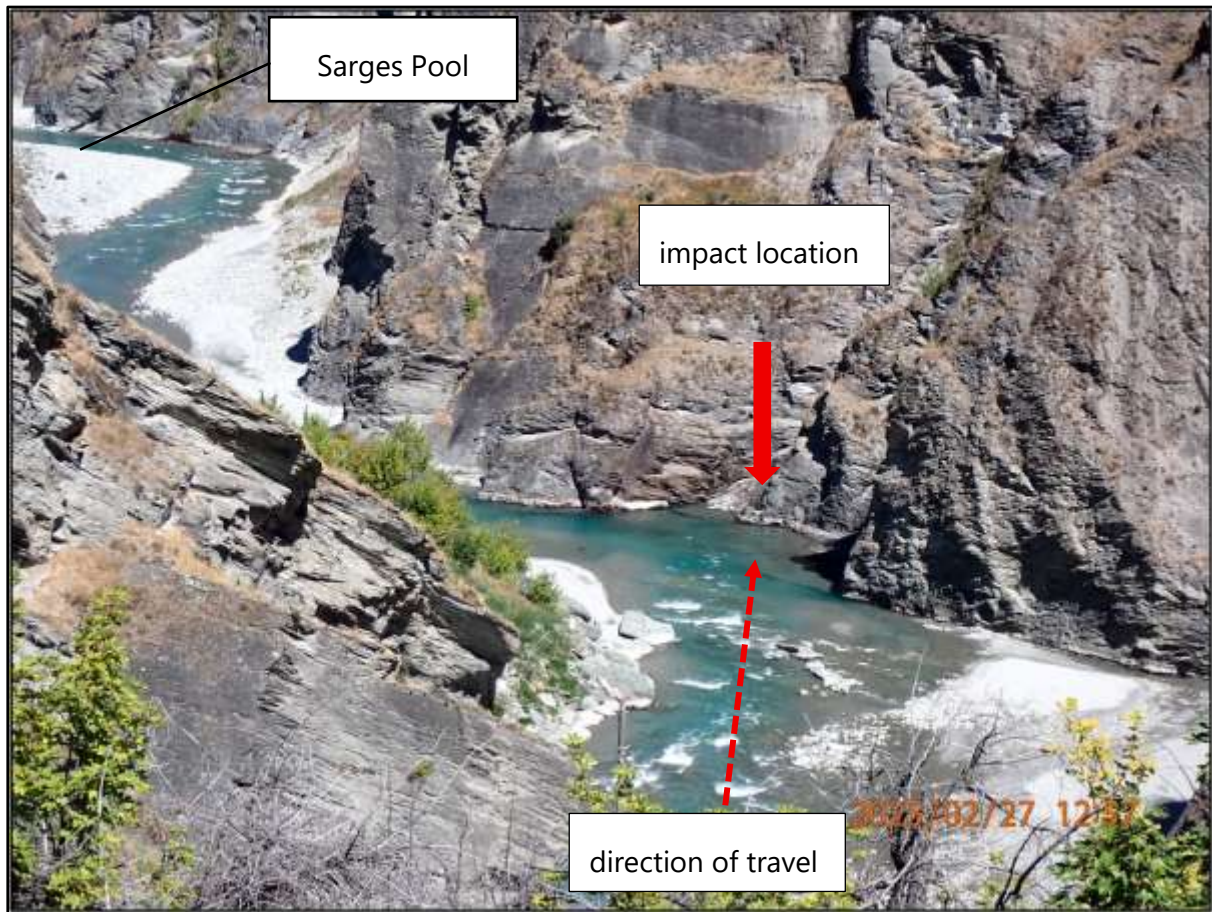
Figure 6: Accident location – looking downriver from near Blue Slip

- 2.11. At about 1702, *Discovery 2* collided with the canyon wall, into a rocky bluff, at an estimated speed of 30–35 kilometres per hour. The driver briefly assessed the extent of the injuries to passengers and damage to the boat. The driver decided that a medevac⁸ would be required, so called "Mayday" on the radio and requested SCJ base to arrange a helicopter evacuation. *Armadillo's* driver heard the radio calls and contacted *Discovery 2* to offer assistance. The *Discovery 2* driver instructed them to

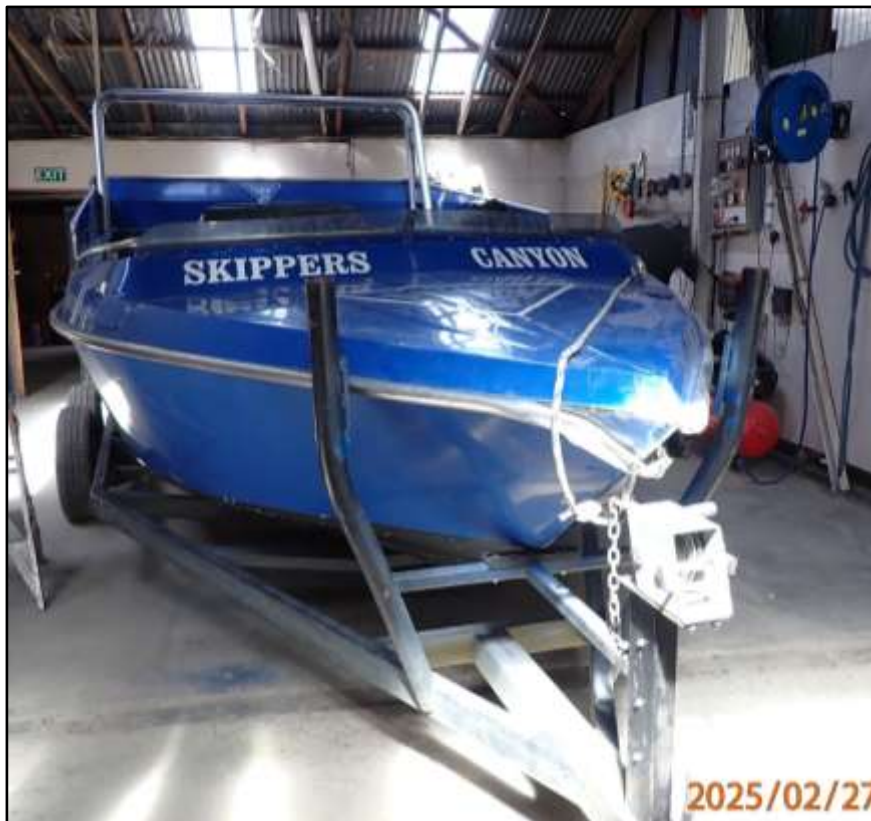
Figure 7: Damage to the bow of *Discovery 2*

- 2.24. Damage to *Discovery 2* consisted of moderate buckling and cracking of the hull at the bow and windscreen, bent handrails and bent seating.

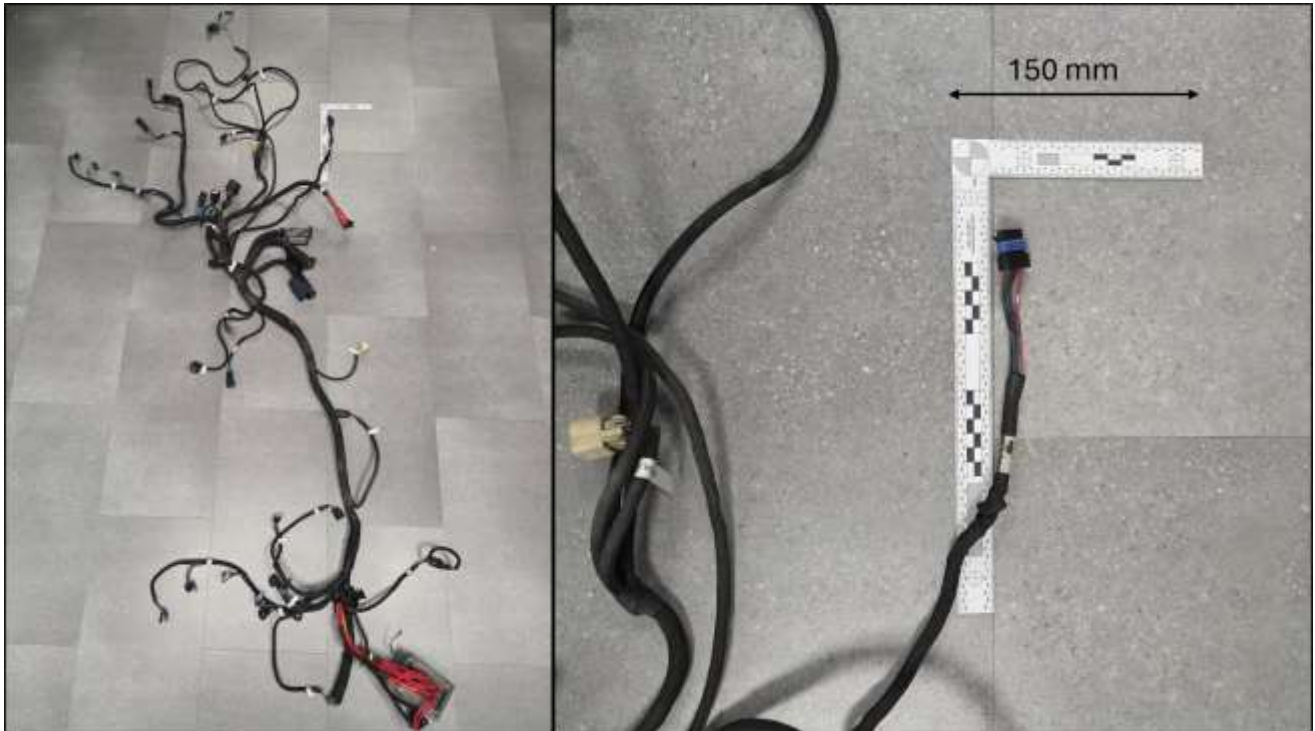
Figure 8: The entire wiring harness (left) and the pedal position sensor lead (right)

- 3.9. Testing and inspection schedules for forensic examination of the wiring harness and leads were devised by the operator and the Commission's independent expert. The examination was carried out under laboratory conditions and observed by a Commission investigator. It identified chafing damage to the wire protection on the pedal position sensor (PPS)¹⁴ lead (see Figure 8 to 10).

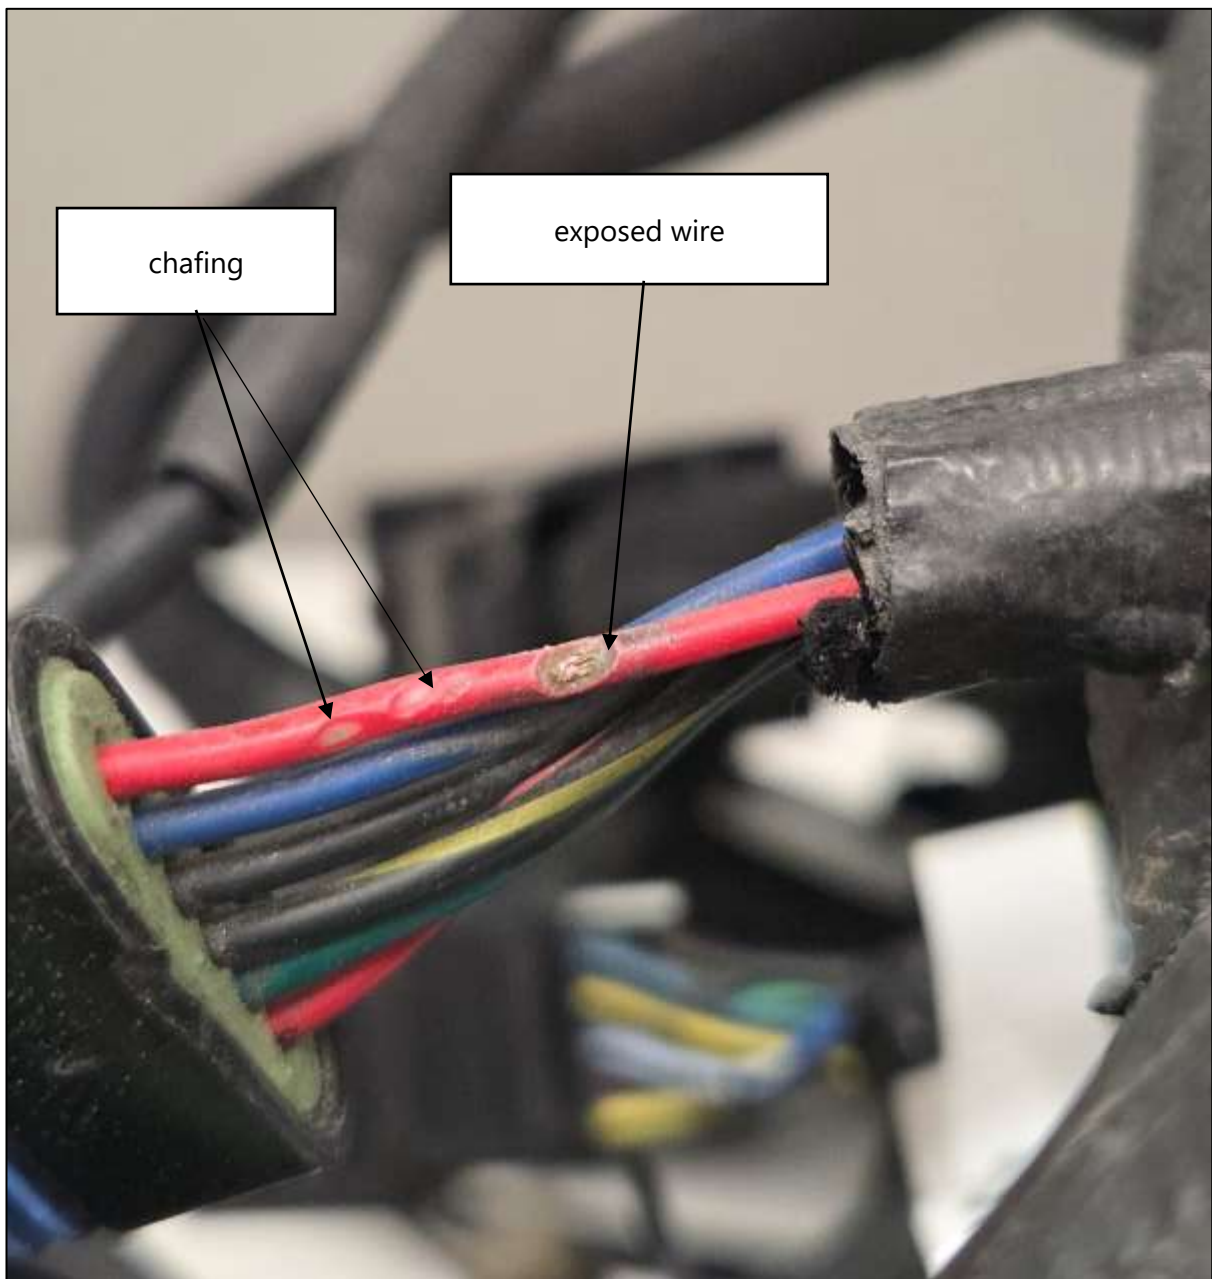
Figure 9: The pedal position sensor lead showing signs of chafing where the wire is exposed

- 3.10. KEM Equipment Incorporated confirmed that arcing on the PPS lead would probably cause the engine to cut out. The Commission's investigators travelled to Skippers Canyon to test this hypothesis with the Commission's independent expert and the operator. When the wiring harness was reinstalled, it naturally rested against the area of the suspected short circuit (see Figure 10). This point appeared to be a rough casting edge on the engine.

- 4.1. It is **virtually certain** that the engine shut down because part of its wiring harness had chafed against a casting edge of the engine. The chafing exposed a wire and eventually caused a short circuit when it came into contact with part of the engine. This resulted in the loss of the 5-volt reference voltage signal shared by the critical engine sensors and the engine shut down.

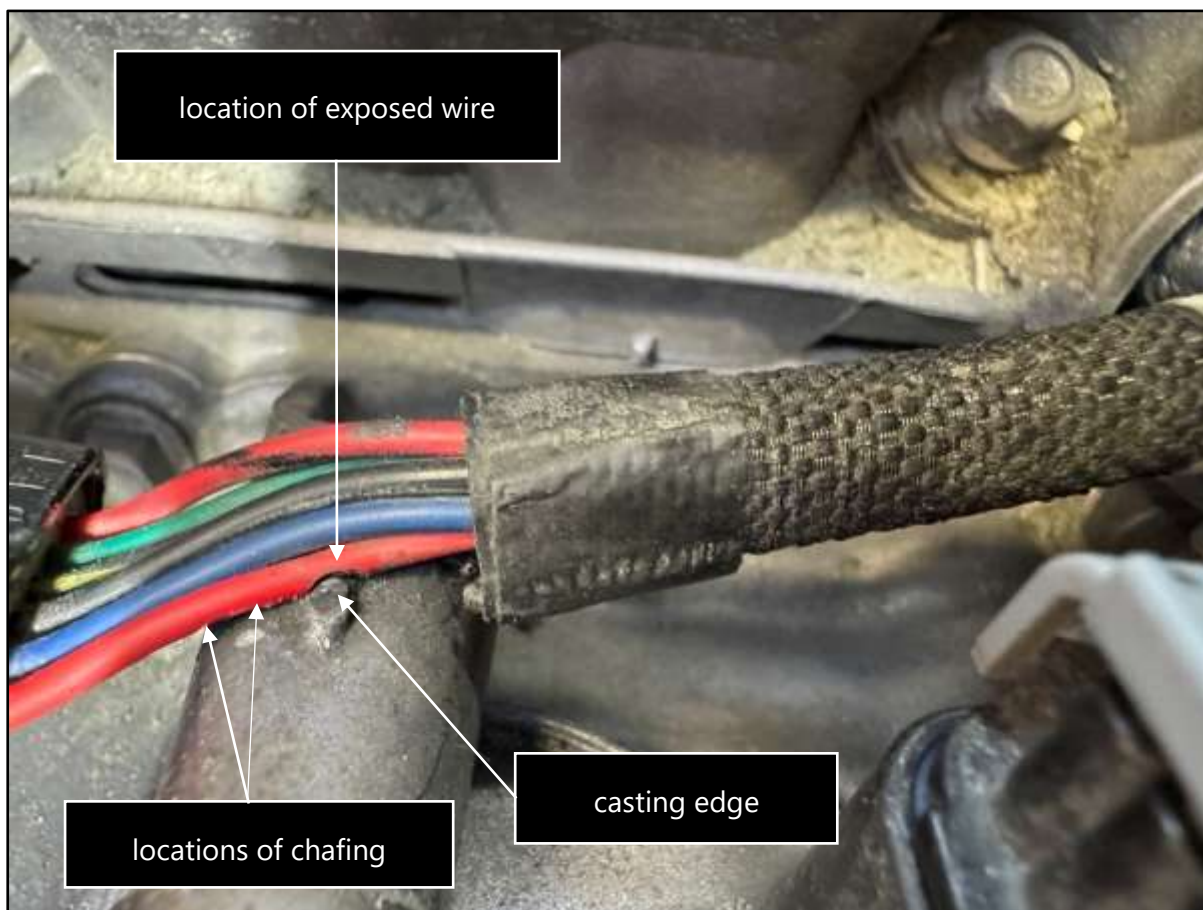
Figure 10: Damaged wire in situ with chafed area against casting edge

- 3.11. Testing was conducted at idle, and then at 4000 revolutions per minute to replicate the conditions of the original incident. In both conditions the engine stalled when the wire was earthed. Earthing removed the 5-volt reference voltage¹⁵ shared by the critical engine sensors causing the engine to stall.

- 3.12. The Commission's independent expert concluded that the test showed the suspected short circuit could and did cause the engine shutdown.
- 3.13. Given the indications of chafing and short circuit on the identified wire of the PPS lead, it is **virtually certain** that the engine shut down because part of the engine's wiring harness had chafed against the casting edge, earthing the wire.

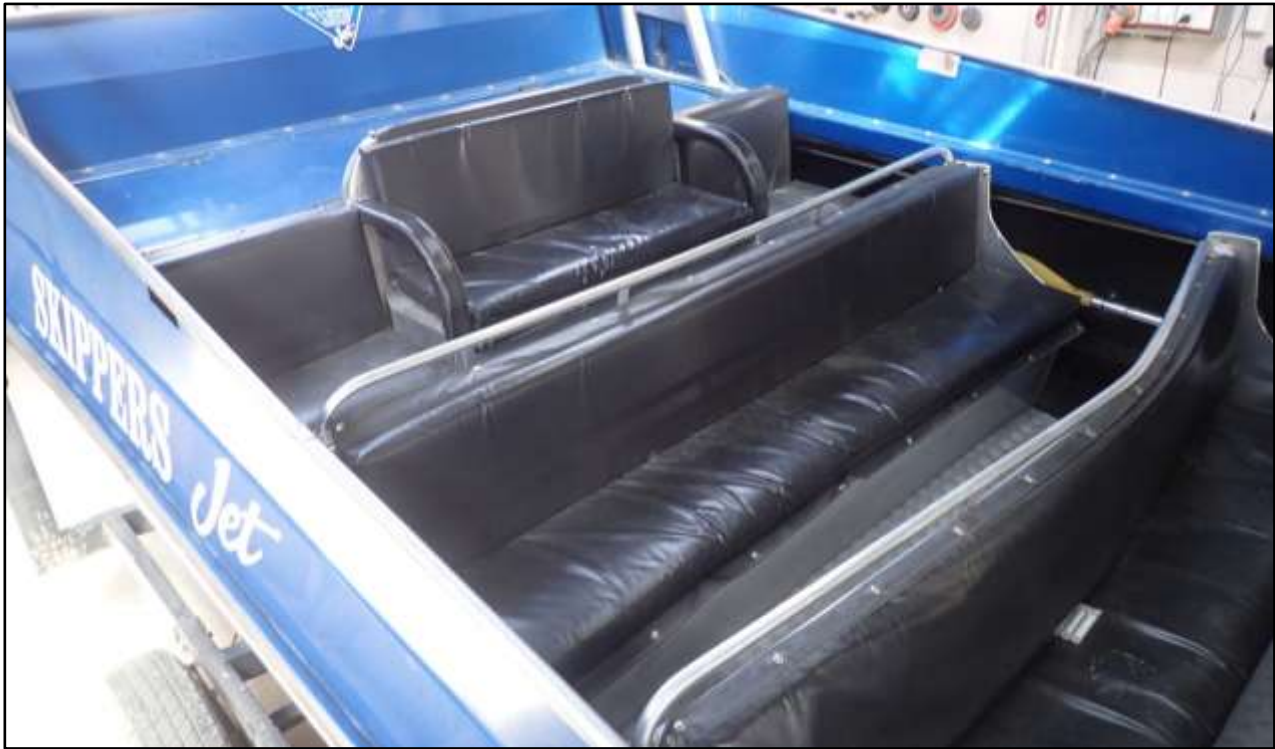
Figure 11: Deformation of seating and handrail from passenger's impact

- 4.6. Padding of seats and surrounds was inadequate to protect the passengers from injury during a sudden stop.
- 4.7. Passengers were not informed of, and were therefore uncertain about, what was an appropriate brace position for an emergency on board a jet boat. It is **likely** that some passengers suffered worse injuries due to this uncertainty.

- 6.3. On 25 March 2026, the Commission recommended that the Director of Maritime New Zealand work with New Zealand commercial jet boating stakeholders to review and improve the requirements prescribed to commercial jet boat operators to ensure that safety measures on board are adequate to protect passengers from injury. **[015/26]**
- 6.4. On 14 April 2026, Maritime New Zealand replied:
