# Final report

***Rail inquiry RO-2024-104***

***Freight train MR1***

***Signal passed at danger and near miss with HRV***

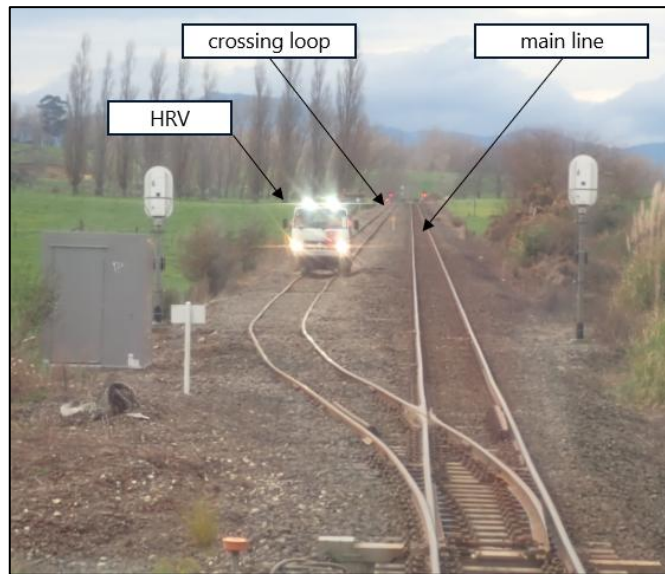
**Figure 5: Location of HRV at the Kereone crossing loop**

track and stopped approximately 50 metres (m) short of the signal that led back onto the main line (see Figure 5).

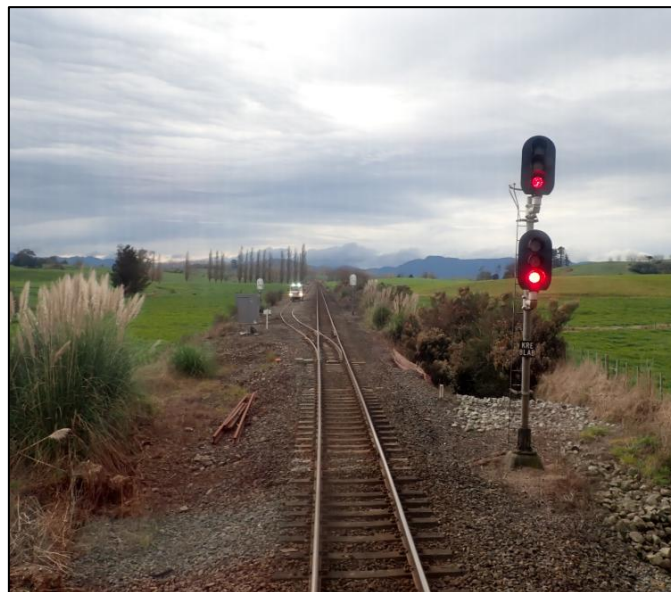
**Figure 8: Entry signal (signal 8L) with the HVR in the Kereone crossing loop**

- 2.31. At 1143:57, as the TTC and HRV operator were finalising the new track occupancy authority, the train passed the entry signal (signal 8L) at stop, travelling at a speed of 51 km/h, and entered the main line at Kereone (see Figure 8).

- 2.32. The signalling system at Kereone station is not equipped with any engineering systems to stop a train or rail vehicle from passing a signal at stop.

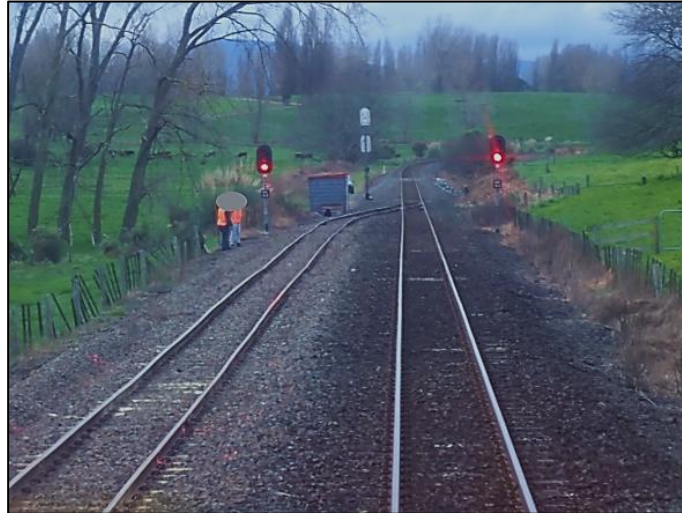
**Figure 9: Crossing loop signal (signal 4LB) on the left and exit signal (signal 4LA) on the right**

- 2.34. At 1143:57, the TTC and the STC observed the train on the train control system mimic screen<sup>24</sup> pass the entry signal (signal 8L) at stop. Passing a signal at all red (stop) without authorisation is contrary to KiwiRail's Rail Operating Rules and Procedures and is referred to as a signal passed at danger (SPAD). The train proceeded down the main line towards the exit signal (signal 4LA) (see Figure 9).

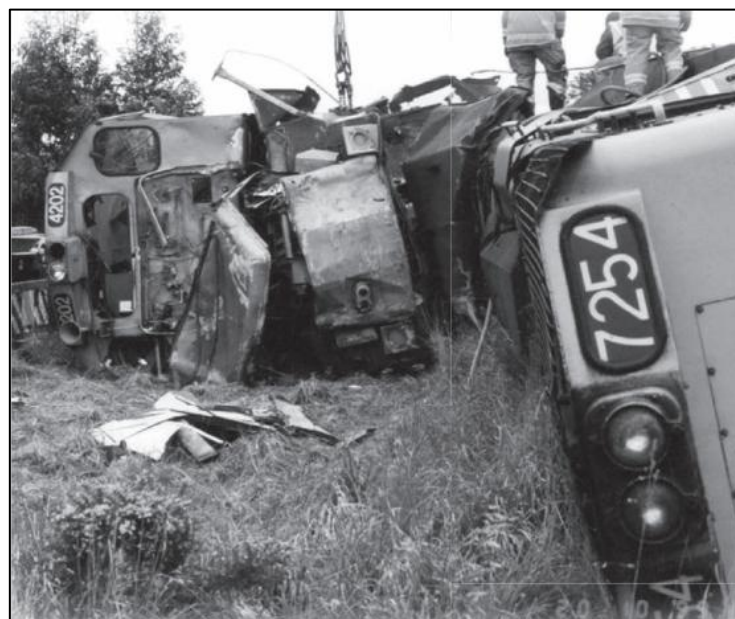
**Figure 16: Train collision at Waipahi station**

- 2.65. On 20 October 1999 at around 0702, Train 938, a northbound express freight train, collided with Train 919, a southbound intercity express freight train, which was stationary on the main line within station limits at Waipahi (see Figure 16).

- 2.66. The collision resulted in significant damage to both trains and the death of the locomotive engineer of Train 919.

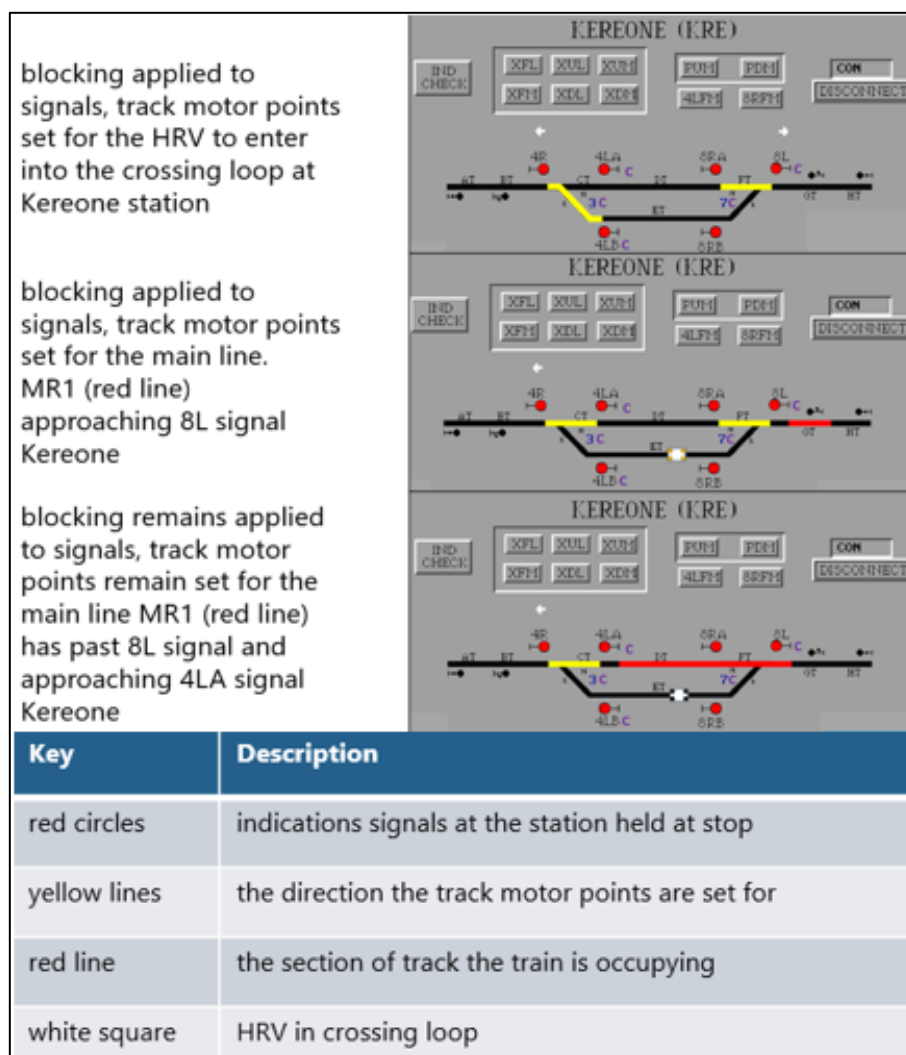
Figure 21: Signal log showing signal and track points positions at Kereone during the incident

- 3.13. The Commission's testing found that the TTC computer command inputs and the trackside signals displayed the correct signal aspects to stop the train at Kereone station's entry signal.

- 3.17. Having reviewed all available evidence, the Commission found that it is **virtually certain** that the signalling system for Kereone station was operating correctly when the train passed through. It is also **virtually certain** that both signals at Kereone station were set at stop (red) when passed.

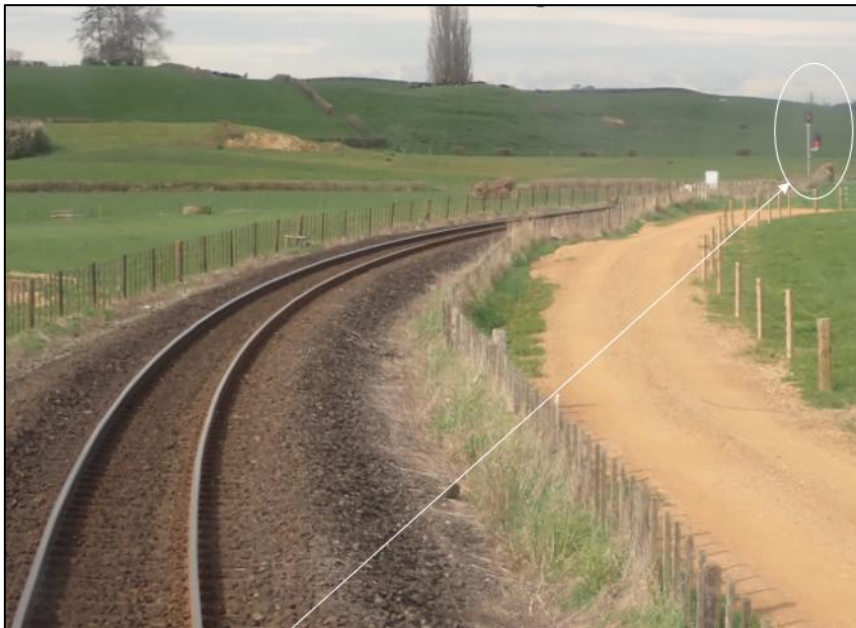
**Figure 22: Signal sighting of intermediate signal on the right-hand bend**

- 3.23. The impact of confirmation bias may have been enhanced on the LE's approach to the intermediate signal. This is because while the intermediate signal met KiwiRail's signal sighting standards and could be seen clearly from approximately 600 m away, the track leading to the signal was on a right-hand bend. As a result, the signal became harder to read as the train got closer to it due to the curvature of the track (see Figure 22).

- 3.24. In particular, the upper unit of the signal (yellow) became harder to read than the lower unit (red). Therefore, it is **about as likely as not** that the LE mistakenly perceived a normal clear signal as they approached the intermediate signal (see Figure 23).

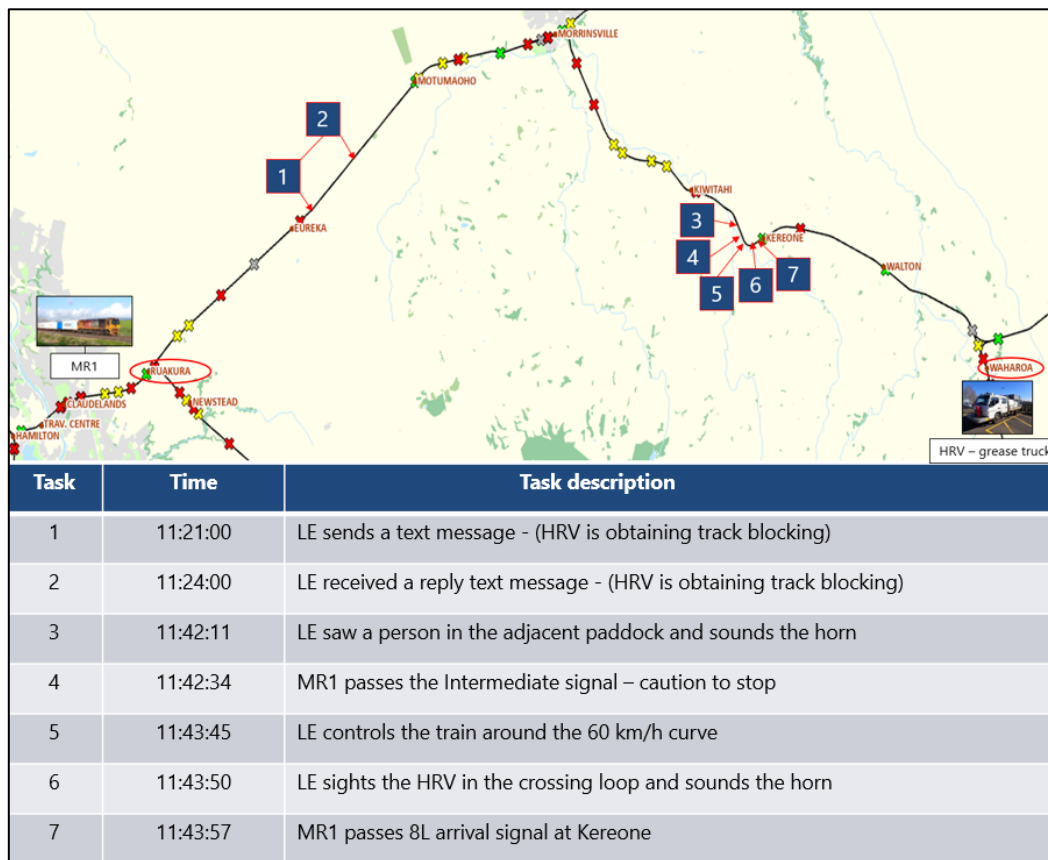
**Figure 24: Task descriptions and timeline leading up to incident**

3.28. The LE was subject to several distractions in the lead-up to the incident. At 1121, the LE wrote and sent a text message, then received a response to the text message at 1124 (see Figure 24, Tasks 1 and 2).

- 3.29. As attention is a limited resource, it is **very likely** the LE did not hear the conversation between the TTC and HRV operator as they were distracted by their mobile device. This removed an opportunity for the LE to receive advanced notice of the upcoming crossing with the HRV at Kereone station, and to expect signals directing them to prepare to stop the train.

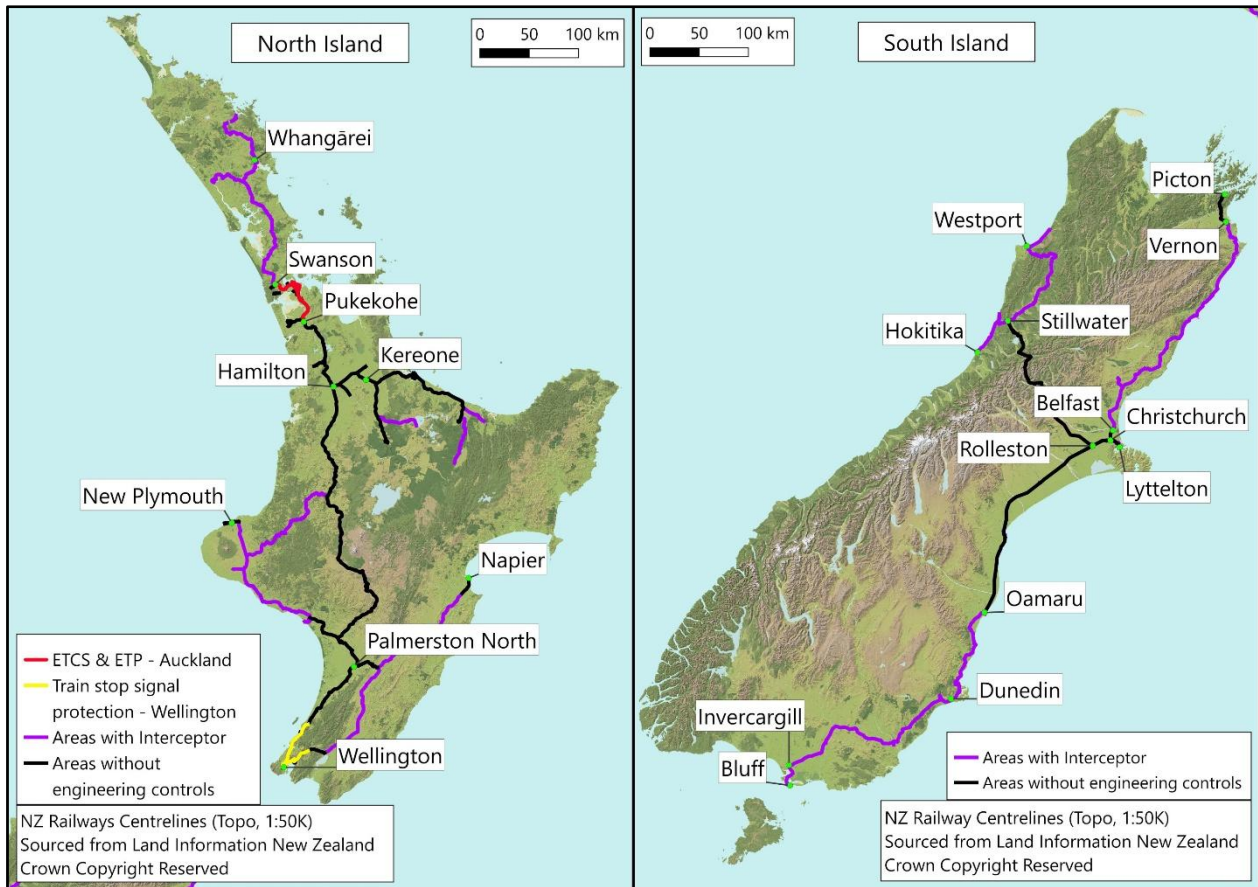
**Figure 25: Locations of engineering safety systems**

- 3.35. In this incident, the existing administrative control (a reliance on the LE recognising and then reacting appropriately to signal aspects) proved inadequate to prevent the SPAD because the control failed to compensate for variabilities in human performance.

3.39. There is a range of engineering safety systems that could be implemented to prevent unintended rail vehicle movements and vehicles exceeding the limits of authority, including:

- 6.3. On 25 February 2026, the Commission recommended that KiwiRail utilise engineering safety controls in areas of its rail network where none currently exist, to mitigate the risk of human error by locomotive engineers and reduce signal passed at danger incidents. **[001/26]**
- 6.4. On 13 March 2026, KiwiRail replied:
