# **Final report**

***Rail inquiry RO-2025-102***

***Runaway rail-vehicle collision and near miss with  
rail crew***

***Port Chalmers, Dunedin***

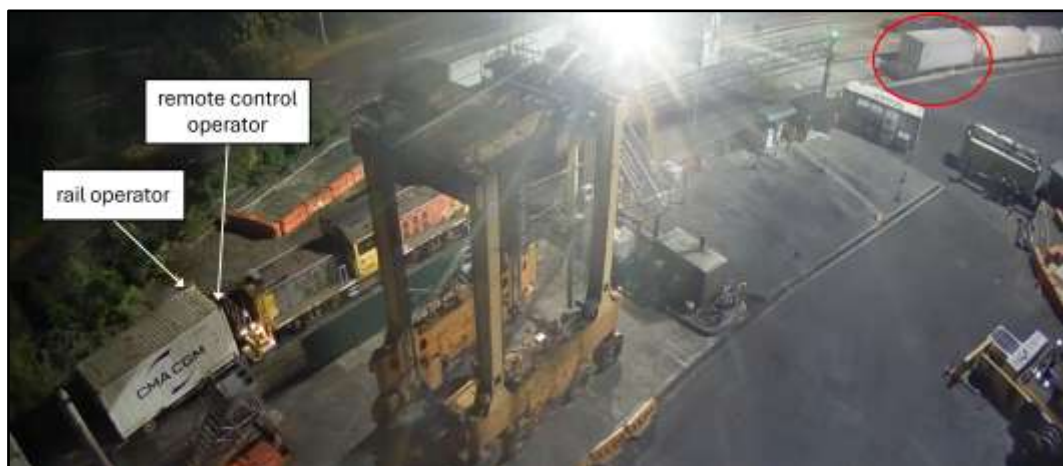
**Figure 6: Position of wagons and shunt crew at 0129:28**

2.29. At 0129:28, the RCO tried to connect the remaining 16 wagons to the shunt locomotive, but because of the curvature of the track the wagon coupler connection would not align and lock in place. At the same time, the nine unsecured roll away<sup>19</sup> wagons had moved approximately 15 m towards the crew (see Figure 6).

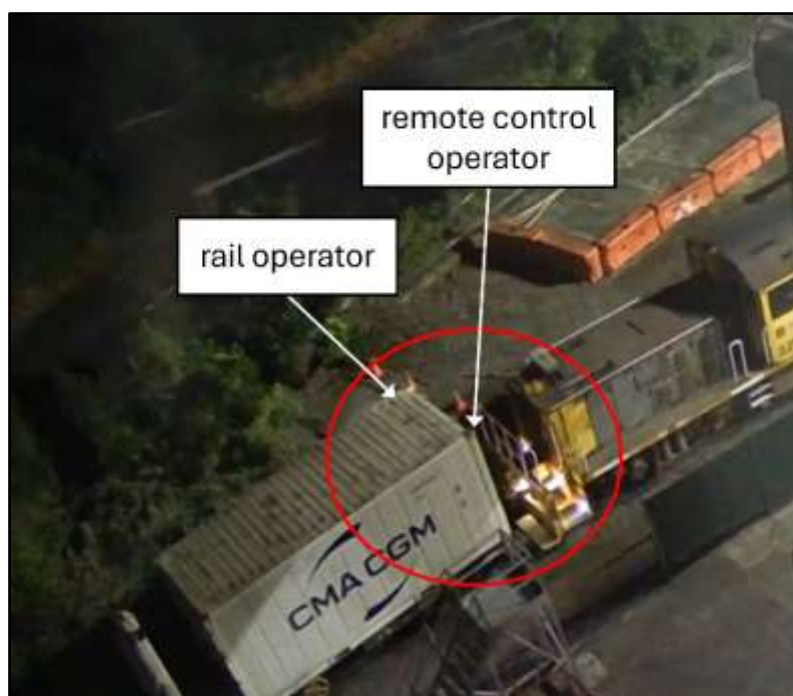
**Figure 7: Position of RCO and RO while connecting the air hoses**

2.30. At 0130:20, the RCO advised the RO that they had successfully coupled the locomotive to the wagon's coupler. The RO then went between the wagon and locomotive to join the two air-brake hoses together. The crew were still unaware of the wagons slowly moving towards them (see Figure 7).

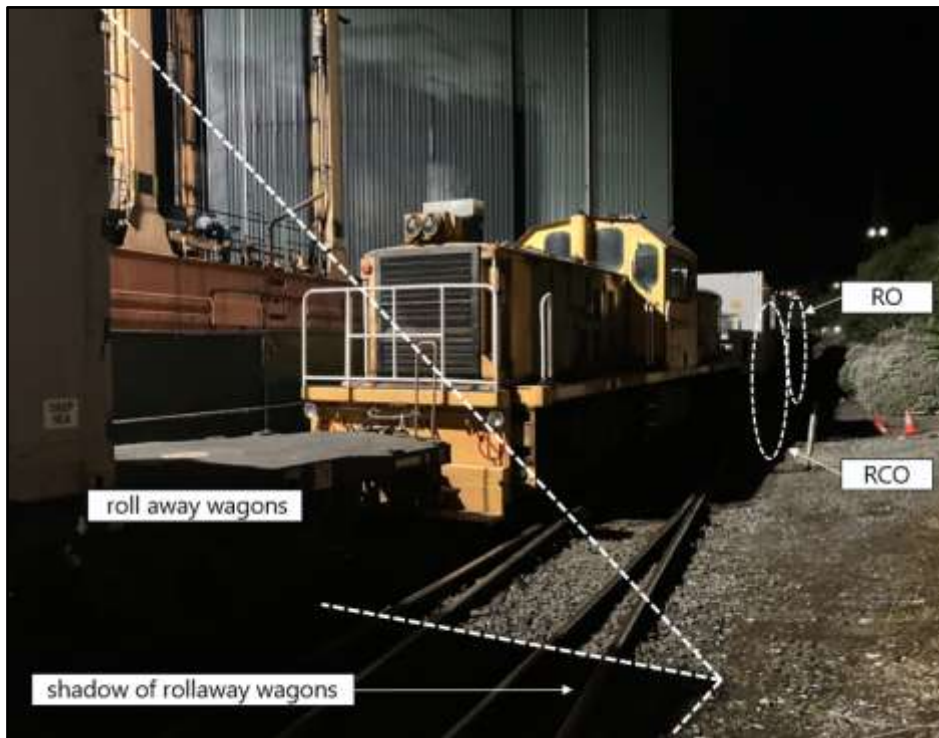
**Figure 8: Shadow cast by roll away wagons**

2.31. After joining the hoses, the RO moved out from between the wagon and the locomotive. About three seconds later, the RCO noticed a large shadow moving towards

them. The RCO yelled at the RO, “get out of the way” and applied the locomotive’s emergency brake using the remote-control pack (see Figure 8).

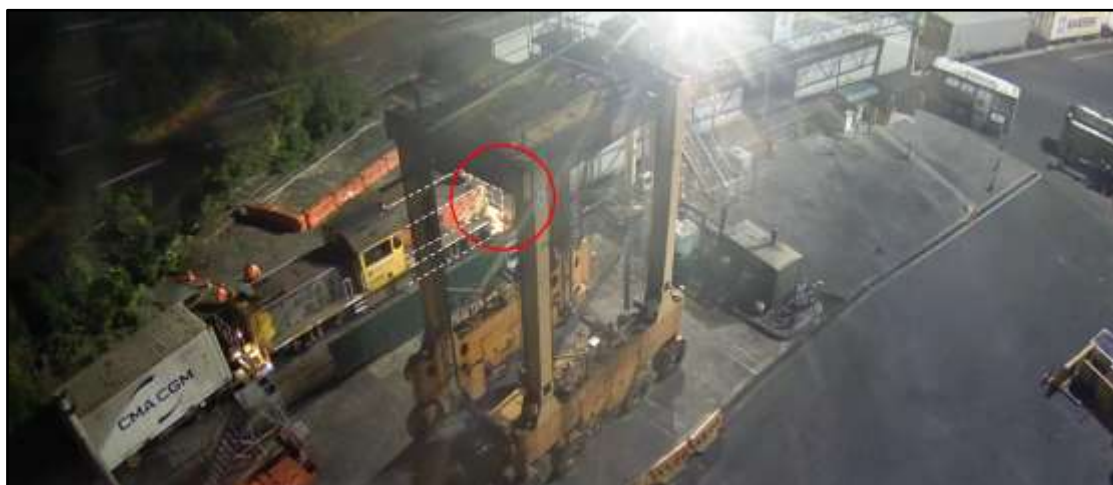
### Figure 9: Position of wagons and shunt crew at time of collision

2.32. At 0130:30, the nine wagons totalling 472 tonnes (t) collided with the front of the locomotive and remaining 16 wagons. The impact caused the locomotive to be pushed backward approximately 1.2 m at a speed of 3 kilometres per hour (km/h) (see Figure 9).

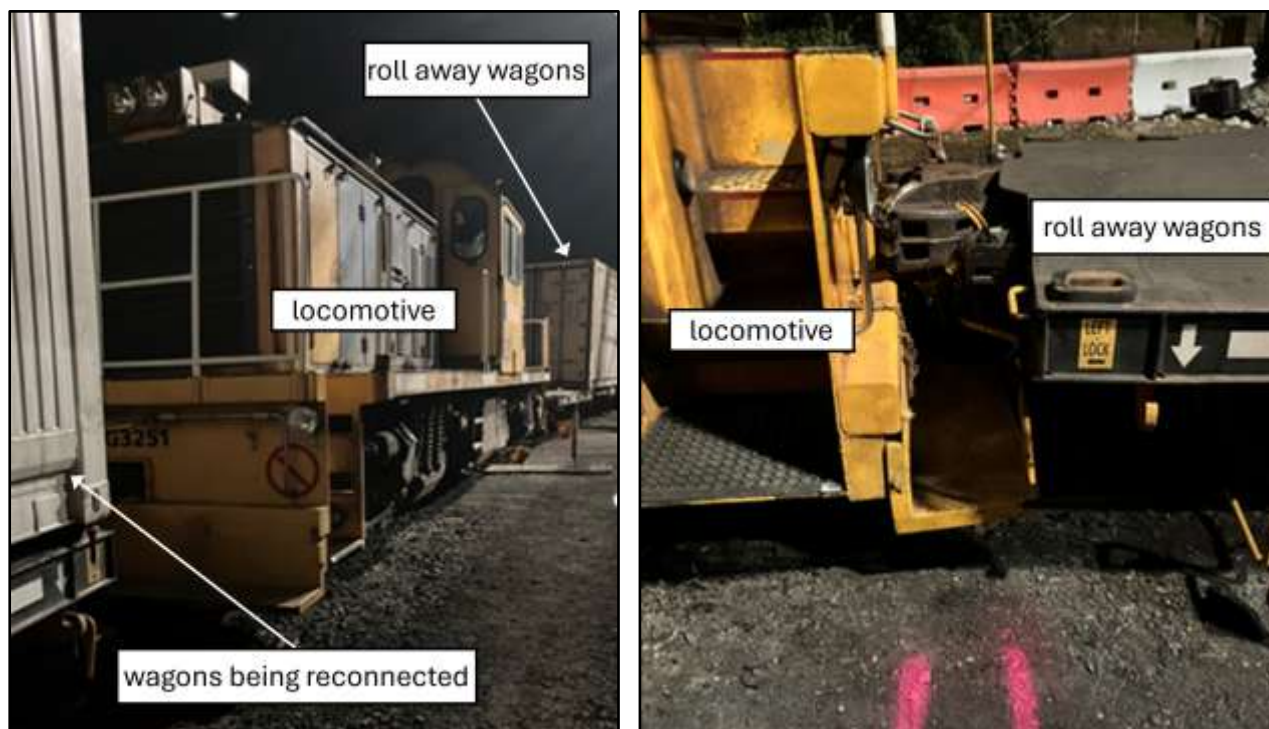
Figure 10: Position of locomotive and roll way wagons after collision

2.33. The force of the collision caused the locomotive and wagon buffer that were previously connected to the remaining 16 wagons to part and separate by approximately 1 m (see Figure 10).

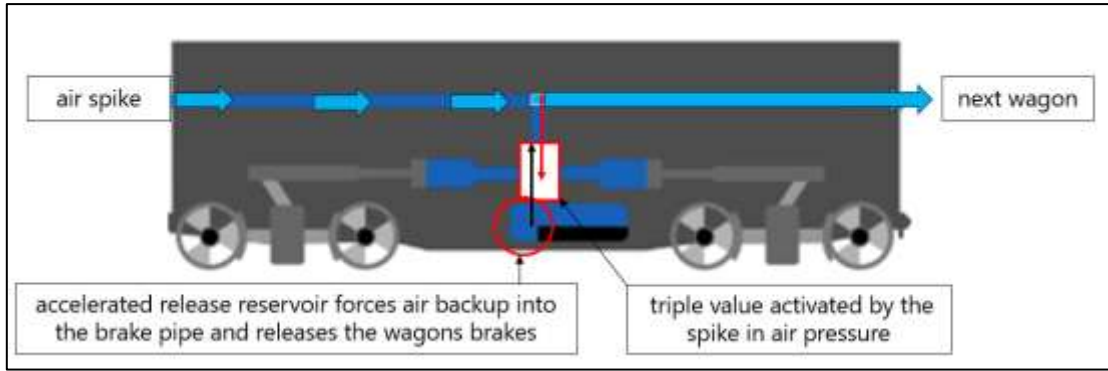
**Figure 19: Air spike releasing the air-brake system**

- 3.20. A rise in air pressure against the releasing air sends a false signal to each of the wagon's triple valves, resulting in the brakes being released. Once the first wagon is affected, it is accelerated when the auxiliary reservoir releases pressurised air back into the brake pipe. This causes a cascading effect that progressively releases the brakes on each subsequent wagon (see Figure 19).
- 3.21. This is exacerbated when the air in the wagons brake pipe is closed off by moving the brake pipe tap to the closed position, this is called 'bottling the air'.<sup>27</sup>

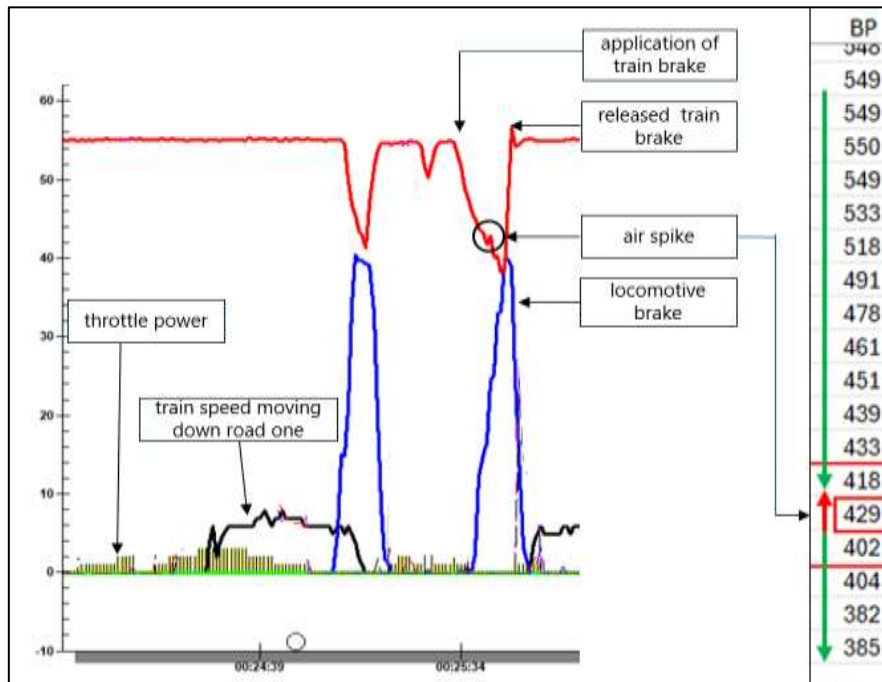
**Figure 20: Tranzlog data recording air spike in air-brake pipe pressure**

3.22. In this incident, the locomotive's Tranzlog data recorded an 11 kPa rise in brake-pipe pressure while the RCO was applying the brakes to the nine wagons on road 1. It is **virtually certain** that this pressure spike and the bottled air triggered the release of the air-braking system (see Figure 20).

- 3.34. In this incident, the RCO was not aware that they had moved the tap on the wagon as air was still equalising within the brake pipe. Lifting the tap too early caused the system to release the applied brakes, leaving the rake of wagons unsecured when the RCO detached the shunt locomotive.

- 6.3. On 24 March 2026, the Commission recommended that the chief executive of KiwiRail review and improve KiwiRail's training on the air-brake operation system and include the associated risks of not following the required procedures. **[010/26]**
- 6.4. On 13 April 2026, KiwiRail replied:

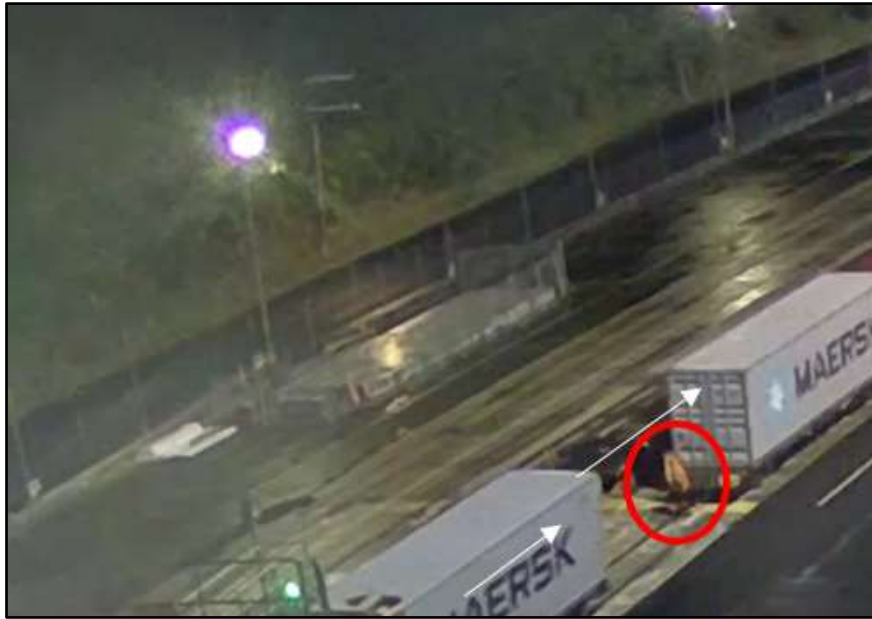
**Figure 24: CCTV showing rail staff in a dangerous position**

- 3.40. Commission investigators obtained and reviewed CCTV<sup>28</sup> footage for the ten days before the incident. This footage captured 88 individual rail-vehicle stabling movements. The Commission found all 88 movements involved non-compliance with the rules. Furthermore, 11 of the rail-vehicle movements involved staff moving into unsafe positions, placing them at risk of harm or injury (see Figure 24).
