Transport Accident  
Investigation  
Commission

# Final report

***Aviation inquiry AO-2024-001***

***Runway excursion (overrun)***

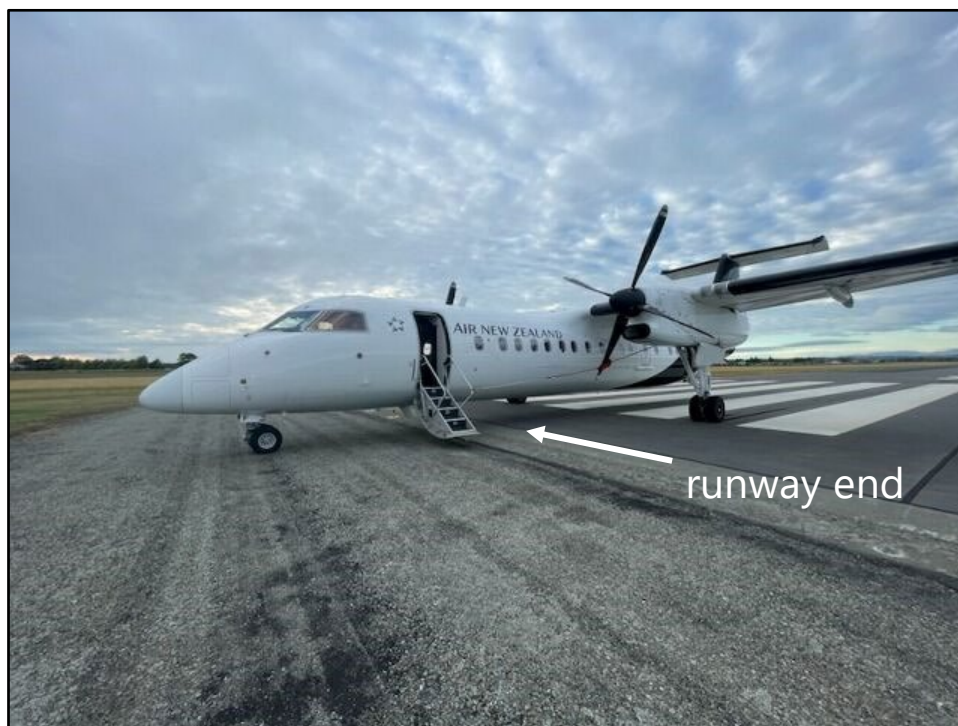
**Figure 5: Location of aeroplane after stopping**

- 2.7. At 0649:24, the captain retarded the power levers and started braking action. At the same time, the FO was recorded saying 'Oh no no', and the captain uttering an expletive. The aeroplane had accelerated to 114 kt (211 km/h), 17 kt above V1, before it started to decelerate under braking. The aeroplane was brought to a halt at 0649:34 with the nosewheel 4.7 metres (m) beyond the end of the runway but still on the bitumen (see Figure 5).

- 3.11. The aeroplane travelled 4.7 m past the end of the designated runway area but remained on the sealed bitumen overrun.

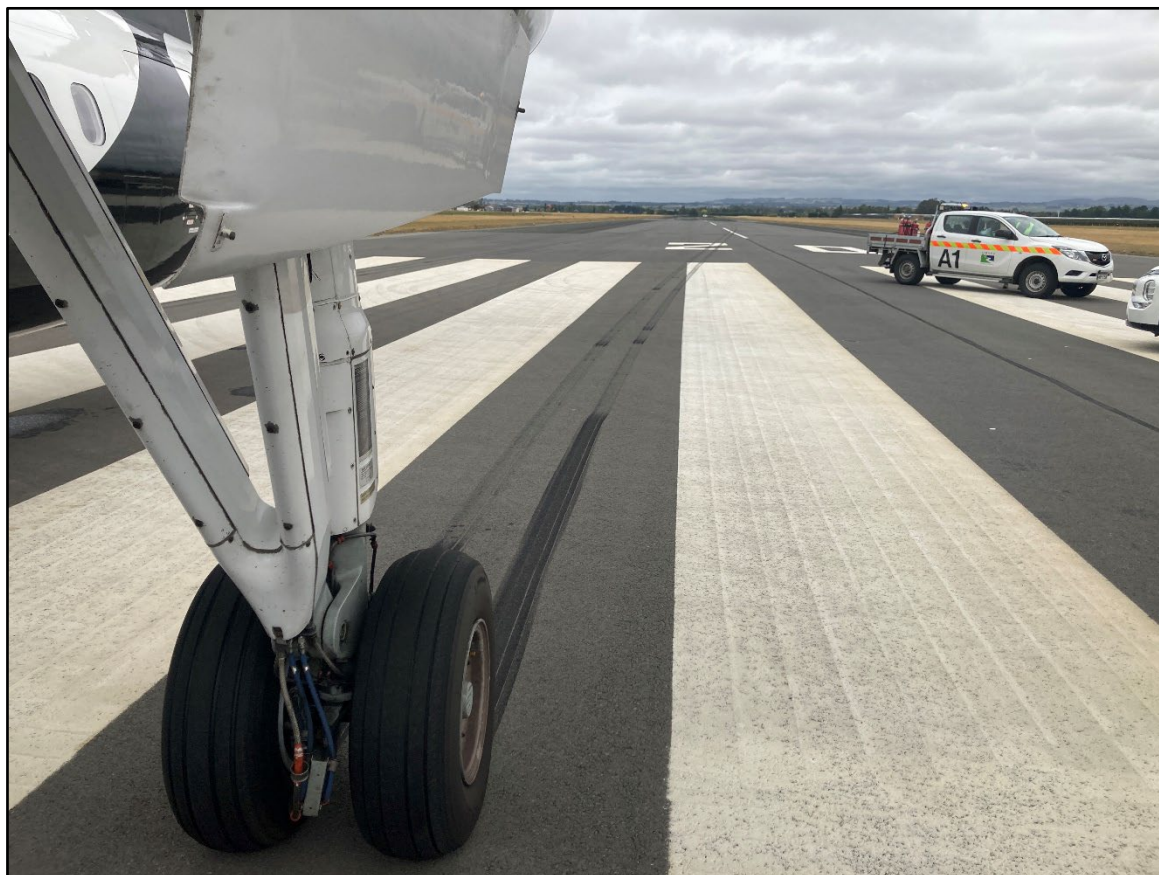
**Figure 6: Braking marks**

- 3.10. The anti-skid system functioned as designed with both main wheels starting to lock up several times but then releasing, resulting in some skidding as the aeroplane slowed to a stop. The anti-skid activation was not fully symmetrical and so the aeroplane started to deviate right of the centreline by 2–3 m before the captain was able to correct this movement (see Figure 6).
