Transport Accident
Investigation
Commission

Final report

Aviation inquiry AO-2024-001
Bombardier DHC-8-311, ZK-NEF
Runway excursion (overrun)
Timaru Aerodrome
7 February 2024

May 2026

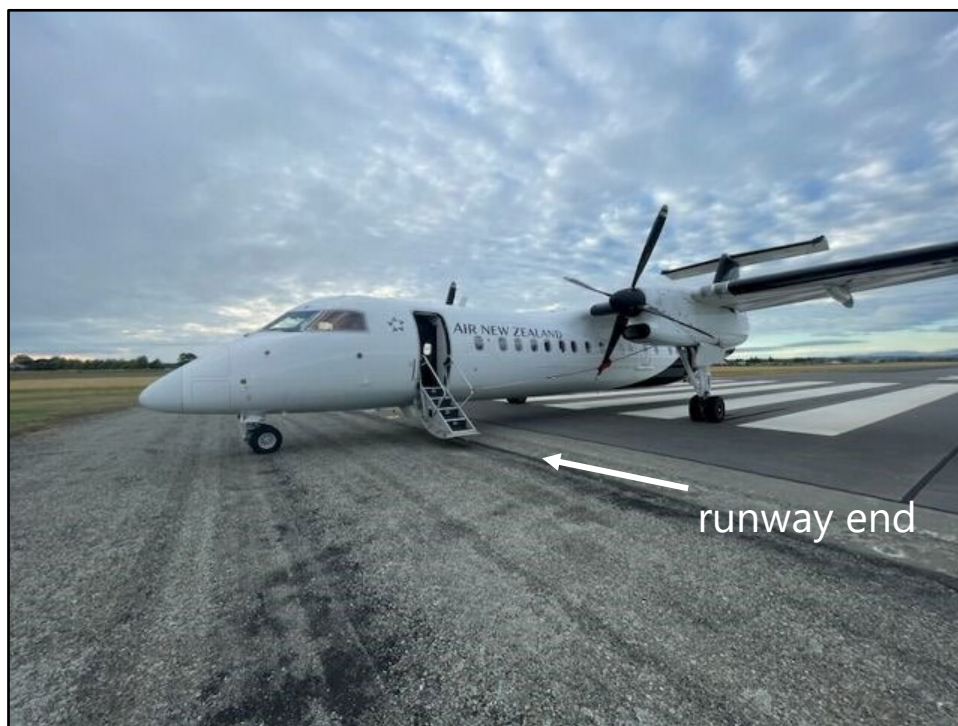
Figure 5: Location of aeroplane after stopping

- 2.7. At 0649:24, the captain retarded the power levers and started braking action. At the same time, the FO was recorded saying 'Oh no no', and the captain uttering an expletive. The aeroplane had accelerated to 114 kt (211 km/h), 17 kt above V1, before it started to decelerate under braking. The aeroplane was brought to a halt at 0649:34 with the nosewheel 4.7 metres (m) beyond the end of the runway but still on the bitumen (see Figure 5).

- 3.11. The aeroplane travelled 4.7 m past the end of the designated runway area but remained on the sealed bitumen overrun.
