Transport Accident  
Investigation  
Commission

# **Final report**

***Aviation inquiry A0-2025-003***  
***Bell Textron Canada Limited 206L-3 helicopter,***  
***ZK-IGD***  
***Loss of control – ground***  
***4.5 NM west of Whakatāne***  
***27 July 2025***

**May 2026**

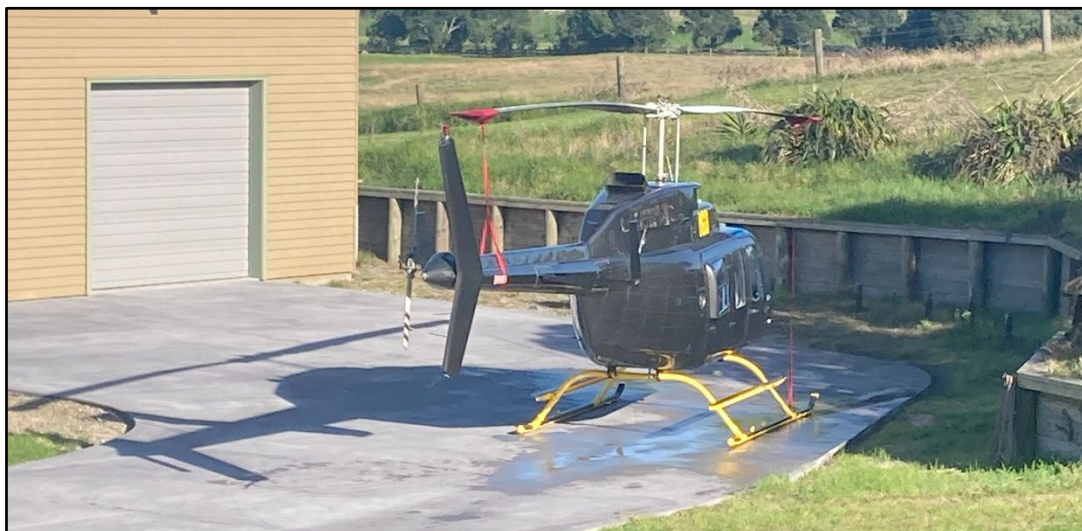
**Figure 3: ZK-IGD parking spot from a previous visit**

- 2.28. Evidence marks on the concrete include a divot,<sup>13</sup> consistent with the location of the end of the main rotor blade when it first struck the ground (see Figure 8). A small hole in the retaining wall, in line with the concrete strike marks, is consistent with a blade-tip weight penetration.
- 2.29. There were several paint marks consistent with various parts of the helicopter. Of note are the yellow and orange paint marks in the approximate position of the left skid during the accident sequence (see Figure 3, Figure 8 and Figure 9).

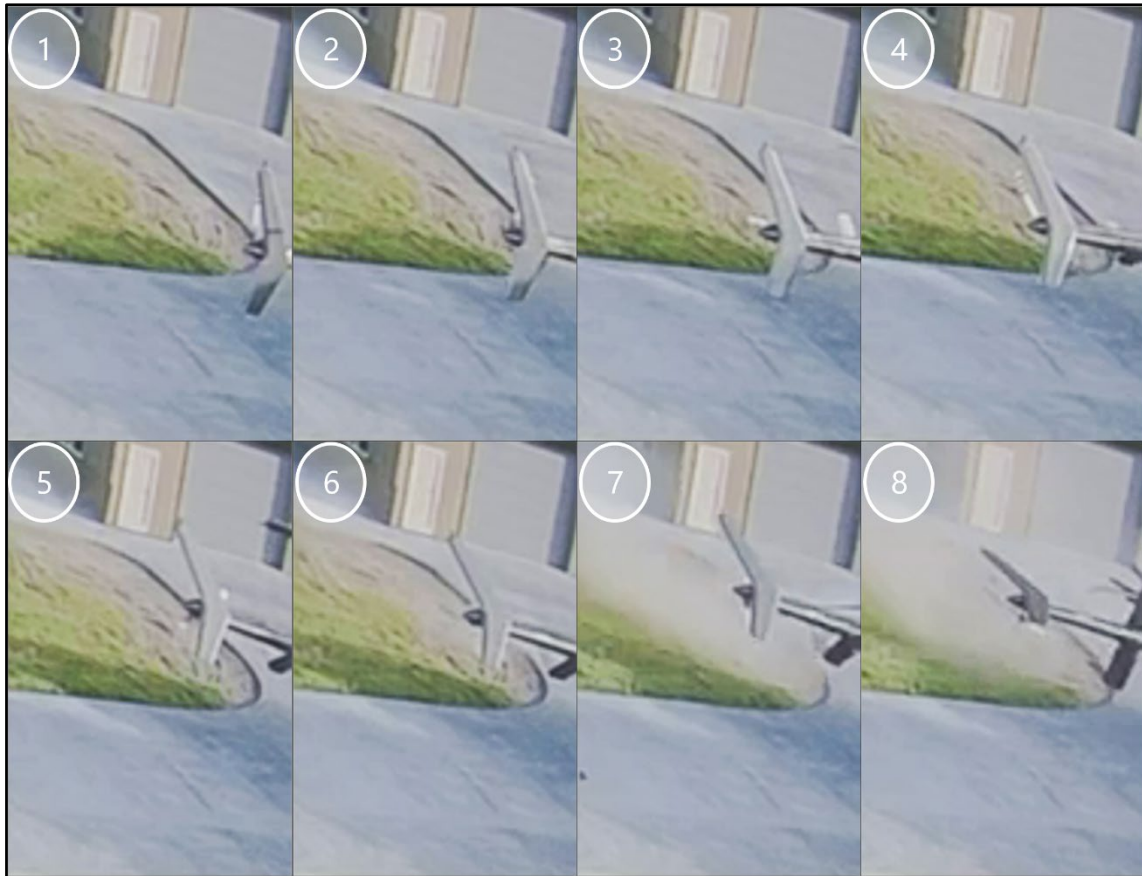
**Figure 4: Sequence of rollover from CCTV footage**

- 2.6. As the helicopter started to move left away from the retaining wall, it began rolling to the left (see Figure 4). The main rotors struck the concrete ground, destroying the blades and causing the helicopter to shake violently and the tail to separate.

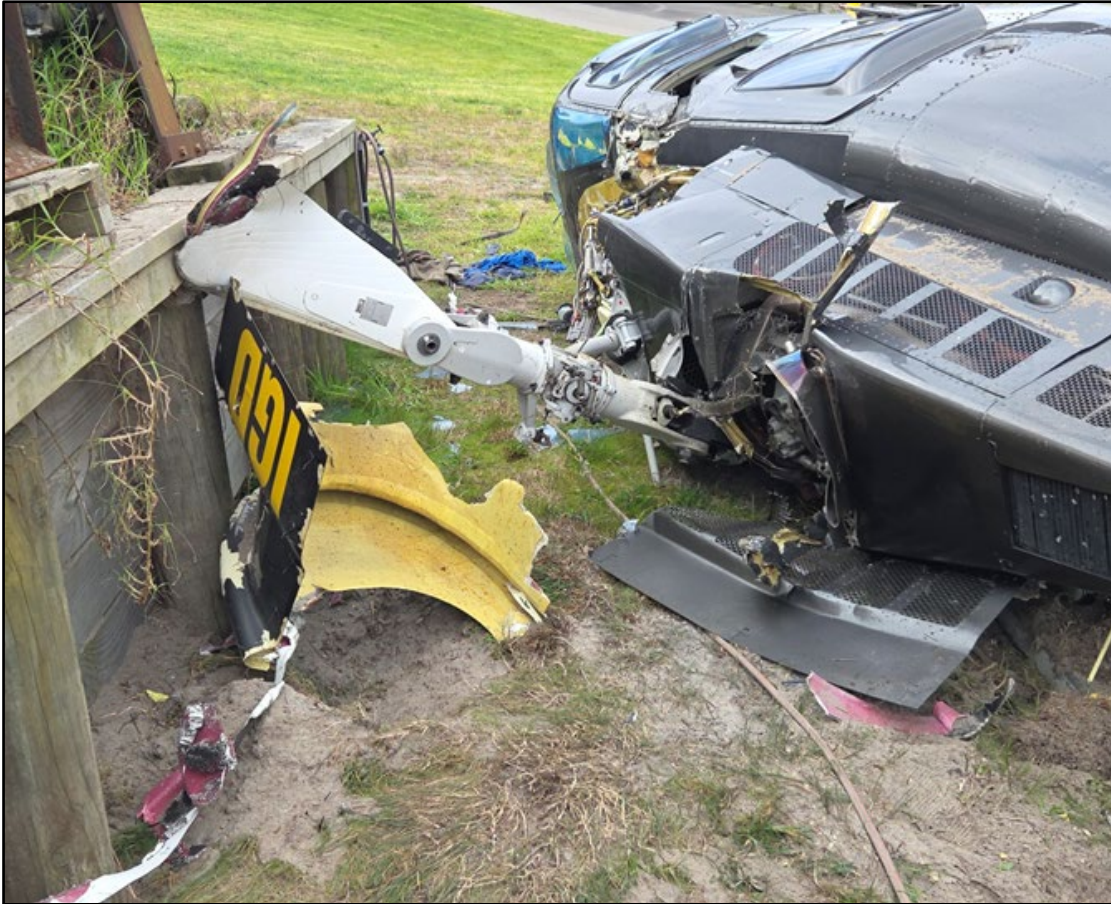
**Figure 5: Top of helicopter and remains of the main rotor blades**

- 2.25. The main rotor blades disintegrated during the accident sequence with only the root of each blade remaining connected to the main rotor hub,<sup>10</sup> which in turn was still connected to the mast (see Figure 5). The remaining parts of the blades were found spread across the accident site.

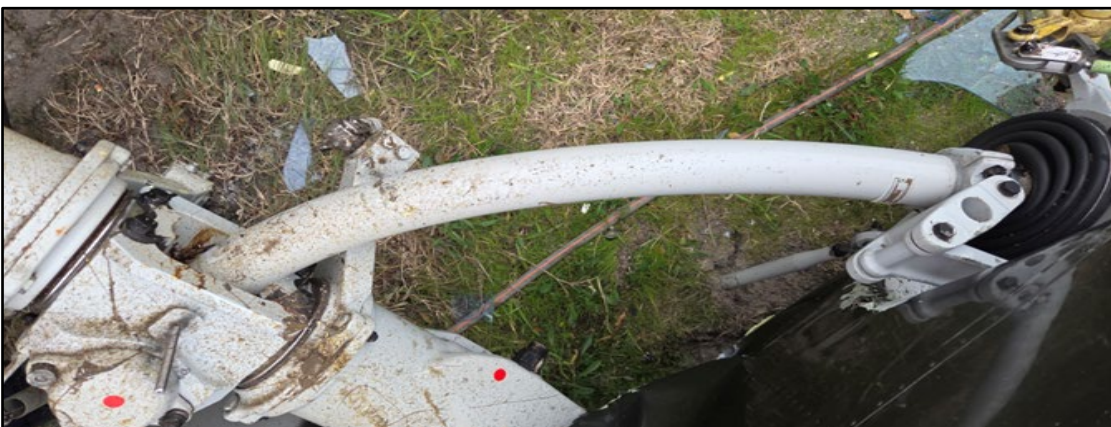
**Figure 6: Main rotor mast bend**

- 2.26. The helicopter's mast was bent through about 90°, although still attached to the transmission<sup>11</sup> (see Figure 6).

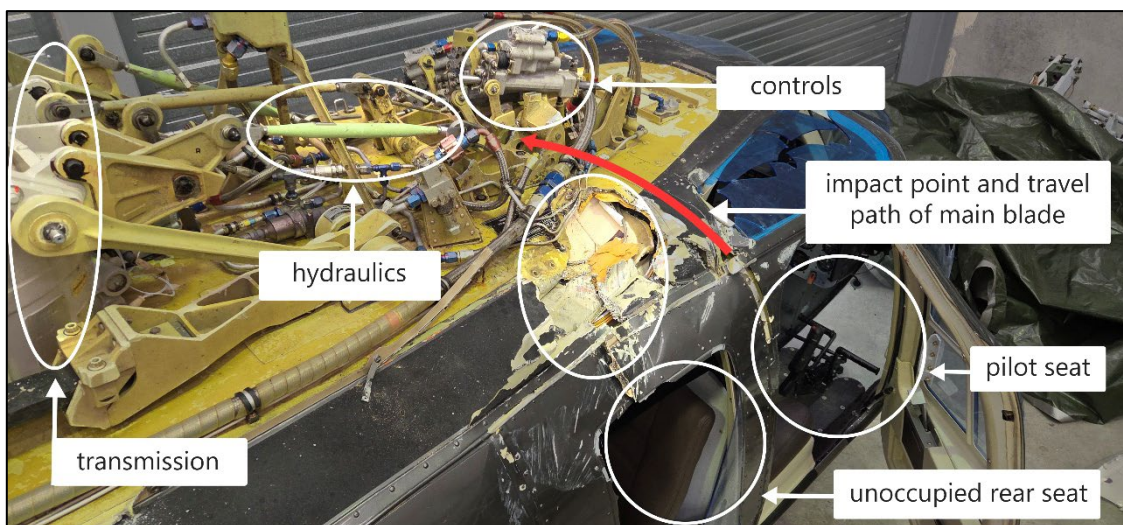
**Figure 7: Top of the cabin and controls**

- 2.27. Strike marks on the right-hand side of the main cabin, next to the unoccupied rear-facing seat position, were consistent with a main rotor striking the cabin and then travelling across the top of the helicopter cabin and through the control linkages,<sup>12</sup> where the hydraulics are located (see Figure 7).

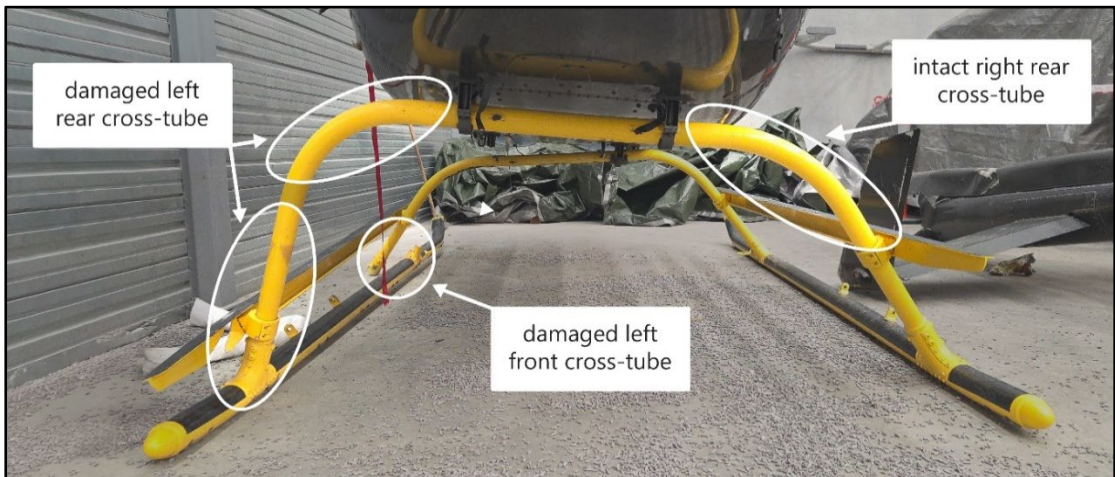
**Figure 10: Rear cross-tubes**

- 2.30. The left-rear cross-tube was bent inwards (see Figure 10), consistent with heavy side loading during the accident sequence. The paint on the outer section of the left rear skid was missing, through the outer yellow layer and an underlying orange layer, showing the bare metal below (see Figure 11).
- 2.31. There was no fire before, during or after the accident sequence, and the fuel tank remained intact.
