Transport Accident
Investigation
Commission

Final report

Maritime inquiry MO-2023-201
Passenger vessel, Kaitaki
Loss of power
Cook Strait, New Zealand
28 January 2023

May 2026

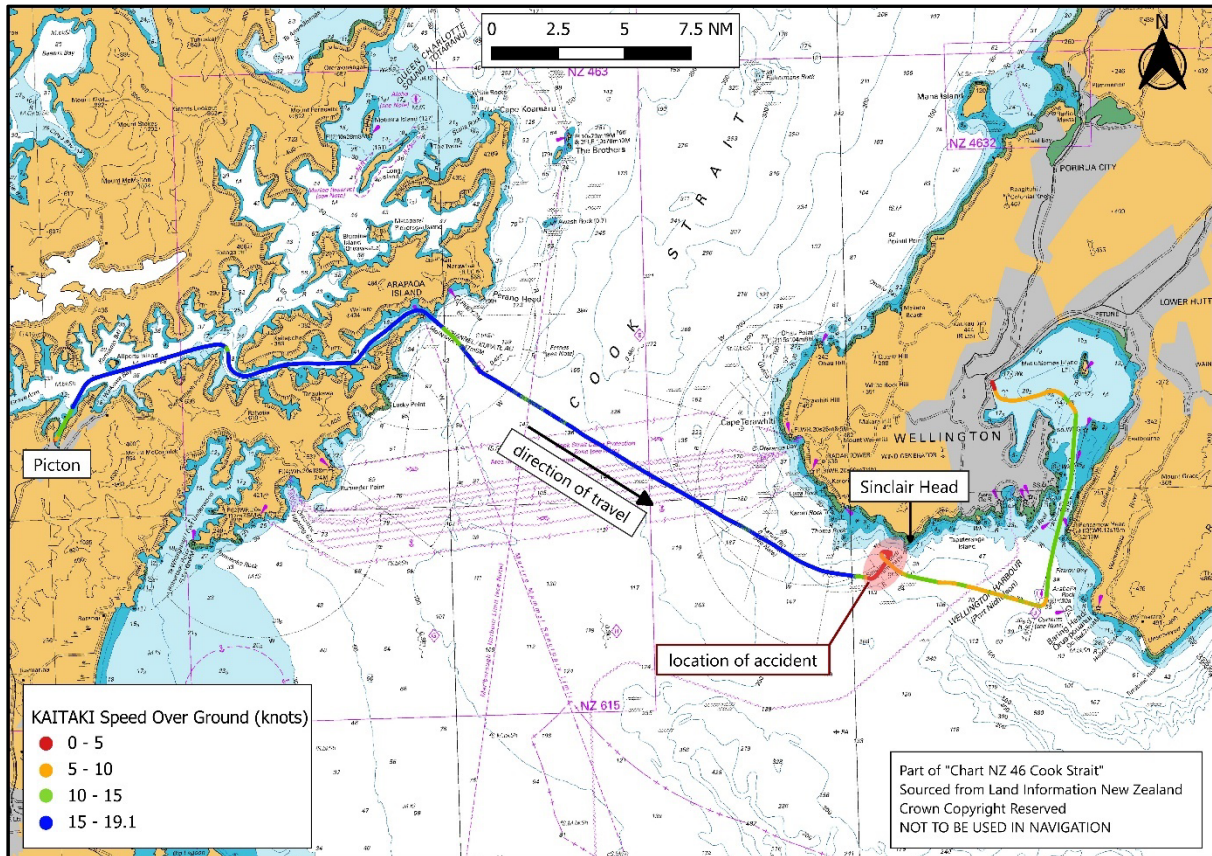
2.7. At 1631, about an hour after the drill ended and while the *Kaitaki* was approximately 1 NM off Sinclair Head following the passage plan,⁶ the starboard shaft generator tripped.⁷ The ship lost power briefly, until the emergency generator automatically started providing electrical power to emergency systems. The two main propulsion engines shut down a few minutes later. This resulted in the ship losing all electrical power (blackout).

Figure 3: *Kaitaki* track and location of incident

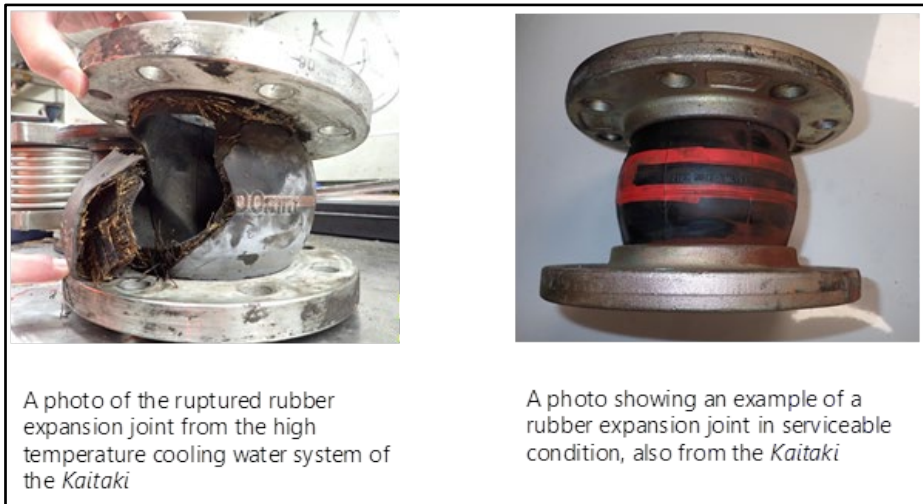
- 2.14. At about that time, an engineer reported a ruptured REJ on the port auxiliary engine, with high-temperature cooling water leaking from the affected component (see Figure 4 and Figure 5). The leak resulted in the cooling water rapidly draining from the cooling system, passing through the ruptured REJ and into the engine room bilge system.⁹ By the time the rupture was noticed, most of the water from the high-temperature cooling system had drained.

Figure 4: The ruptured REJ (left) and a serviceable REJ (right)

- 3.9. REJs begin to deteriorate from their date of manufacture. Over time, the rubber hardens and becomes more susceptible to cracking and delamination. The REJs associated with the engines' high-temperature cooling water system were a safety-critical component on board the *Kaitaki*. Replacing them in accordance with the manufacturer's instructions or FMEA recommendations is critical to ensure reliability.

- 3.10. The REJ that ruptured was installed on the *Kaitaki* in 2018 and had been in service for about five years. Date markings on the REJ indicate it was manufactured in 2005, making it around 18 years old. The nature of the failure of *Kaitaki*'s REJ, in particular cracking and delamination, was consistent with deterioration owing to age.

- they should be no older than eight months from the date of manufacture when installed
- they are inspected annually, including visual, tactile and hardness measurements
- regardless of inspection findings, safety-critical REJs should be replaced after five years. (008/23).

- 5.6. KiwiRail has taken the following safety action to address this issue:
 - reviewed planned maintenance programmes
 - identified all REJs in place
 - replaced all of these sources of single point failures.

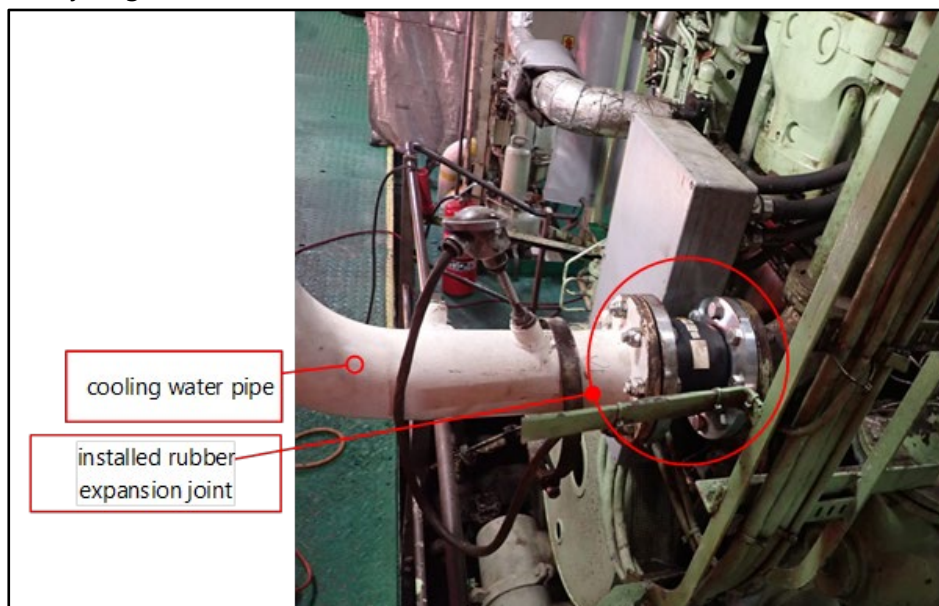
Figure 5: An installed REJ on board the *Kaitaki*

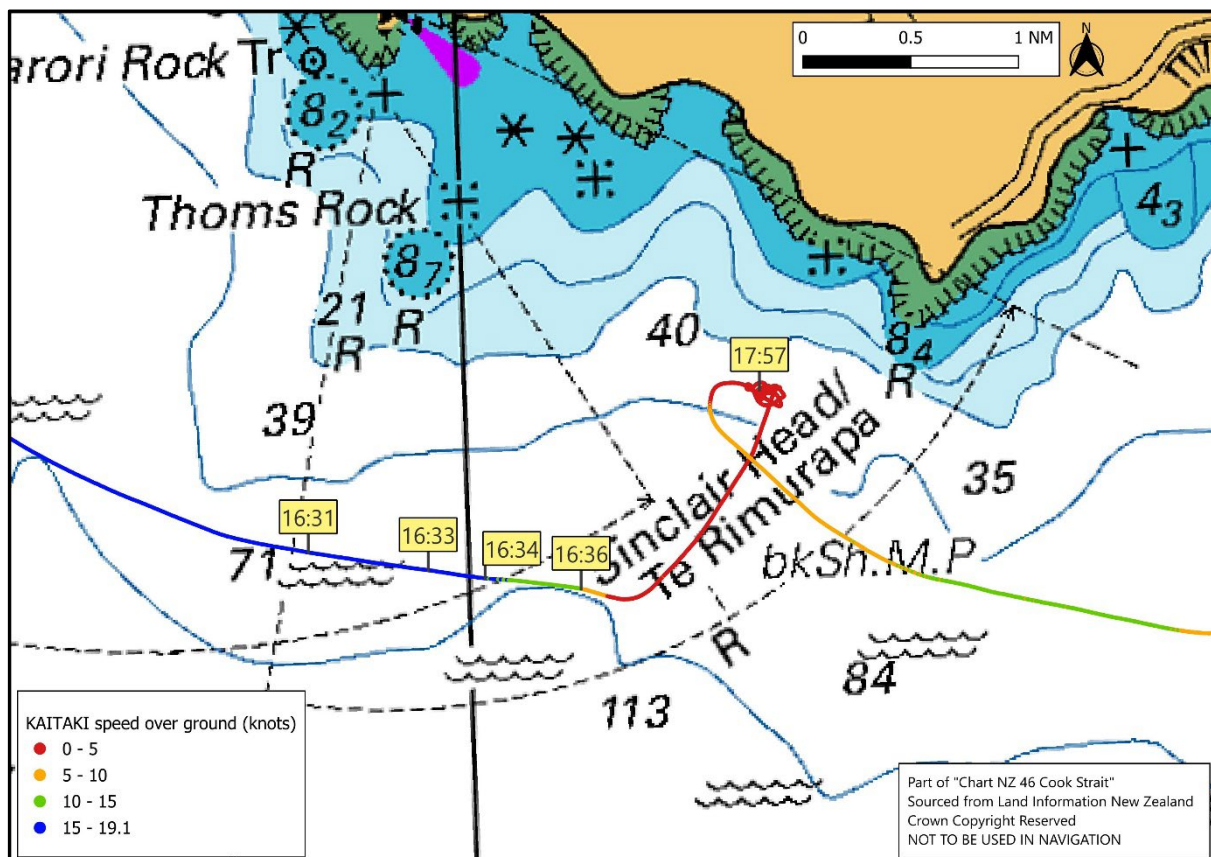
Figure 6: Close-up of the incident area with key time stamps
