Transport Accident
Investigation
Commission

Final report Tuhinga whakamutunga

***Maritime inquiry MO-2024-204
Passenger and freight ferry Aratere
Grounding
Titoki Bay, Picton
21 June 2024***

May 2026

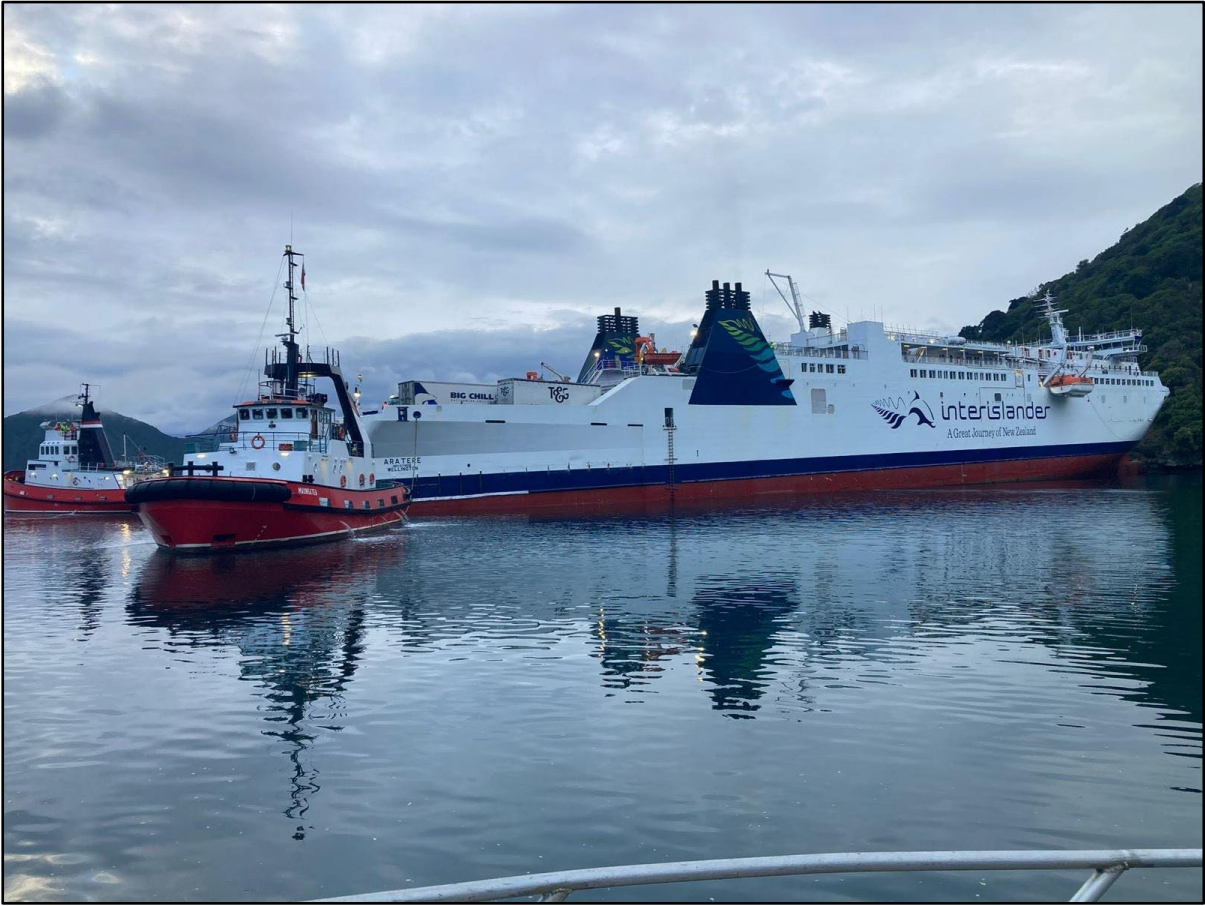
**Figure 1: Passenger and freight ferry *Aratere* aground in Titoki Bay
(Photograph: TAIC)**

- 2.35. The watertight integrity of the *Aratere*'s hull was not compromised, but the grounding dented the hull plating of the bulbous bow, and the internal structure sustained damage that required remedial repair before the ship's return to service. There were no injuries.

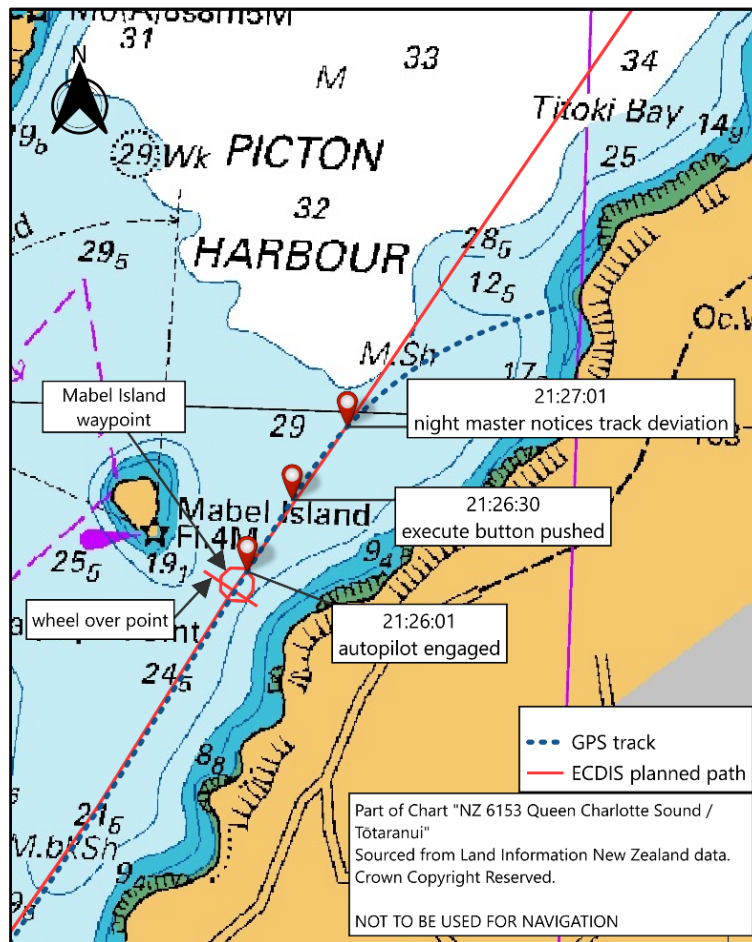
Figure 6: Image showing timeline of events as the *Aratere* began the turn to starboard

- 2.24. The track pilot applied 9° of initial starboard rudder and began to make a controlled turn as if the ship were making the turn around the Snout waypoint.

- 2.25. After 31 s, the night master realised from the ECDIS that *Aratere* was deviating to starboard of the track towards the shore. The night master immediately instructed the helmsperson to take over steering on the wheel, located on the central helmsperson steering console, and to put the rudder 'hard over to port'.

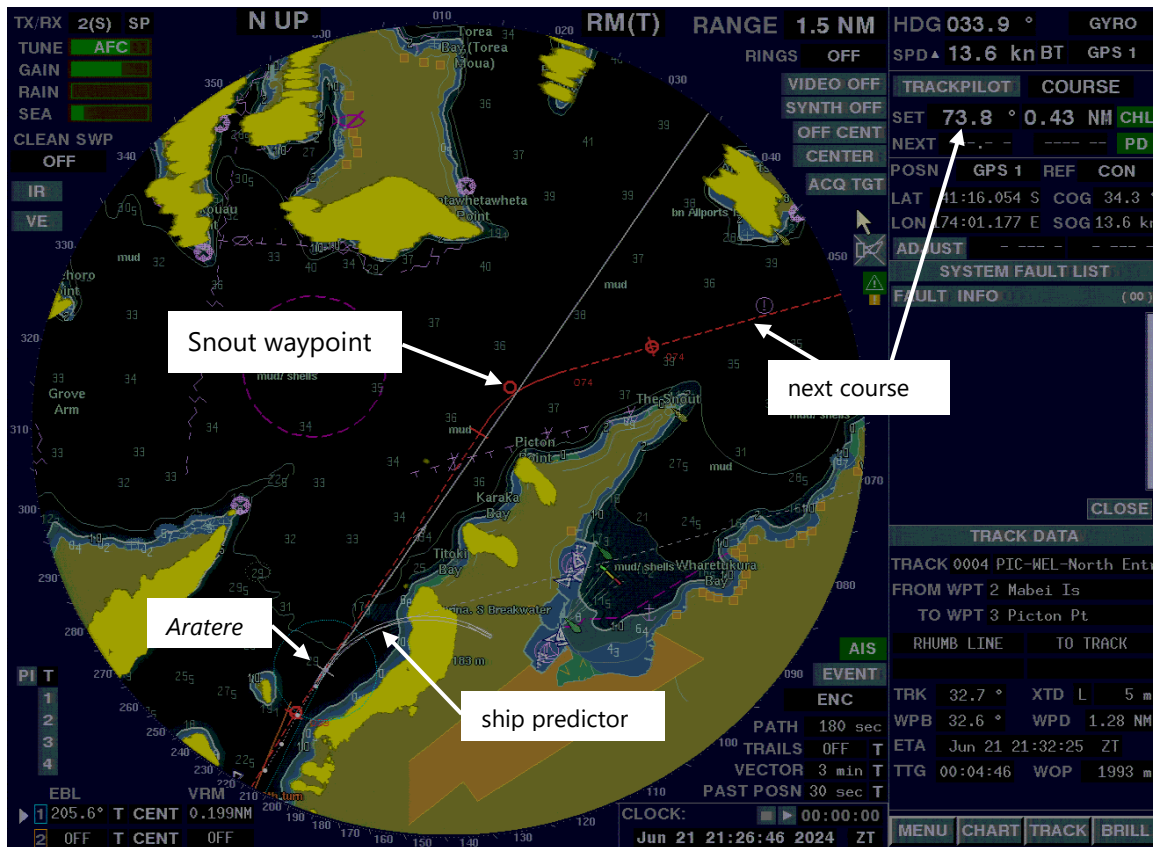
- 2.26. Figure 7 shows a marked-up screenshot of *Aratere*'s ECDIS near the time the night master became aware that *Aratere* was deviating from the planned track. The set course was displayed as 73.8° with a radius turn of 0.43 nautical miles (NM), which was the next turn and course around the Snout waypoint. The ship predictor is a feature that shows the pilot where the ship will be in the immediate future, based on current speed and rate of turn.

Figure 7: Screenshot from *Aratere*'s electronic chart display system (ECDIS) near the time the night master became aware that *Aratere* was deviating from the planned track

- 2.27. The helmsperson pressed the 'takeover' button on the central helmsperson steering console²⁴ in an attempt to transfer control from the autopilot to hand steering, and then turned the wheel hard to port. However, the transfer of steering command from the track pilot module to the wheel position did not occur and *Aratere* continued its turn to starboard, still controlled by the autopilot.
