Transport Accident
Investigation
Commission

Final report

Aviation inquiry AO-2024-004
Airbus A320, registration VH-VFF
Loss of control – ground (LOC-G)
Christchurch

31 May 2024

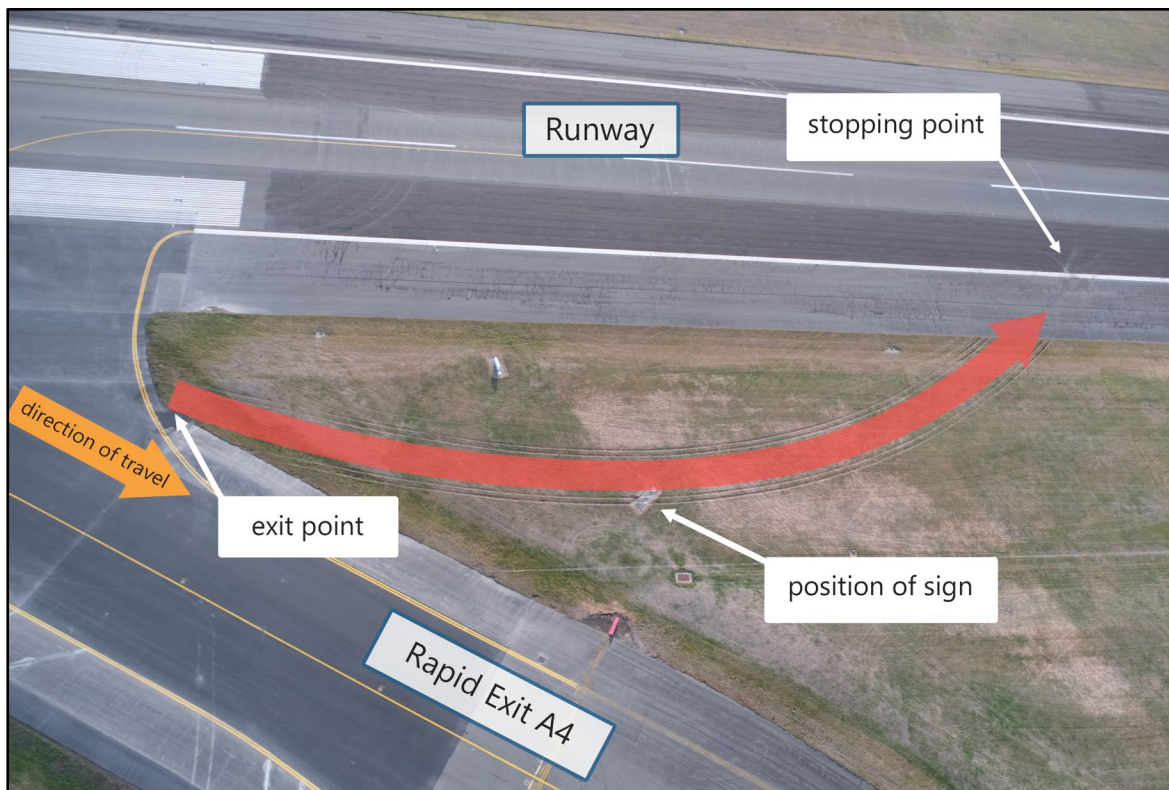
Figure 6: Path of taxiway excursion

- 2.44. The aeroplane turned off the runway and entered rapid exit A4, then left the taxiway and crossed over the grass. The No. 2 engine impacted a movement area guidance sign (MAGS) and then the aeroplane continued in a curved path back to the runway, where it came to a stop (see Figure 6).

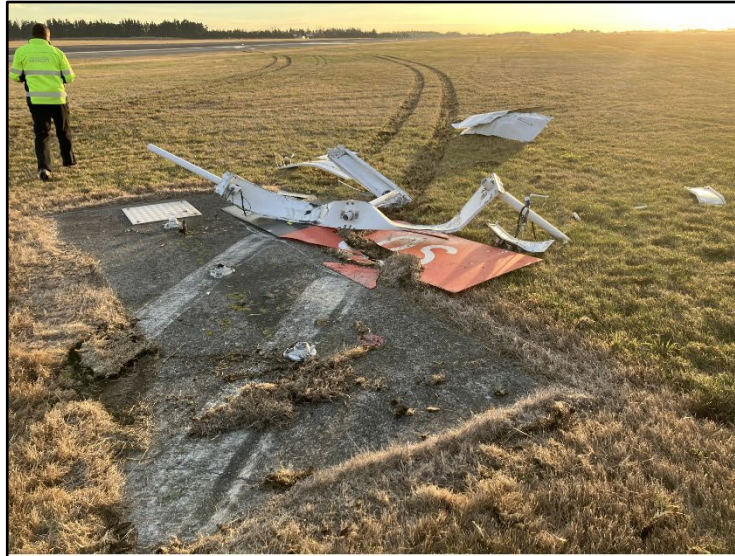
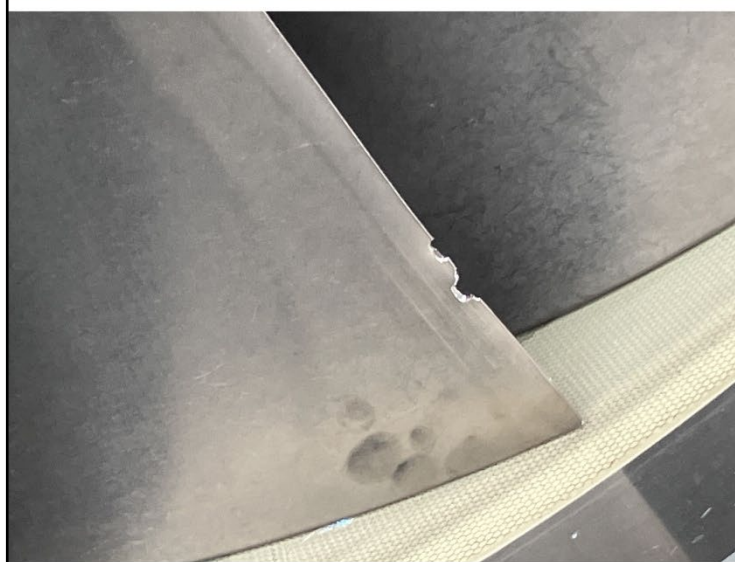
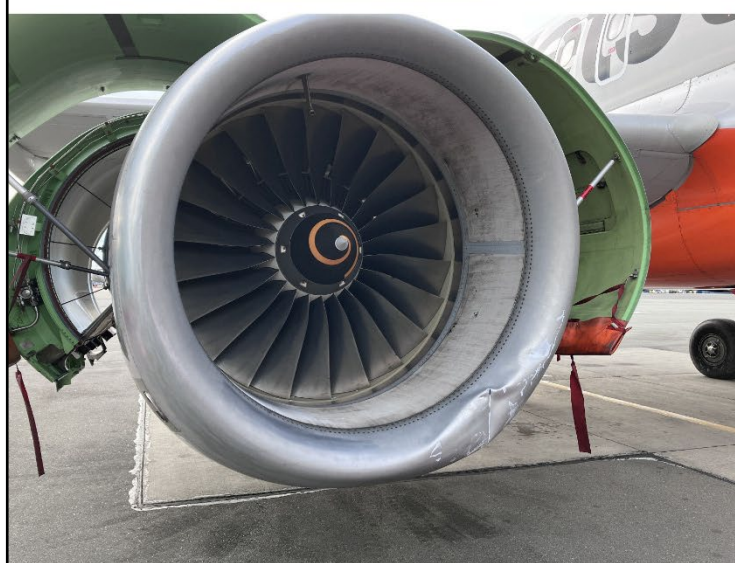
Figure 7: Engine damage from MAGS sign impact

- 1.4. No one was injured but the aeroplane suffered significant damage to parts of the number two engine as a result of hitting the signboard.

- 2.45. Initial examination of the aeroplane found that No.2 engine had suffered significant damage to the input low-pressure fan blades and engine cowling from impact with the MAGS.
- 2.46. Further examination found that hydraulic oil had been leaking from within the right-hand main landing gear stowage bay. The leak was traced to a rupture in a hydraulic pipeline that passed through the right-hand side main landing gear bay. The pipeline was a high-pressure titanium alloy pipe. The leak resulted in hydraulic oil being sprayed around the area (see Figure 7 and Figure 8).

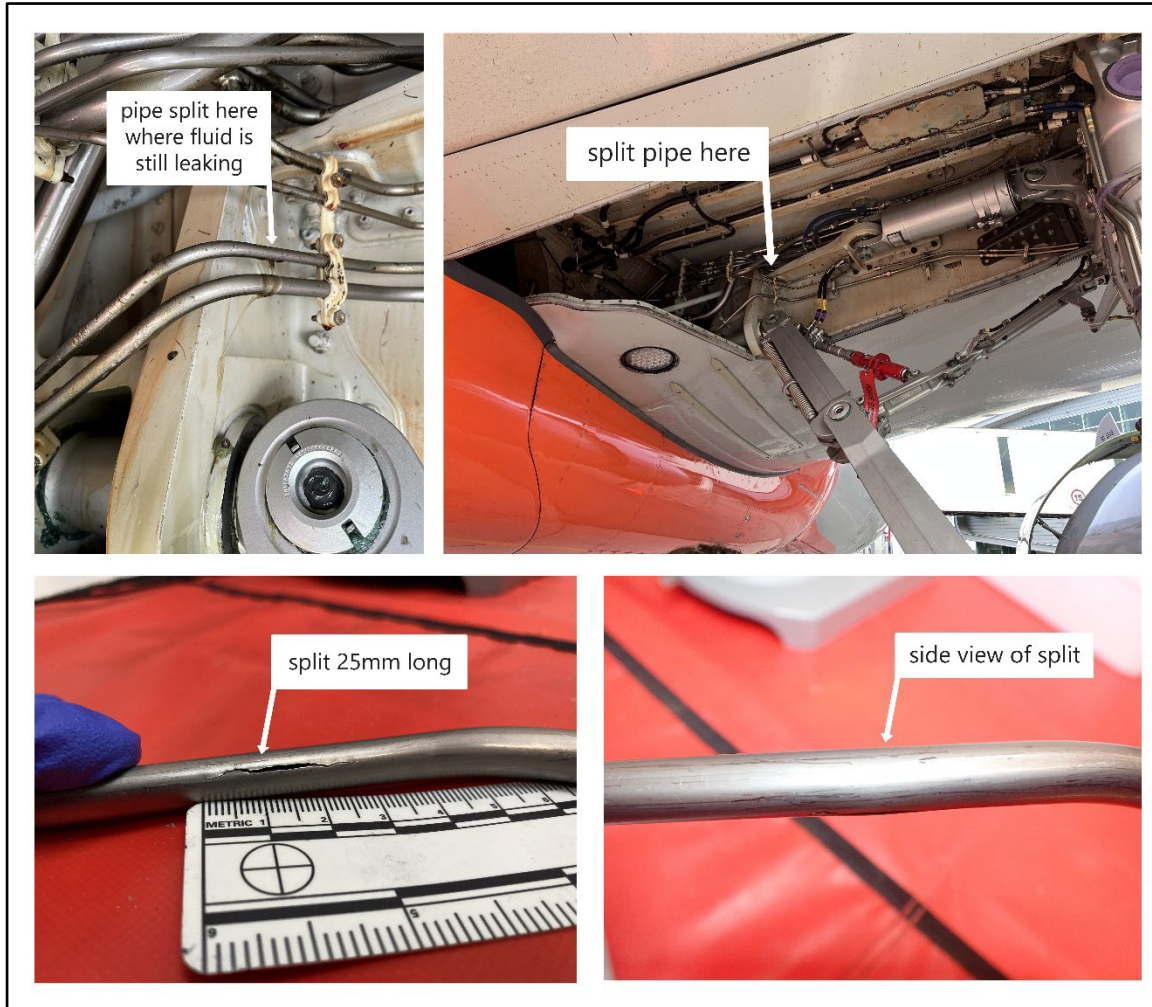
Figure 8: Hydraulic pipe failure

- 2.47. The split was 25 millimetres (mm) long and the pipe's²⁹ cross section was oval in that area. Normally the pipe was round with a 9.5 mm outside diameter, but near the split the pipe diameter was 11.5 mm across the split and 8.5 mm across the perpendicular dimension.

- 3.14. Upon inspection after the accident, the hydraulic pipe was found to have split along a straight run between two pipe clamps. The pipe had an outside diameter of 9.5 mm and wall thickness of 0.5 mm. The hydraulic fluid was pressurised to 3000 PSI (206 Bars) so, once split, the yellow hydraulic system's fluid contents drained very rapidly under high pressure.

- 3.15. The failure had occurred in the centre of a 100 mm straight section of the 1.8 m pre-bent pipe. The pipe was oval in this area of the split rather than being round. When viewed from below, it appeared normal due to the inspection angles; the difference in width from that view angle was only 1 mm. The area was out of the way of moving parts, close to the aeroplane's internal framework in the wing and firmly supported between two pipe clamps. The pipe had no markings on the external surface that showed it had been crushed or mechanically distorted.

- 3.18. The examination confirmed that the pipe material met the Airbus specification, but found that it had been physically deformed into an oval cross section in a small area by some means that could not be determined. The mode of subsequent failure was determined to have been overload on the inner pipe wall surface.

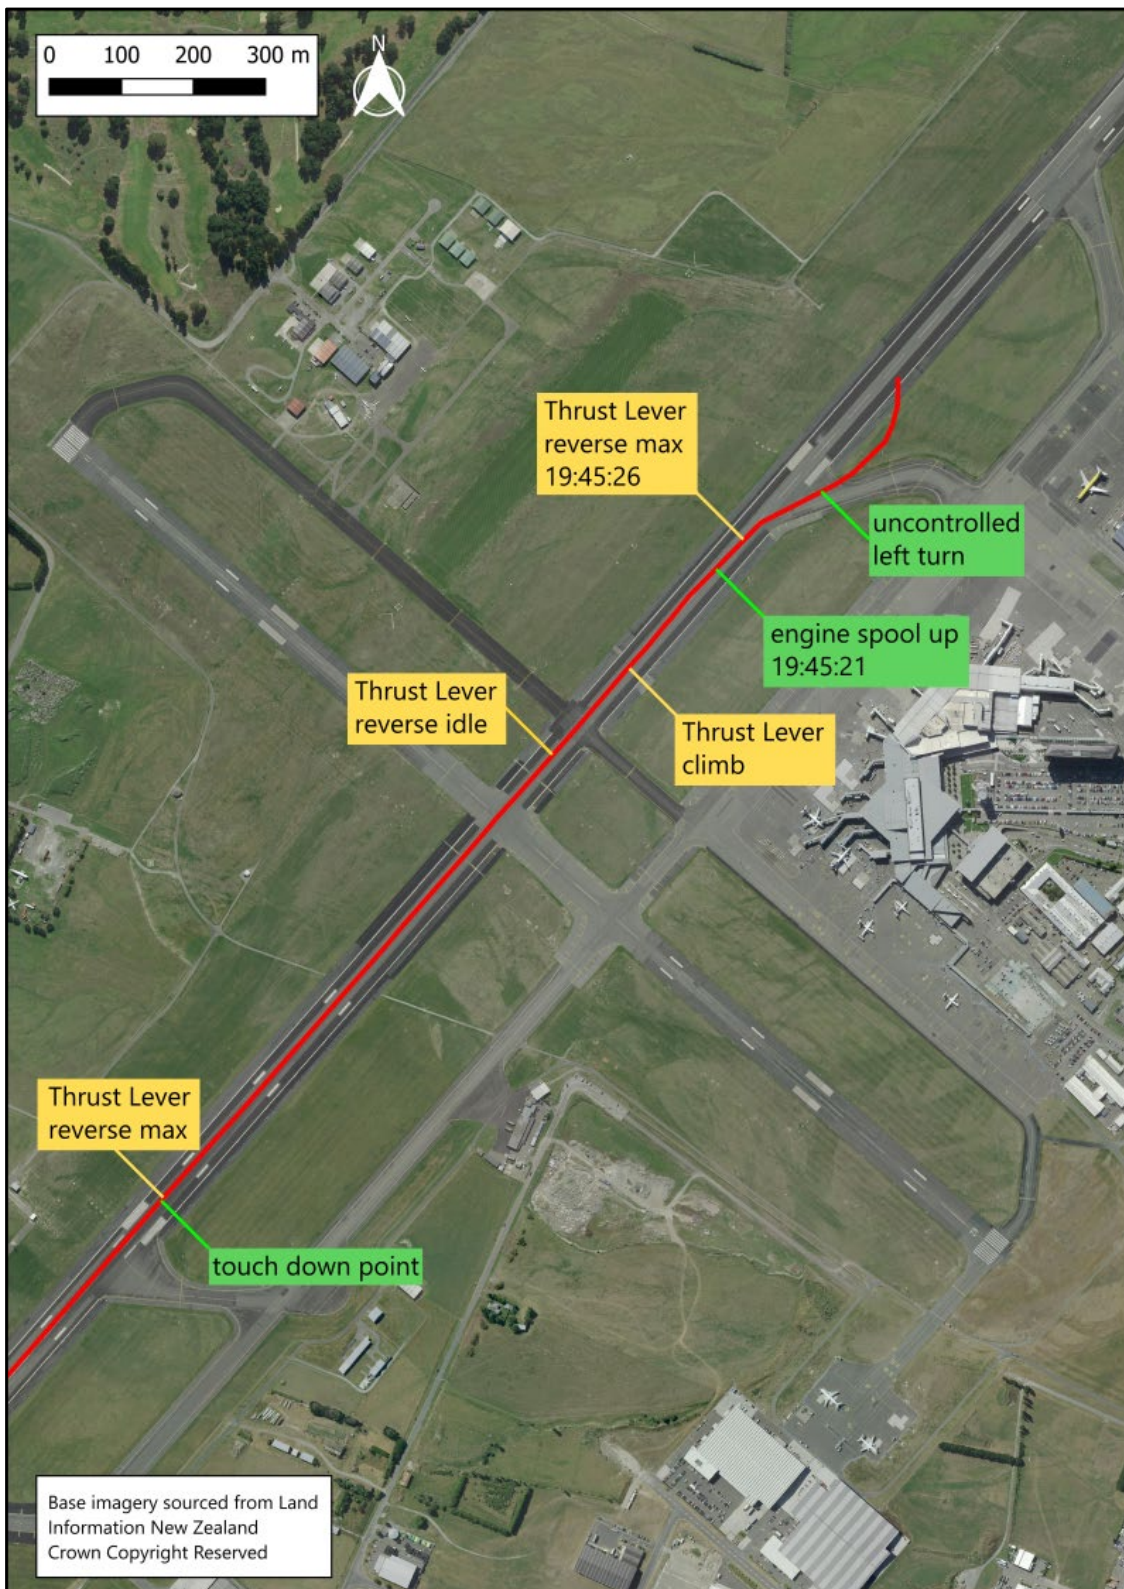
Figure 9 : Overview of landing roll
 (Note: times are in UTC)

- 3.48. The movement of the thrust levers into REV MAX after the engines spooled up led to an unexpected, uncontrolled yaw moment to the left. This was because the reverser on the No. 1 engine deployed, but the No. 2 engine reverser was disabled by the hydraulic failure and remained in the stowed position. The ECAM displayed an alert message, 'ENG 2 REVERSER FAULT', which the pilots had not expected at that time because they believed they had already stowed the reversers.

- 3.49. As both engines had previously accelerated towards CLIMB power, they were developing more thrust than they would at FWD IDLE. When REV MAX was selected, both engines slowed down. The engine's inertia prevented an immediate response to changes in thrust settings. The left engine reverser deployed, and the engine developed maximum reverse thrust while the right engine was still producing forward thrust, although it was reducing. This asymmetric thrust and pilot inputs caused the aeroplane to turn left for 60 degrees from 19:45:32.

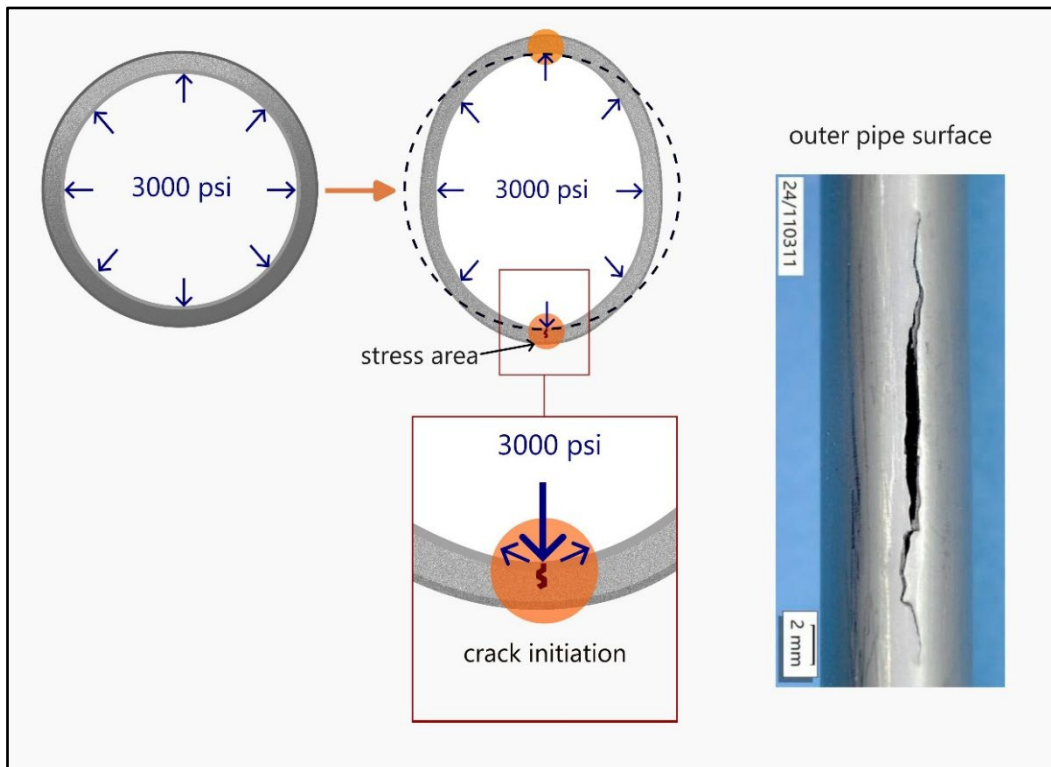
Figure 10: Mode of pipe failure

crack had reached 95% of the pipe's wall thickness when it failed from ductile overload. It then opened to a 25 mm-long split along the longitudinal axis of the pipe.

- 3.33. The hydraulic pipe failed as a result of overload stress on the inside surface at a deformed section of the pipe. The deformity was **very likely** caused when the new part's packaging was damaged in transit from the Airbus Filton warehouse in Bristol to the Airbus Fuhlsbüttel warehouse in Hamburg. However, the part was not subsequently inspected for damage and remained labelled as a serviceable item. The damage was not detected before installation or while it was in service.
- 3.34. Airbus has acknowledged the source and timing of the initial damage and recorded the case in its safety management system. Airbus informed the Commission that it will use this incident as an example in refresher training for its warehouse operators to prevent a recurrence.

- 4.3. Cyclic fatigue, due to the pressurisation and depressurisation of the hydraulic fluid at each engine start-up and shut down, **very likely** exacerbated crack formation.

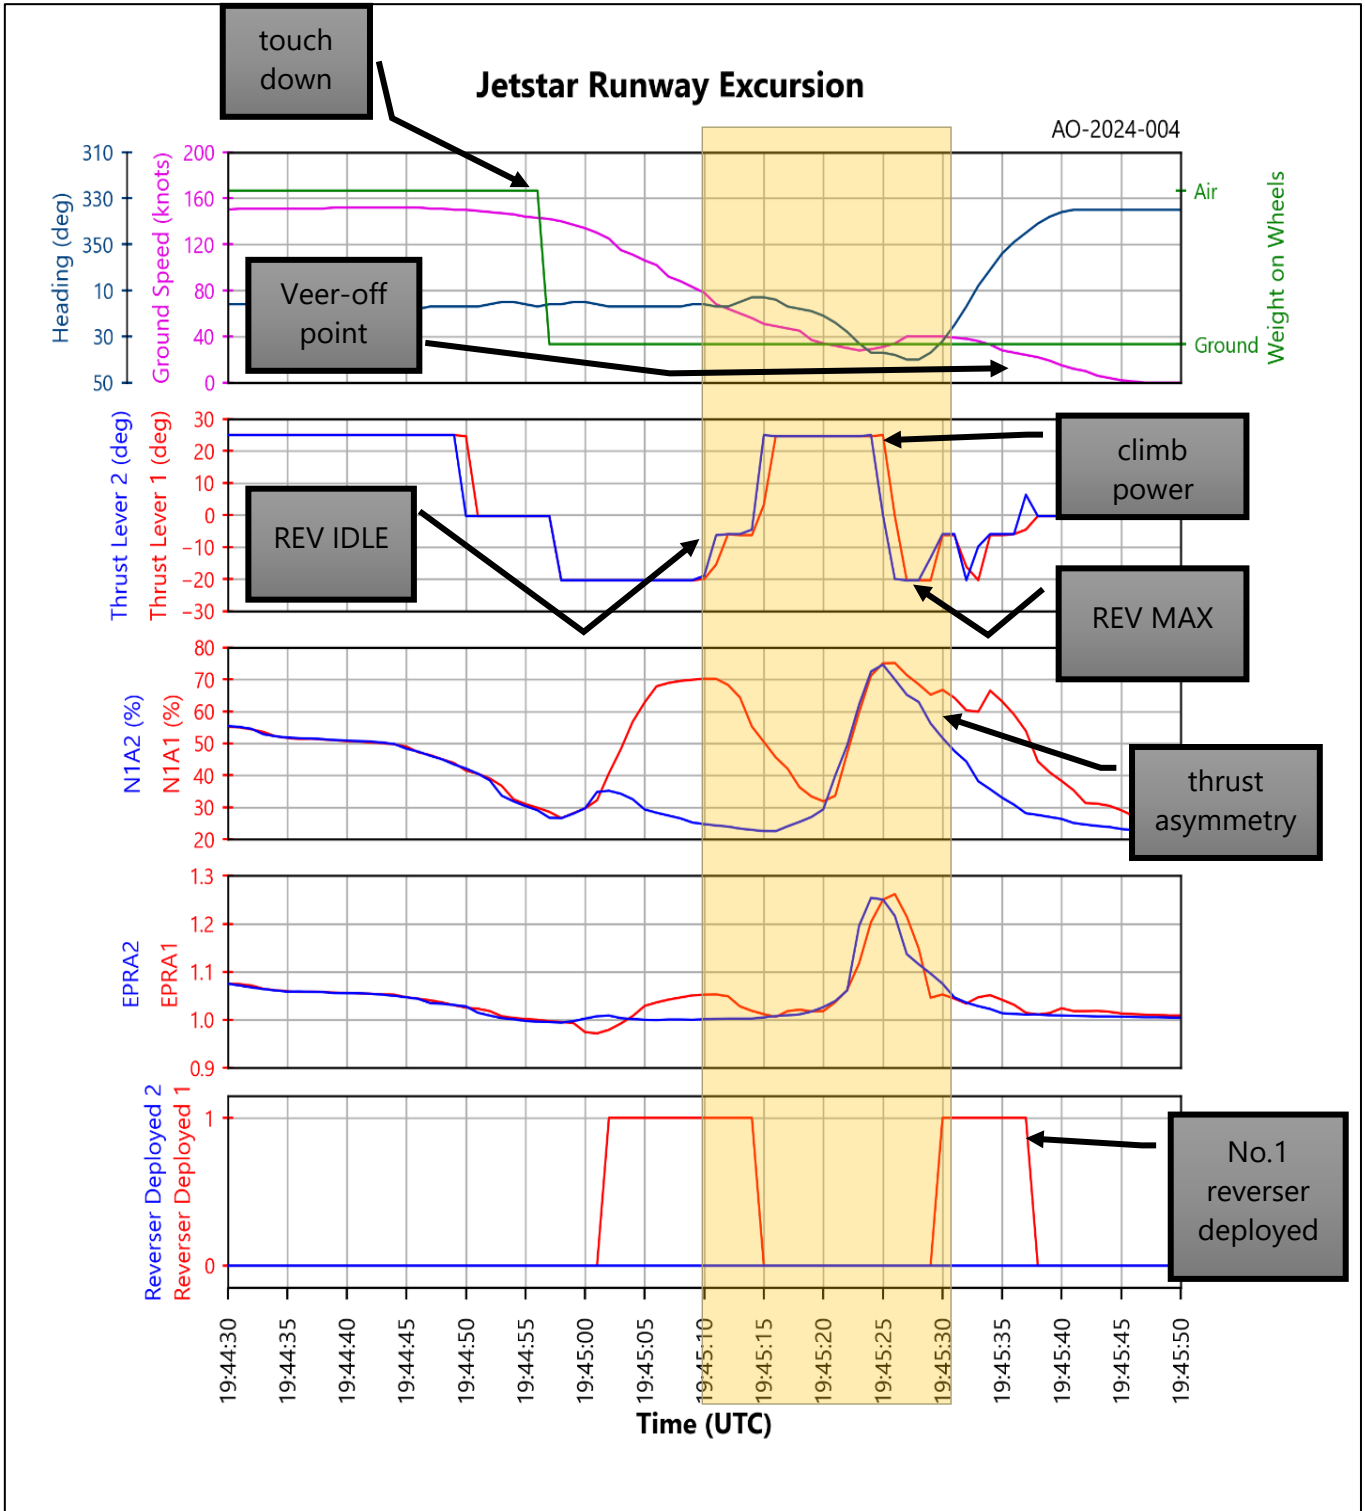
- A6.1 The data from the DFDR, presented in Figure 15: DFDR data graph shows the aeroplane movements from landing to the time of the veer-off from the rapid exit A4. The highlighted band is the excursion from the taxi exit.

- A6.6 The fourth row shows the EPRA. This is the parameter that the engine FADEC controls to maintain engine power as set by the thrust levers. The ratio is calculated from the engine low-pressure turbine exhaust pressure divided by the engine inlet pressure (see Appendix 4 for the arrangement of the engine and approximate pressure sensing points). The graph shows that both engines powered up evenly about eight seconds after the thrust levers were placed in CLIMB power, then reduced to a low setting corresponding to the REV MAX power setting, immediately after the thrust levers were placed in REV MAX.

- A6.7 The fifth row shows when the reversers were deployed. It takes about two seconds for the reversers to move from closed to open or the other way. The reverser tabs can only be lifted when the thrust levers are at FWD IDLE. No. 2 reverser did not deploy, but the thrust lever was in the reverse segment and both thrust levers were moved together.
