Transport Accident
Investigation
Commission

Final report

Aviation inquiry AO-2024-005
Airbus Helicopters AS 350 BA, ZK-HJM
Impact with terrain
Paringa River,
40 km northeast of Haast
20 July 2024

June 2026

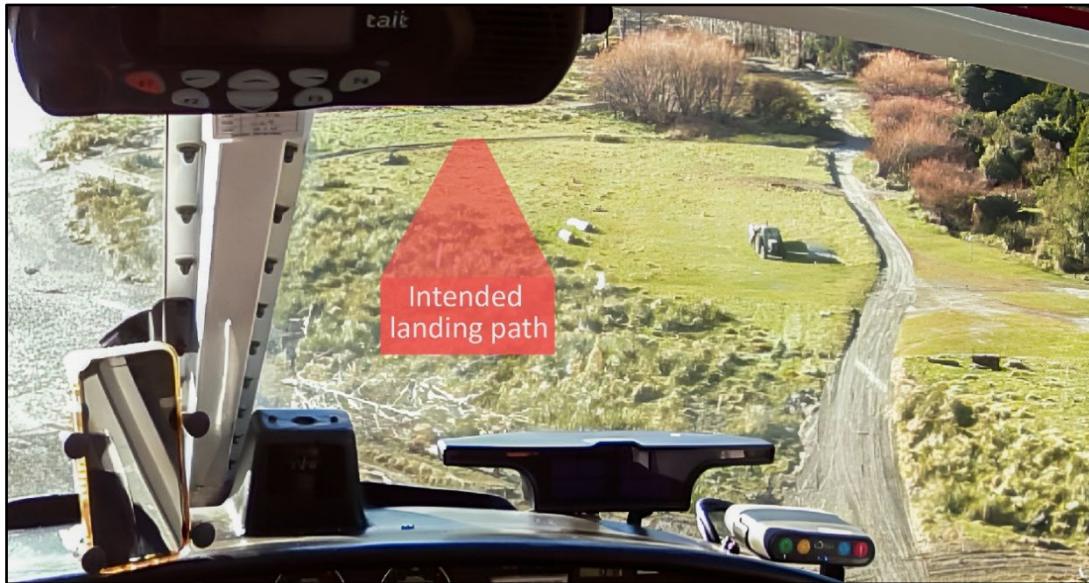
Figure 3: Landing Site
(Credit: On-board video camera)

During interviews the pilot said that they intended to make a run-on landing to the flat grass area (see Figure 3).

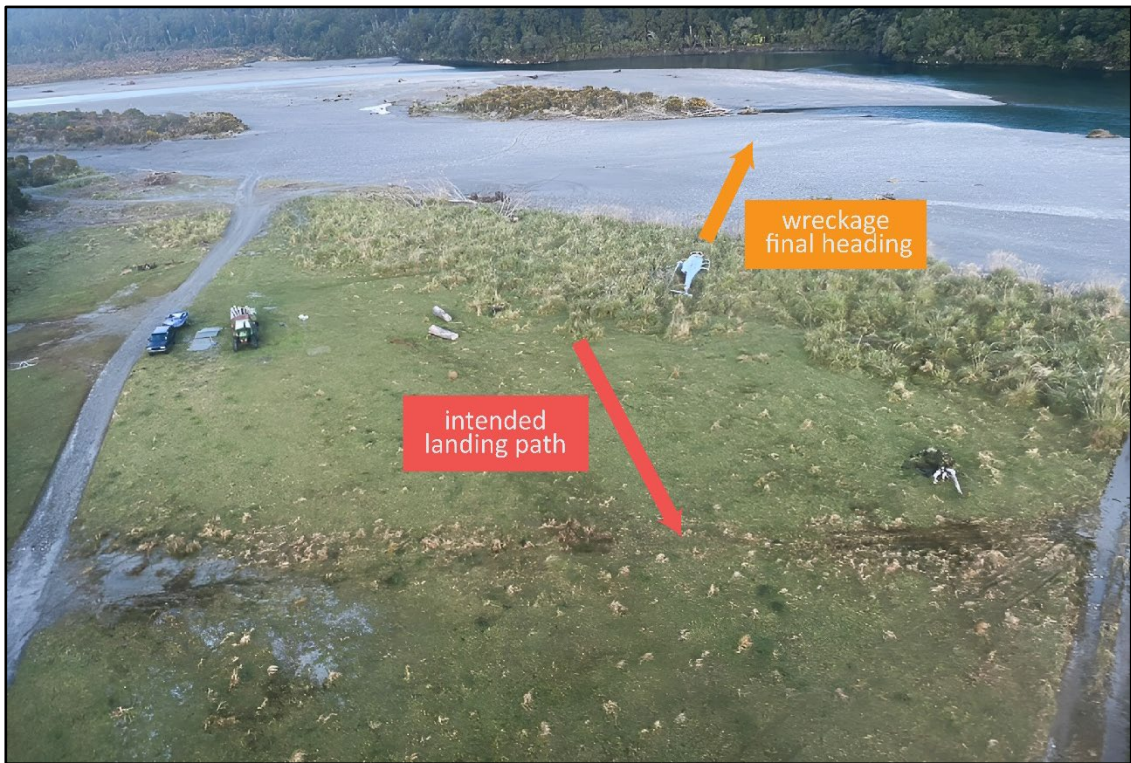
Figure 4: Final position of the helicopter

- 1.4. The helicopter came to rest on its left side, facing about 180 degrees from the original direction of travel.
- 1.5. The activation of the helicopter's emergency locator transmitter³ alerted the Rescue Coordination Centre who dispatched a rescue helicopter to the site. Both occupants were transported to hospital with minor injuries. The helicopter suffered significant damage.

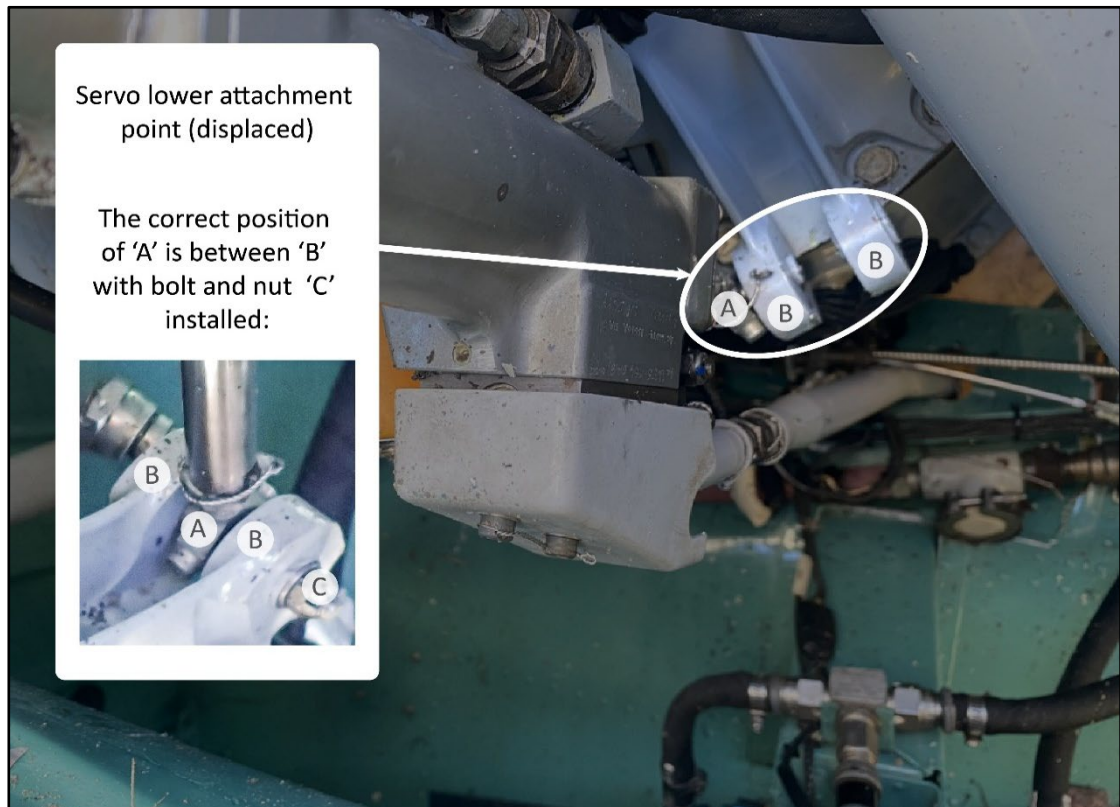
- 2.12. The pilot and passenger inspected the helicopter after the accident. They discovered a bolt missing from the lower attachment point where the left main rotor hydraulic servo connects to the transmission housing (see Figure 5 and Appendix 1). After the accident, the pilot and passenger located the bolt on the helicopter transmission deck. However, the nut was unable to be located at the site.

Figure 5: ZK-HJM left hydraulic lower attachment point bolt missing and hydraulic lower connection point no longer connected

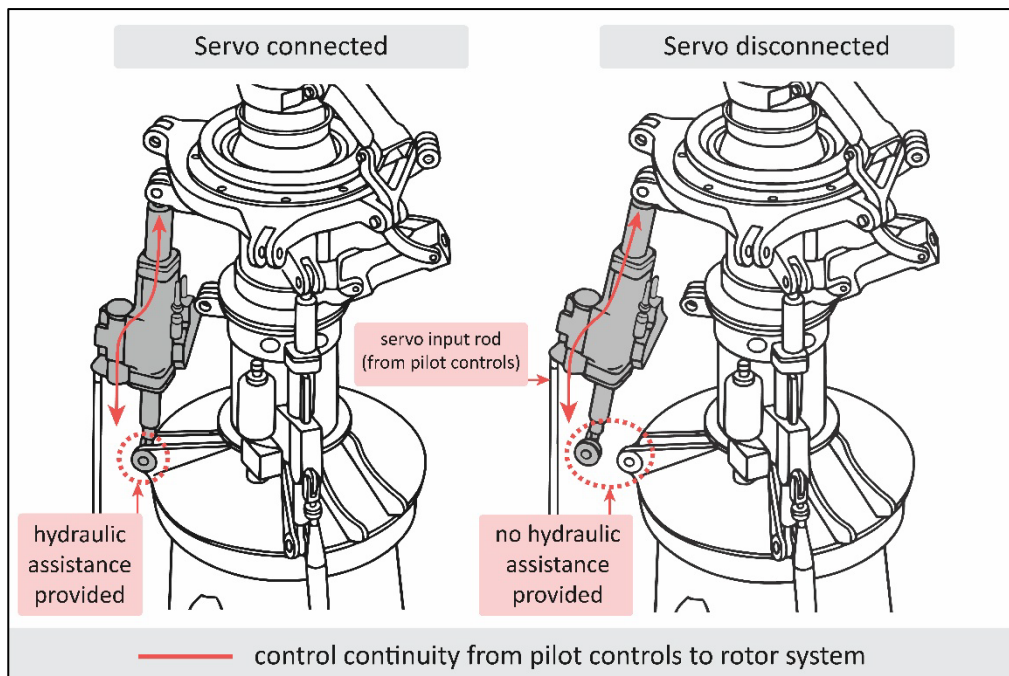
- 3.13. The flight manual stated that the AS350 helicopter was controllable with inoperative hydraulics, however the load feedback can be very heavy, especially at higher airspeeds. When a single hydraulic servo is no longer providing assistance on one of the three controls, in this case due to the disconnection of the lower attachment point from the MGB conical housing, the pilot is subject to those loads in one direction. This condition would exhibit symptoms as a heavy cyclic on one side.

- 3.14. When the collective is raised in this situation, all three control rods are raised; however only two are hydraulically assisted, while the third is not. This will manifest as the cyclic pushing towards the unassisted side and requires the pilot to be able to match the force exerted by the hydraulic system on the still-connected servos.

Figure 6: Hydraulic servo lower end disconnection

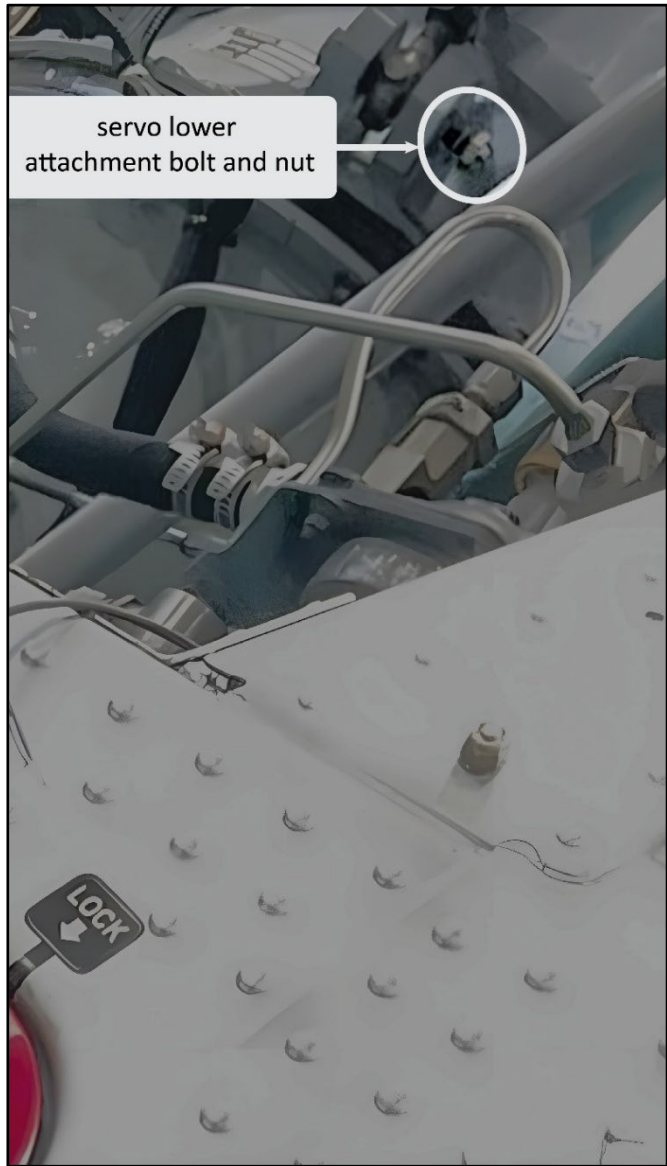
Figure 7: ZK-HJM lower attachment bolt and nut during maintenance
(Credit: Engineer A, marked up by TAIC)

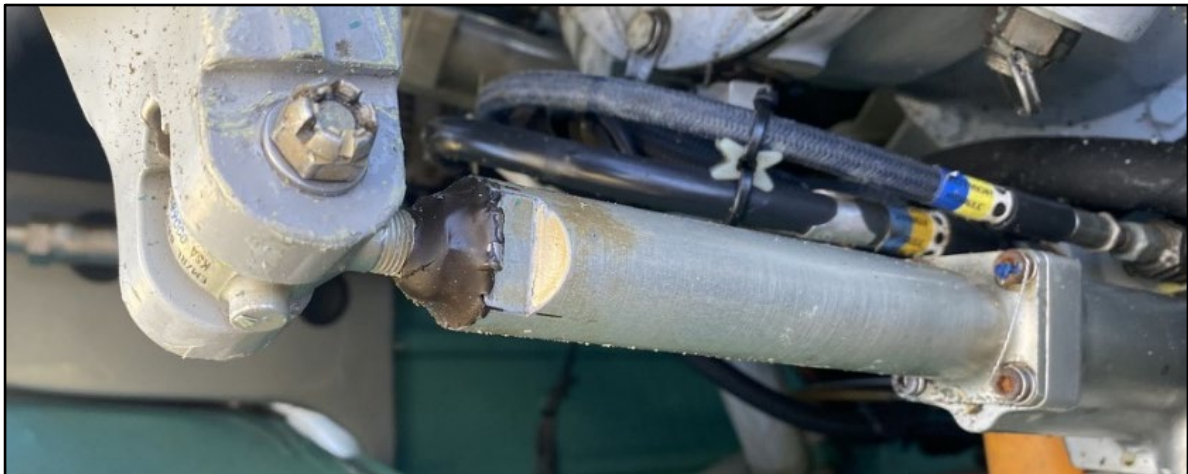
Figure 8: Left hydraulic servo upper attachment point, taken post-accident
(Credit: TAIC)
