Transport Accident
Investigation
Commission

Final report

Maritime inquiry MO-2025-203
Bulk carrier, Thor Nitnirund
Serious injury
Cook Strait, New Zealand
20 March 2025

June 2026

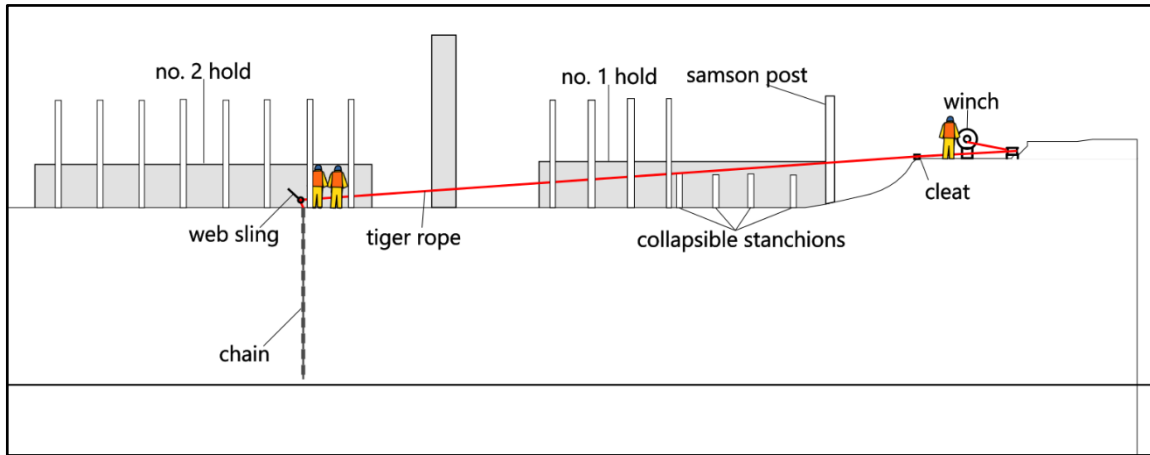
Figure 3: Side view of crew positions while retrieving the lashing chains

2.7. The crew ran the tiger rope aft from the starboard mooring winch, through a cleat¹¹ and outboard of the collapsible stanchions¹² at no. 1 hold to the forward end of no. 2 hold (see Figure 3, 4 and 5).

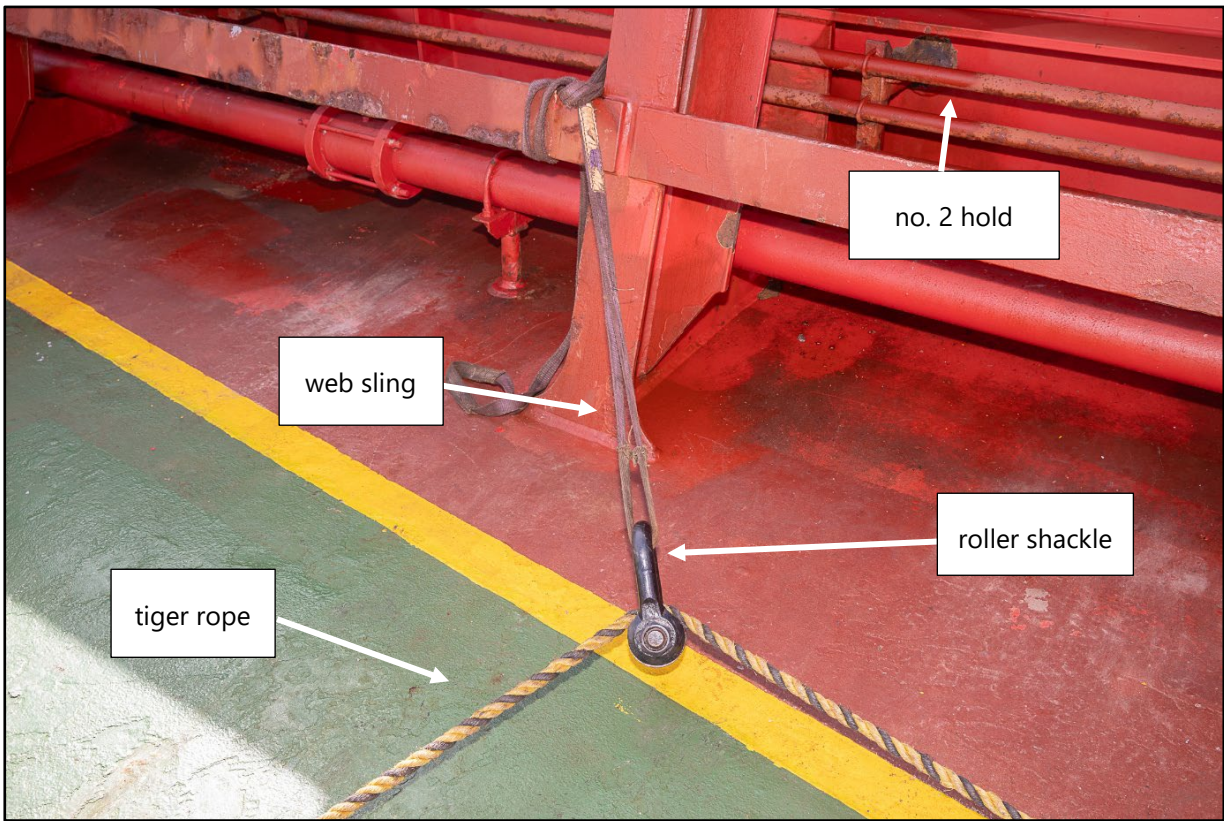
- 2.8. At no. 2 hold, they rigged one end of a 1-tonne safe working load¹³ flat synthetic strop (referred to as a web sling) to the coaming¹⁴ at no. 2 hold. The crew attached a roller shackle to the other eye of the web sling, and the tiger rope was passed through the roller shackle, making a 90-degree bend (see Figure 6). The tiger rope was then attached by another shackle to the lashing chain.

Figure 6: Recreated scene showing the web sling, shackle and tiger rope at no. 2 hold
 (Credit: New Zealand Police)

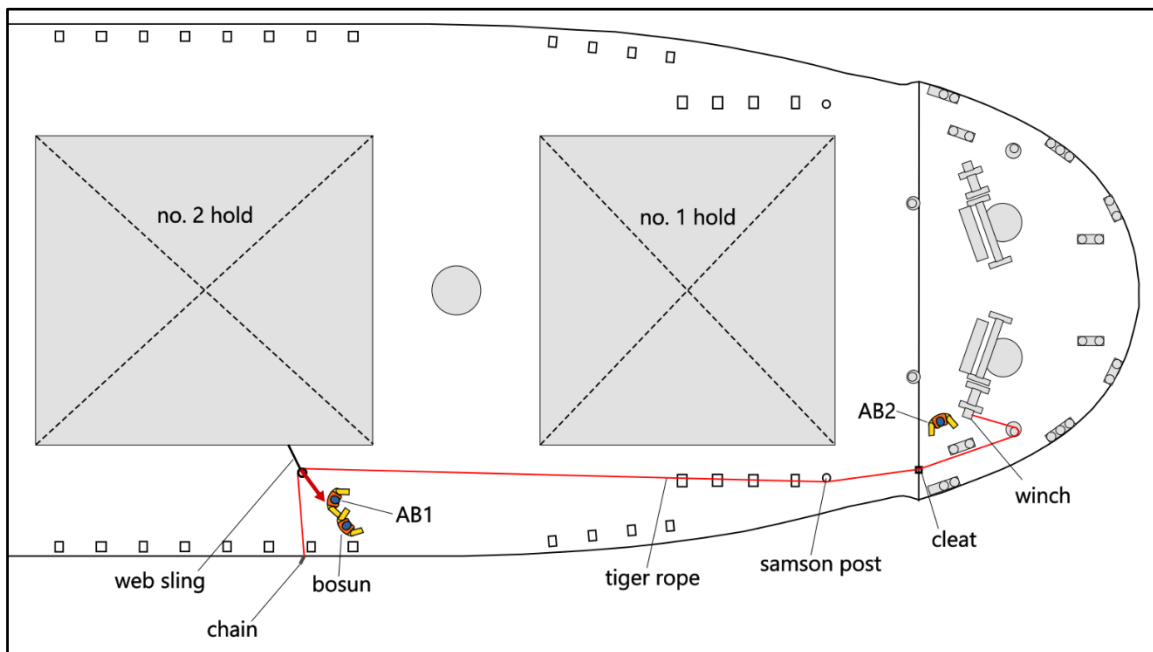
2.9. At 0949, the bosun and one AB (AB1) stood at the starboard side of no. 2 hold, next to the web sling and roller shackle. The other AB (AB2) went to the forward mooring deck to operate the starboard mooring winch (see Figure 7). They lifted the first chain which came up easily. They then started lifting the second chain.

Figure 7: Overhead view of arrangement for retrieving the lashing chains, showing tiger rope and crew locations

- 2.10. At about 0955, the web sling parted, causing the tiger rope to recoil across the deck. The tiger rope and shackle struck AB1 with significant force in the back of the legs. This caused them to strike their head on the deck and collide with the bosun before both crew members landed near the ship's bulwarks. The bosun got to their feet a few seconds later and went to assist the injured AB.

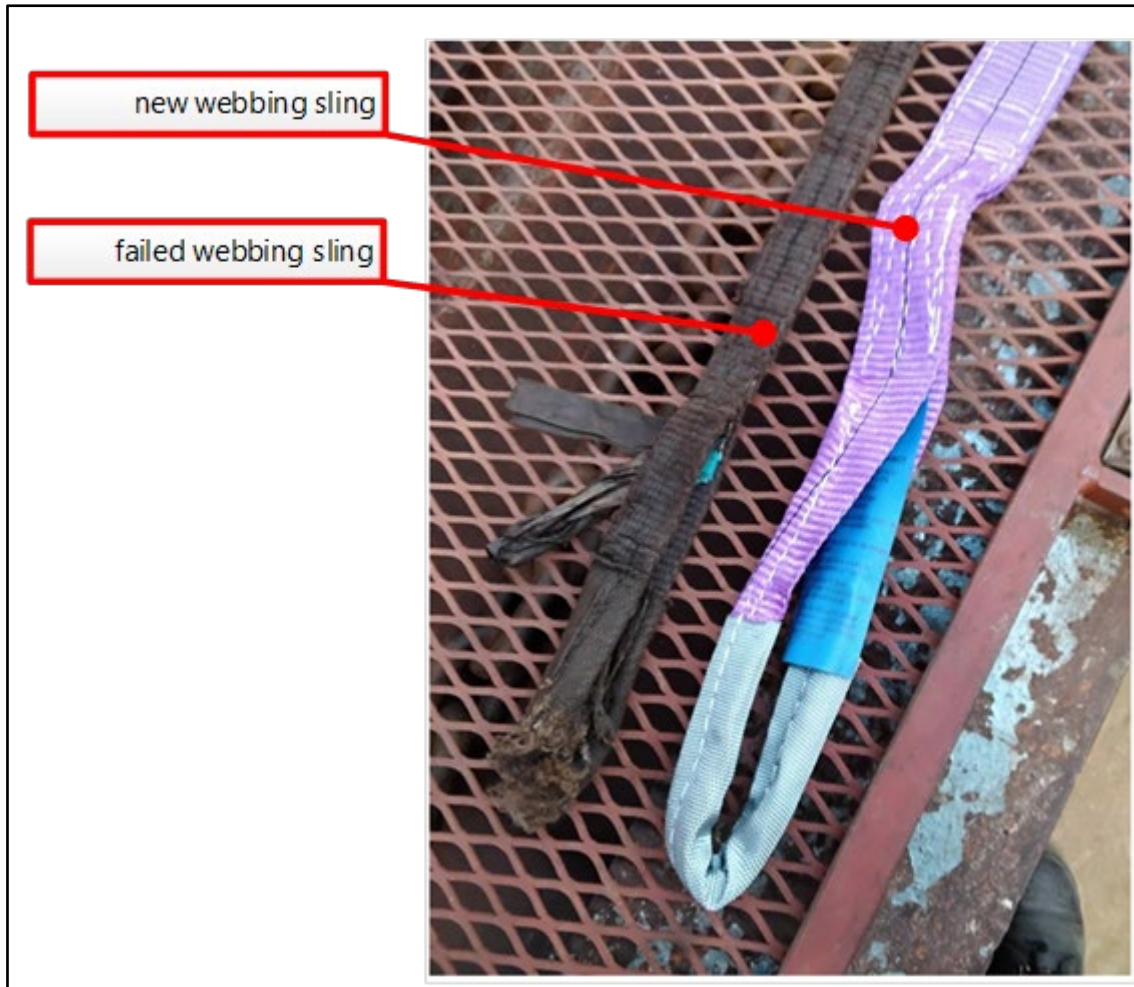
- 3.4. The web sling that failed during the accident was a flat synthetic web sling with a 1-tonne safe working load.
- 3.5. The Commission examined the failed web sling and found that it was saturated with oil and generally in poor condition (see Figure 8). The bearing surface of the eye was completely cut in half and frayed. On assessment of the cut, investigators noticed that some of the frayed material appeared dirty, and only a portion of the webbing fibres appeared clean. This indicated that some of the webbing had been chafed before the accident, resulting in a partial cut that damaged the sling.

- 3.6. Such a cut can normally be attributed to using a sling on a sharp edge – an edge that is not rounded or an edge that is rounded but with a diameter too small for the webbing – causing damage to the webbing under load.

- 3.7. The clean fibres represented the remaining webbing material that had failed during the accident.
- 3.8. Web slings are designed in a way that the stitching should be the first point of failure if the sling is overloaded. In this accident, the webbing material failed while the stitching remained intact, further indicating that the webbing material was damaged before the accident.

Figure 8: Comparison of the failed web sling and a new similar web sling

- 3.9. The Commission engaged an independent expert to test the residual strength of the web sling. The generally accepted safety factor of a web sling is 6:1 (Ministry of Business, Innovation & Employment, 2012). This means that a sling with a 6-tonne minimum breaking load¹⁹ has a 1-tonne safe working load.

- 3.10. During the testing, a gradual load was applied to the sling and the sling failed when the load reached 2.86 tonnes. The sling's webbing did not break, but the stitching near the eye end failed, as designed.

- 3.11. Testing revealed that while the sling withstood a load greater than its 1-tonne safe working load, it failed at only 48% of its expected minimum breaking load of 6 tonnes.

- 3.12. Taking into consideration all available evidence, the Commission found that previous damage to the eye of the web sling and its overall poor condition contributed to its failure.

- 3.14. When damage is discovered, the sling should be removed from circulation. Instructions to this effect and to support this process were not contained within the ship's SMS.

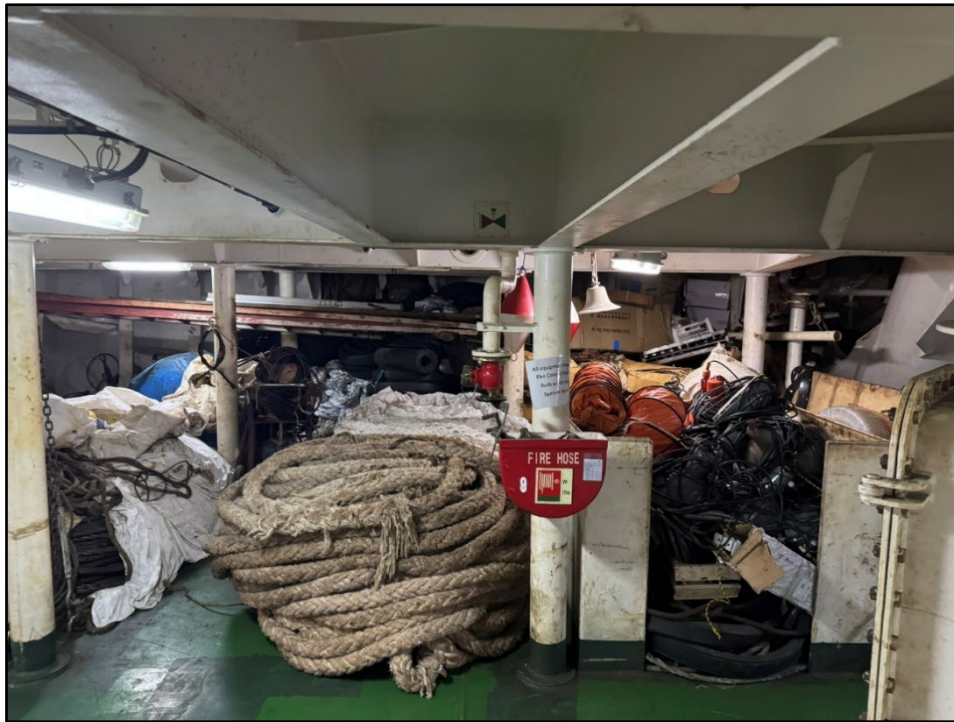
Figure 10: Thor Nitnirund deck store

- 3.32. The loose lifting gear was stored in the deck store, located in the ship's forecastle. Commission investigators found indications of poor housekeeping in the deck store (see Figure 10). An organised deck store helps ensure that items can be easily located and that a proper inventory of equipment can be maintained, clearly separating in-use and out-of-service equipment.

- 3.33. Because the loose gear did not have individual identification tags it would not be obvious to crew if any specific loose gear had been examined. It is **virtually certain** that the bosun picked up the sling to use without realising it had not been subject to the SMS quality assurance. Equipment can be damaged between periodic inspections, so it is essential that all components of a lifting system are inspected before use.

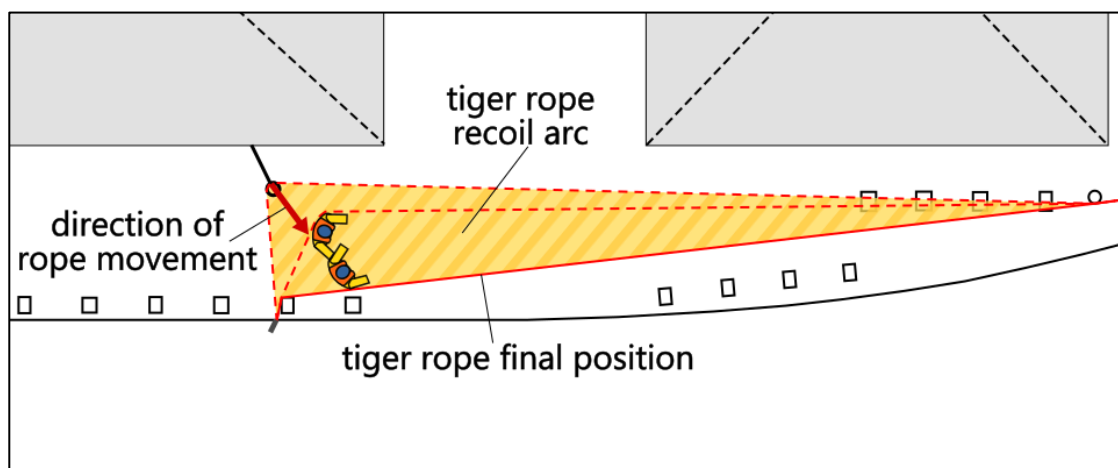
- 3.37. During the lifting operation the bosun and AB1 were standing in the bight of the lifting system (see Figure 11). By doing so, both crew members were in danger of being struck by components of the lifting system when it failed.
- 3.38. The web sling and shackle served to redirect the tiger line to pull the lashing chains on deck towards the hatch coaming. As such, the web sling was susceptible to additional load from the weight of the chain and the opposing pulling force from the mooring winch. Failure of the web sling under strain resulted in the tiger rope and shackle projecting towards the two crew members in an instant.

Figure 11: Unsafe area showing position of bosun and AB1

- 3.39. The risk associated with standing in the bight of a line or lifting arrangement is well known in the maritime industry and is incorporated into basic seamanship training. Opportunities to identify and monitor such a risk commonly take place during pre-task risk assessments and oversight of the task in progress.
