Transport Accident
Investigation
Commission

Final report

Rail inquiry RO-2024-103
Bridge 57 Main South Line, Pier 8 collapse
Rangitata
12 April 2024

June 2026

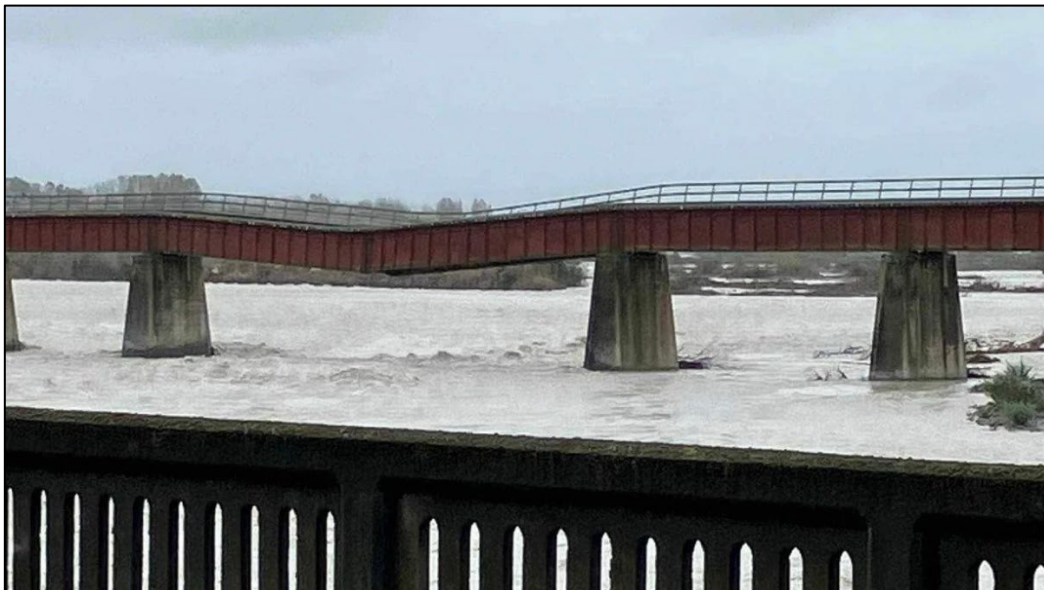
Figure 5: Collapsed Bridge 57 (12 April 2024)

- 2.18 After the inspection, the track ganger reported to the Production Manager that the line was safe to remain open.
- 2.19 At 1037, KiwiRail received a further weather update from MetSolutions. This update included information that the river had peaked at the location of the bridge.
- 2.20 At some point after the inspection was completed at 0941, Pier 8 of Bridge 57 was washed out by the river flow, which caused a partial collapse of the bridge (see Figure 5).

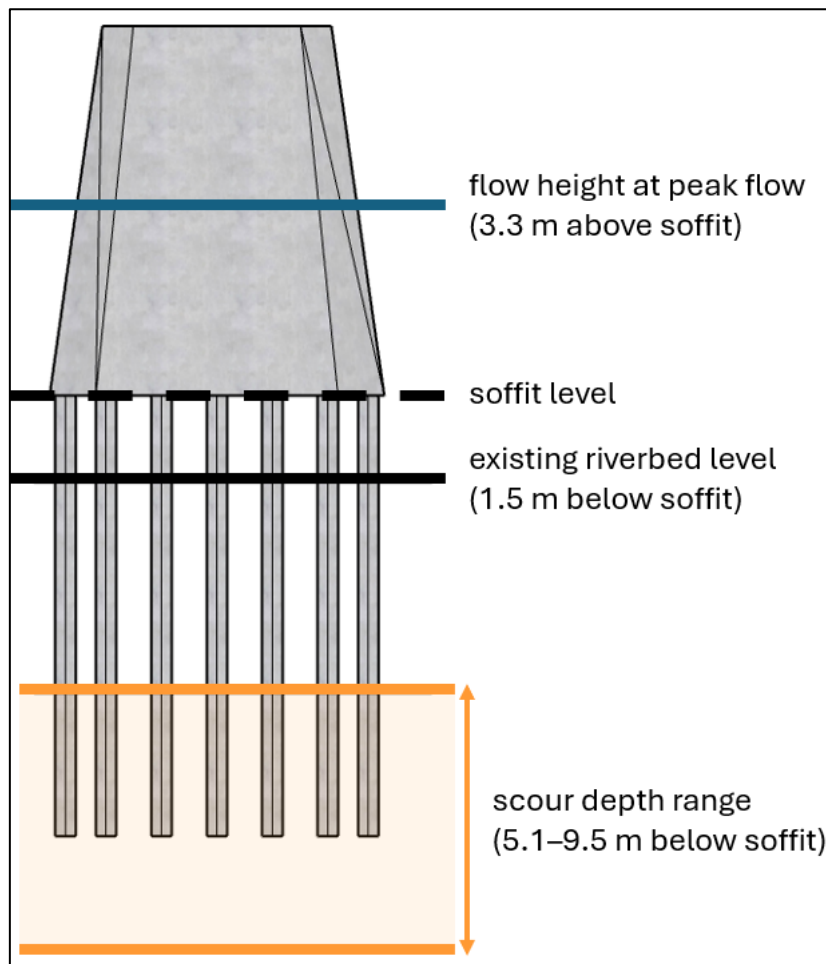
Figure 11: Pier 8 scour depths

- 3.4 Scour depth is the vertical distance below a reference surface that will be eroded and removed by the action of flowing water. This phenomenon, known as scour, is particularly relevant around hydraulic structures such as bridge piers.
- 3.5 The scour depths relating to Bridge 57 have been determined through the tests and research that have been completed and are detailed in Appendix 1.
- 3.6 The theoretical scour depth and flow height on the day of the event for Pier 8 are represented graphically in Figure 11. Because of the uncertainty around the precise velocity of the water flow around Pier 8 on the day of the event, a range of probable scour depths is represented.
- 3.7 The reference point of the soffit of the pier (bottom of the pier section) has been selected to represent the depths and heights.

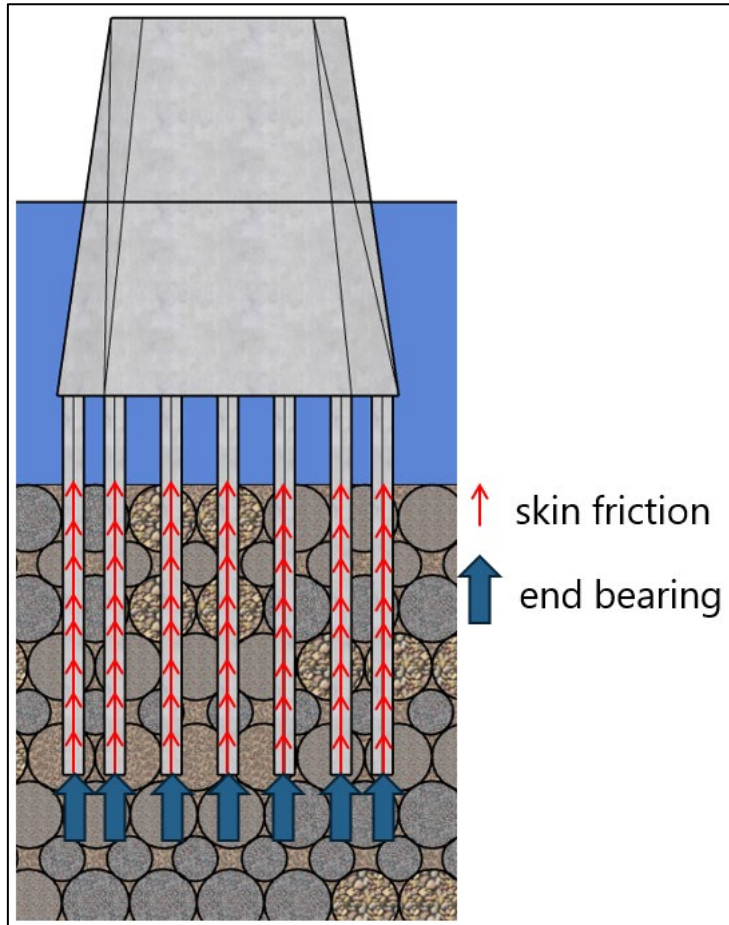
Figure 12: Vertical support mechanism of piles

3.10 The failure of Pier 8 was **very likely** caused by the loss of vertical support from the piles due to the scouring of the riverbed material around the piles. The riverbed material around the piles provides the vertical support through a combination of skin friction and end bearing (see Figure 12).

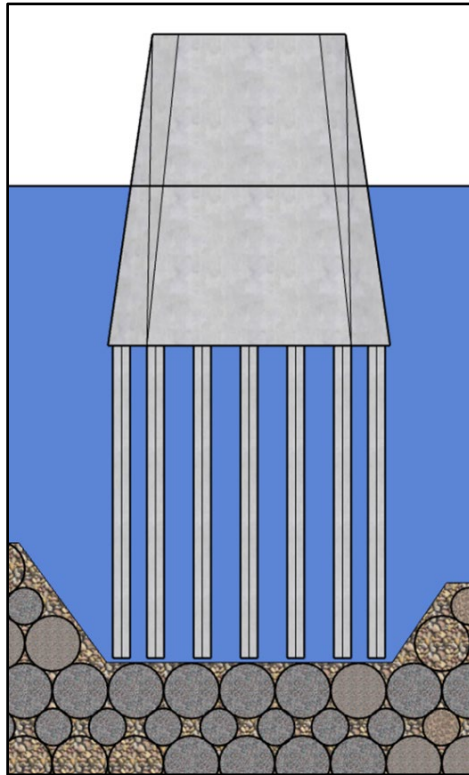
Figure 13: Loss of riverbed through scour

- 3.11 The mechanism of failure was **very likely** as follows:
- (i) sufficient bed material would have been scoured away such that the piles were unable to support the vertical load of the bridge, causing the pier to begin to sink into the riverbed (see Figure 13).

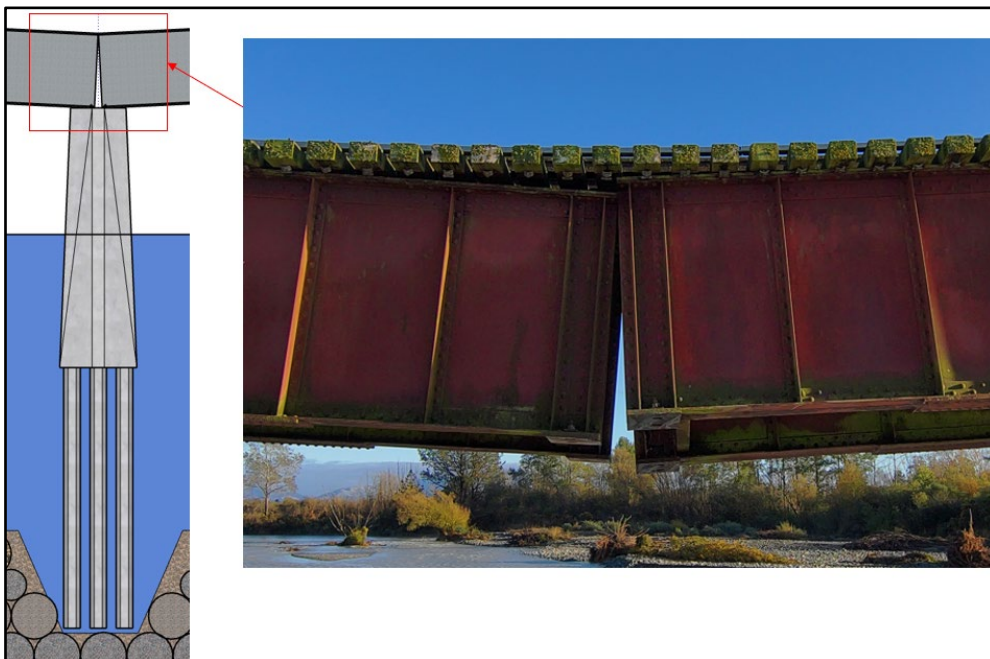
Figure 14: Vertical settlement of pier

(ii) As the pier dropped vertically, the beam ends butted together and began to support their own weight. This resulted in the pier being momentarily suspended from the beams, before the holding down bolts failed under tension (see Figure 14).

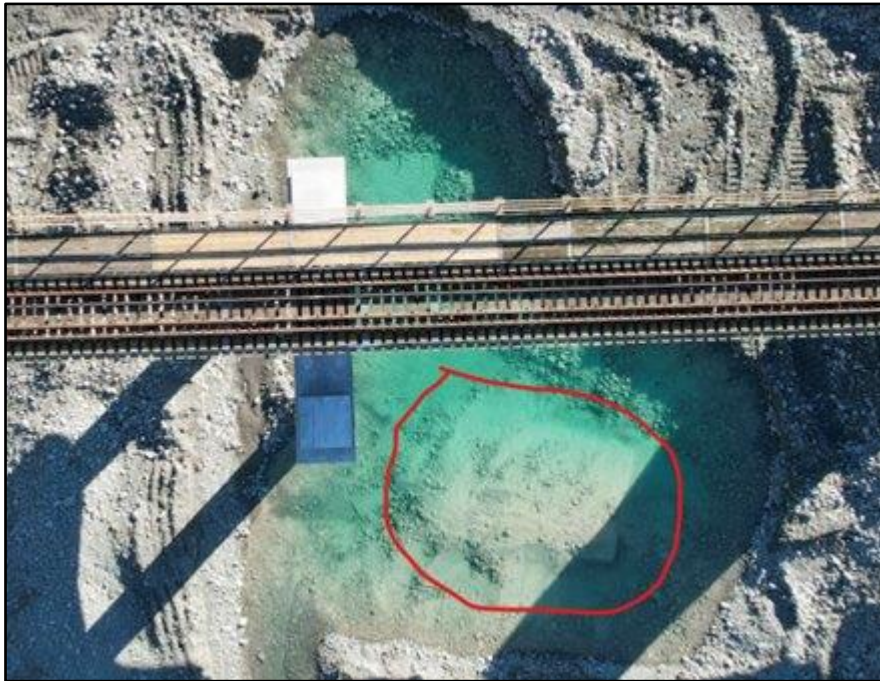
Figure 15: Final location of Pier 8

(iii) Once the connection between the top of the pier and the beams was lost, the pier toppled into the river and settled on the eastern side of the bridge in a downstream river flow (see Figure 15).

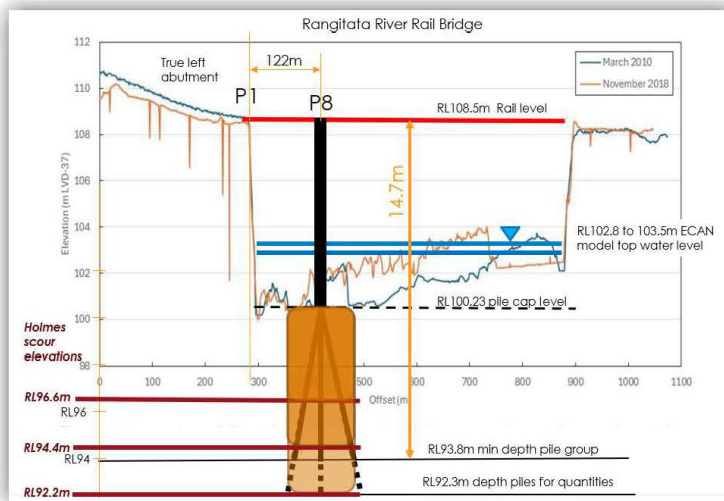
Figure 2: Total scour depth results for velocity = 4.1m/s, 3.1m/s, 2.1m/s assuming 45 degree angle of flow attack on the pier, 10m by 1.5m debris raft, pier width 1.9m

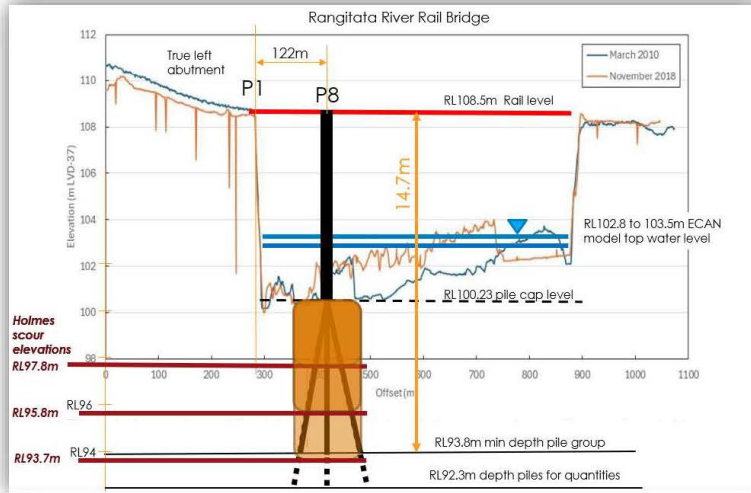
Figure 3: Total scour depth results for velocity = 4.1m/s, 3.1m/s, 2.1m/s assuming 45 degree angle of flow attack on the pier, no debris, pier width 1.9m

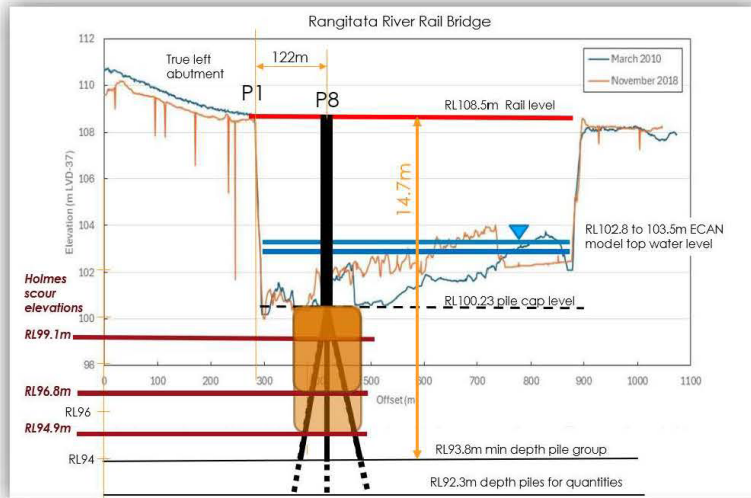
Figure 4: Total scour depth results for velocity = 4.1m/s, 3.1m/s, 2.1m/s assuming 0 degree angle of flow attack on the pier, no debris, pier width 1.9m

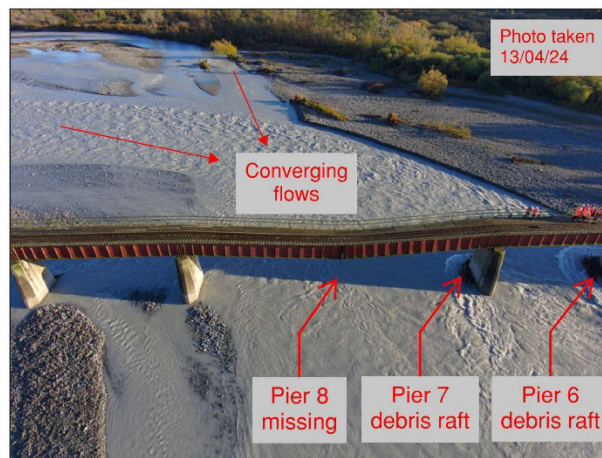
Figure 5: Photo taken above the bridge failure

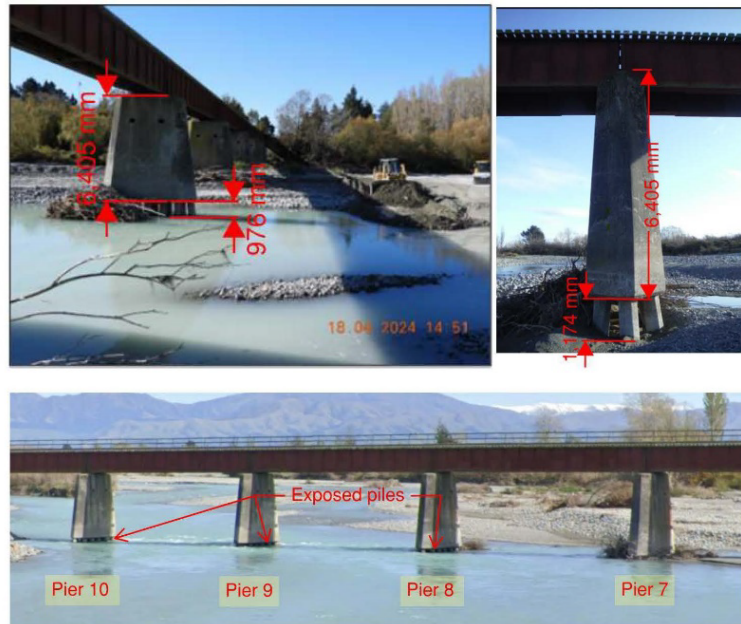
Figure 6: Photos at riverbed level showing scaled dimensions of Pier 6 (top left) with exposed piles and debris raft, 18 April 2024 (post-flood event), Pier 7 (right) with debris raft in 2020 (top right) and pile exposure evident on Piers 8, 9 and 10 pre-flood (bottom).

The top left photograph, taken on 18 April 2024, shows that flood waters have receded exposing the debris raft around pier 6 and exposing approximately 1.0m of pile above the water. A further 0.5m of exposed pile has been assumed below the water level. According to historical inspection records Pier 7 had a similar level of pile exposure pre-flood (top right). Pile exposure is also evident on piers 8, 9 and 10 above water level with further exposure highly likely below water level. Based on the above information a similar sized debris raft and pile exposure has been assumed for pier 8 in the scour analysis. What is apparent is from the above photographic information is that the river bed is highly mobile.

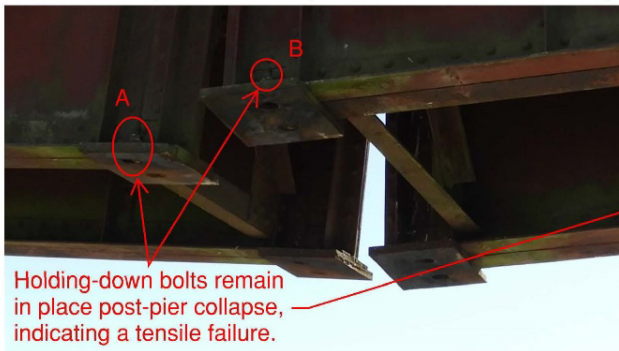
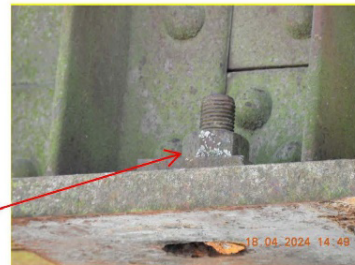
- A TAIC photo from 18 April 2024 identified the following:

Close up of nut and washer at location "A". Note the "fresh" uneven orange fracture surface of the holding down bolt at the underside of the hole.
