# **Final Report**

***Rail inquiry RO-2025-104***  
***Wellington Station signalling power outage***  
***Wellington***  
***27 March 2025***

**June 2026**

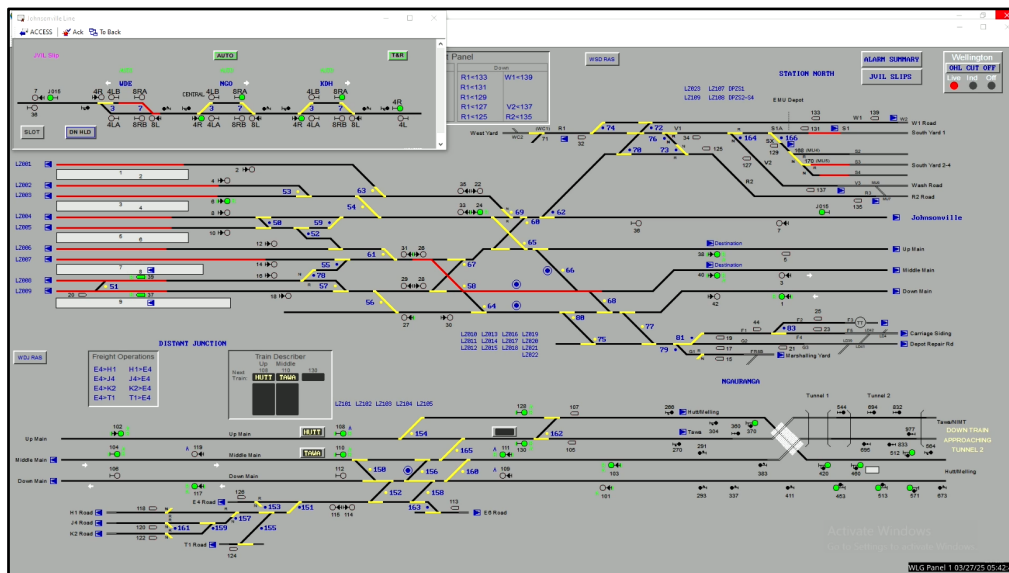
**Figure 4: Train control mimic screen**

- 2.7. The mimic screen was used by the signaller to set routes for trains to follow, and it displayed other critical information such as alarms about the network status.

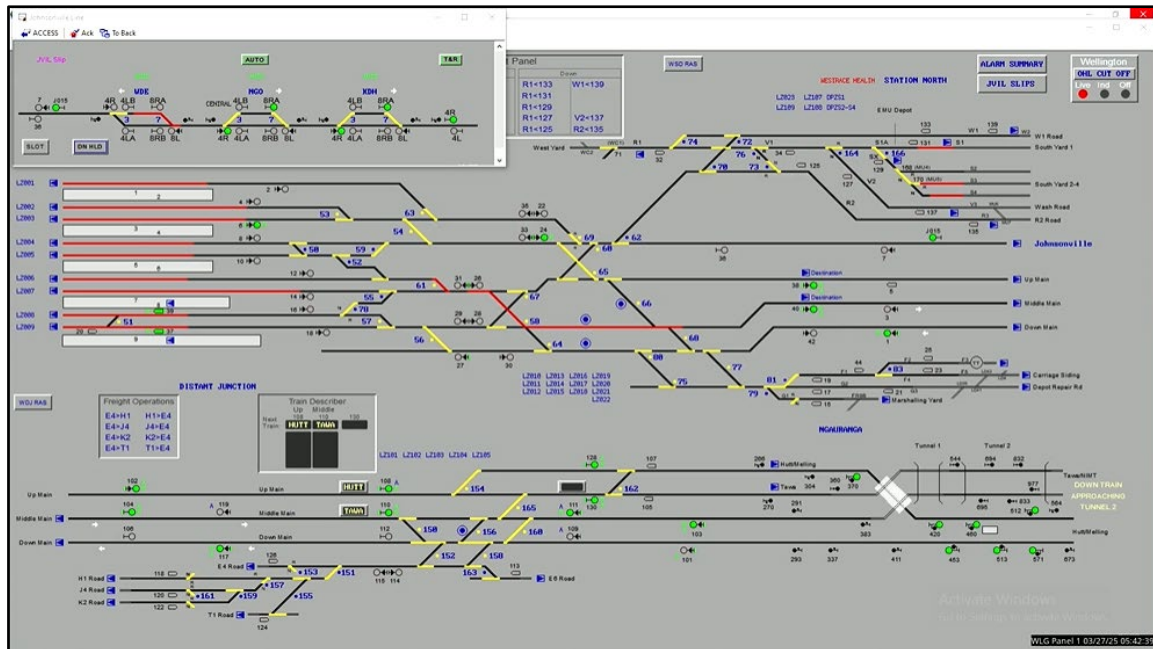
**Figure 5: Wellington Junction train control mimic screen with alarm displaying**  
(Credit: KiwiRail)

- 2.13. From before 0200<sup>4</sup> on 27 March 2025, a visual alarm was regularly displayed at the WROC workstation for the Wellington regional and junction desks that stated 'WESTRACE HEALTH' (see Figure 5). That alarm was displayed on train control's mimic screen for about five seconds, every eight minutes until the power outage occurred.

- 2.14. The WESTRACE HEALTH alarm indicated that there was a power supply problem within the computer-based interlocking system in the Wellington station area. The operators were not aware that this alarm existed prior to the event.

- 2.16. Between 0536 and 0550 the signaller set routes for four trains to depart the station. During this period the visual power supply alarm was displayed twice and not seen by the signaller.

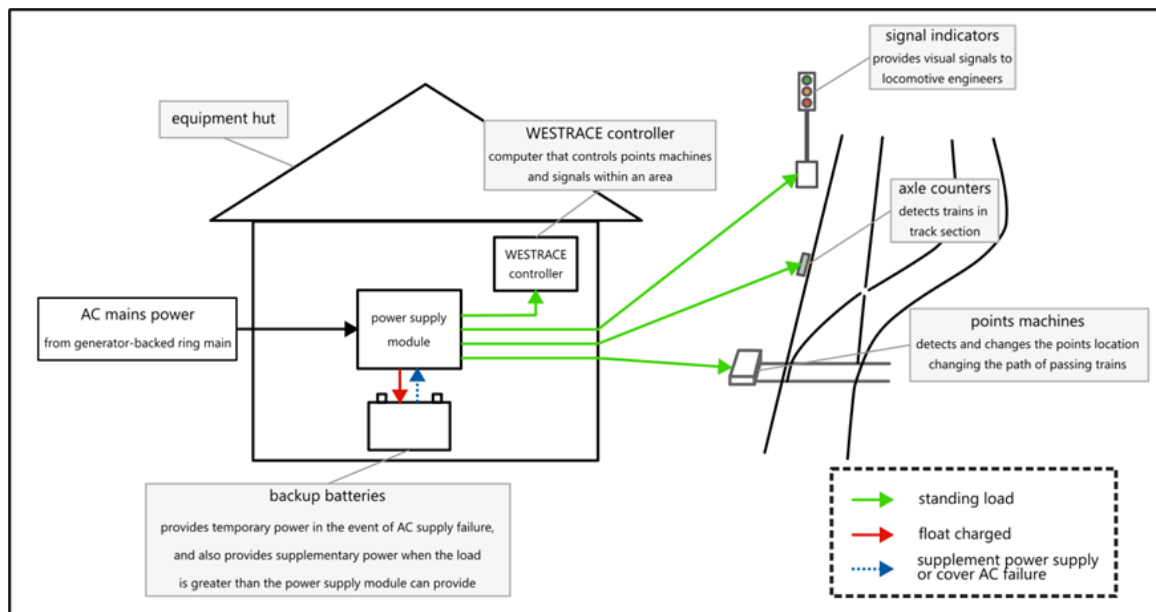
**Figure 6: Wellington Station signalling schematic**

- 2.27. If the AC supply failed, the generator would take over. The batteries ensured that the signalling system continued to operate uninterrupted until the generator connected to the ring main.
- 2.28. The power supply module that failed was a standard product provided to Siemens by their supplier and used in the signalling system at Wellington Station.
- 2.29. The battery was expected to provide power during periods of high load demand that were greater than the power supply capacity. The battery would then recharge when the rail traffic reduced between peak travel times. This design was approved by KiwiRail as part of the Wellington Station resignalling project.

- 3.17. The Commission found that the power supply system designed for this critical safety system had not adequately considered the reliability of DC power supply in equipment hut M0005, Rack A. The power supply module depended on the battery bank to supplement peak load current, but the battery backup was not treated as a critical subsystem for continued operation of the signalling system. The power supply module was configured as a float voltage battery charger and power supply with a fixed voltage output. The voltage was set to match the optimum float charge voltage per battery cell in the battery bank.

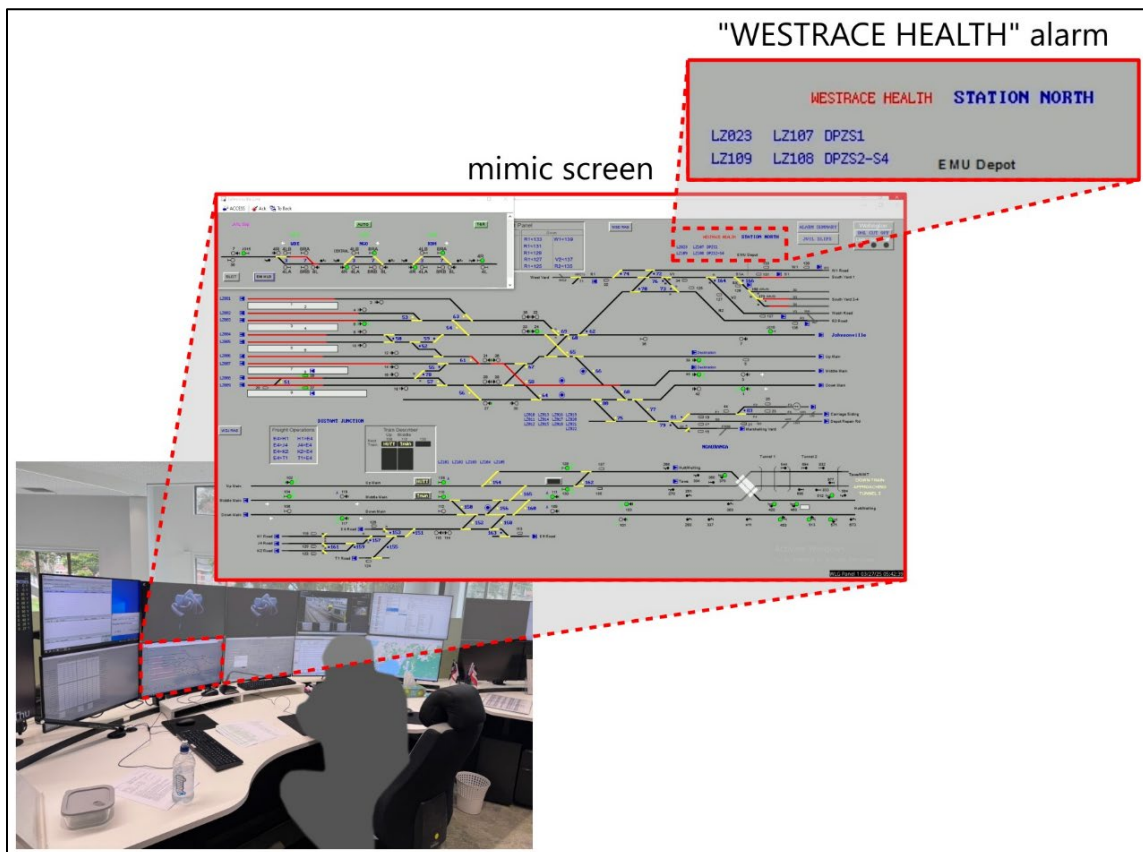
**Figure 7: Alarm presentation**

- 3.33. In the lead-up to the first outage, when the power supply module failed and stopped charging the battery bank, an alarm was triggered. This alarm was presented on the mimic screen at the Wellington Station and Wellington region train controllers' desks.
- 3.34. The alarm consisted of the words WESTRACE HEALTH in red font (see Figure 7). This text was displayed for five seconds at a time before disappearing, then reappearing after eight minutes. The alarm did not include an auditory component, which was reserved for safety-critical alarms. This alarm was not considered safety-critical. The power supply failure did not pose an immediate risk to operations as the signals reverted to red to stop all trains.

- 3.35. The Commission identified three issues with the alarm's presentation.
- 3.36. First, the alarm system only alerted those in the train control centre. Those with the ability and responsibility to address any power supply issue (for example the signal maintenance team) were not included in the alarm system. Even when the alarm was unacknowledged for several hours, the system was not configured to escalate the issue any further. As a result, signalling maintenance staff were wholly reliant on train control to notice the alarm and inform them of the issue.

- 3.39. The signaller, the train controllers and signal maintenance staff were unaware of the power supply issue until the outage occurred. The Commission found that it is **virtually certain** that this occurred due to:
- the inadequate alarm presentation
  - a lack of user training for the alarm system.
