Transport Accident  
Investigation  
Commission

***Maritime inquiry MO-2025-201***

***F/V Antarctic Discovery***

***Incapacitation of crew***

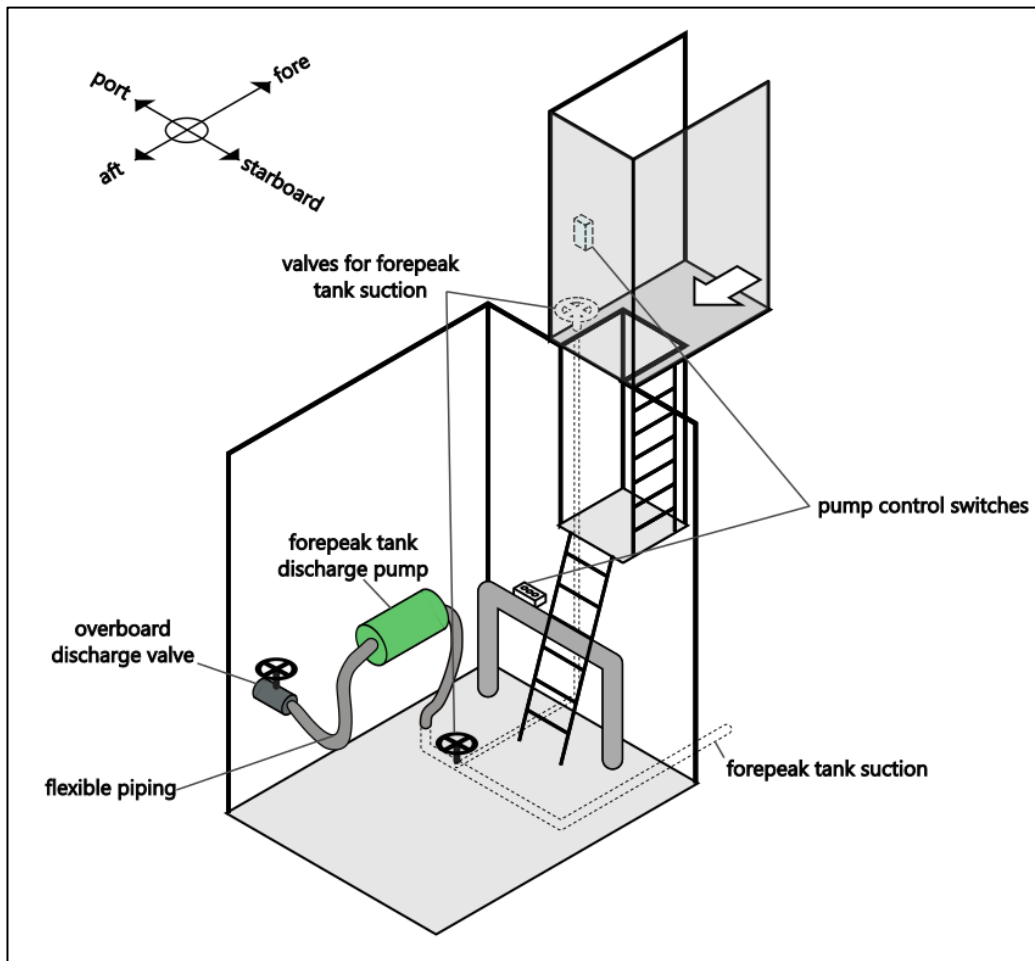
**Figure 6: Representation of forepeak offal system**

- 2.7 The suction side of this offal pump was connected to the existing forepeak tank suction valve. The discharge side of the pump was connected to an overboard non-return valve that penetrated the hull of the vessel below the waterline, through which the offal could be discharged directly to the sea. The offal pump's suction and discharge piping were made from flexible reinforced plastic.

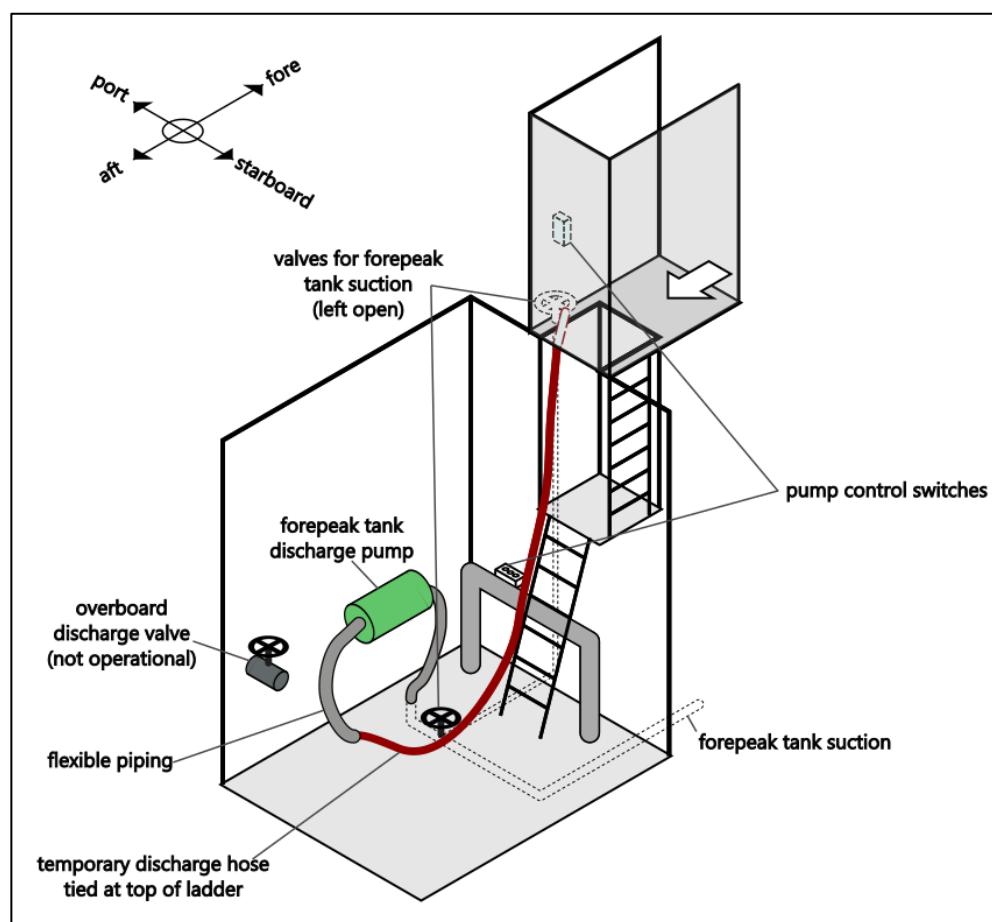
**Figure 7: Simplified diagram showing the modified arrangement in the bow thruster room**

- 2.10 As a temporary fix, the chief engineer disconnected the reinforced flexible hose from the seized overboard discharge valve and placed a cap on the valve to prevent seawater from inadvertently entering the bow thruster room. They then connected the discharge side of the offal pump to a flexible red hose, which was run up the bow thruster access trunking and secured at the top of the ladder (see Figure 7). Additional red hoses were connected to the hose at the top of the ladder and led through the forecastle and down the deck to the moonpool tank. In this way, the offal was pumped from the forepeak tank into the moonpool tank, from where it could be discharged into the sea.

- 2.11 After the offal had been pumped from the forepeak tank, the tank was rinsed several times and left empty. The additional red hoses used to reach the moonpool tank were disconnected, leaving one red hose connected to the discharge side of the offal pump with one end tied to the top of the ladder.

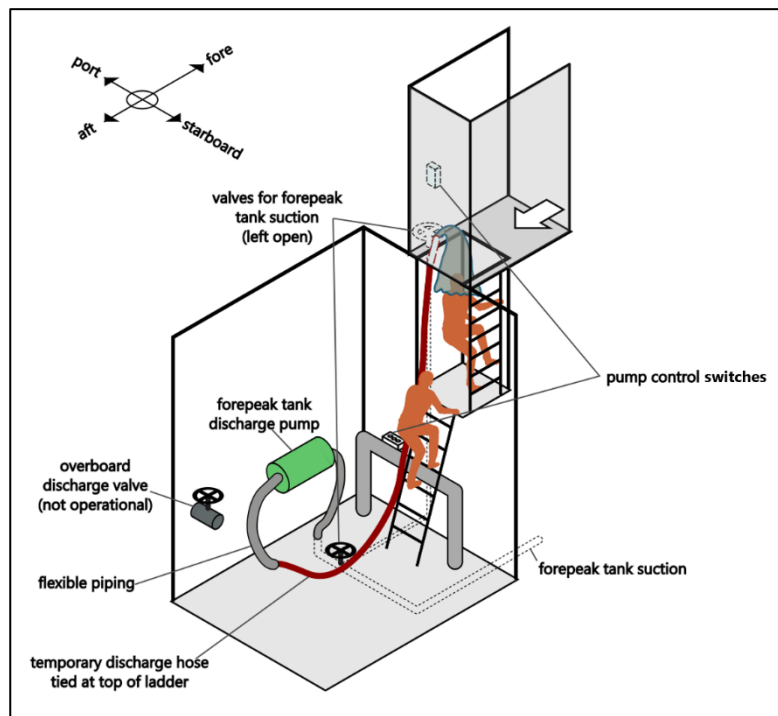
**Figure 9: Fitters escaping bow thruster room by climbing through flow of liquid**

- 2.17 At about 0930, the fitters noticed water raining down from the access ladder, which quickly increased to a significant flow and began to take on a foul odour. They decided to vacate the space and climbed the ladder against the flow of water to exit into the forecastle, then out onto the open deck (see Figure 9). Upon reaching the deck, they quickly made their way to the bridge to inform the vessel's second engineer of the problem.

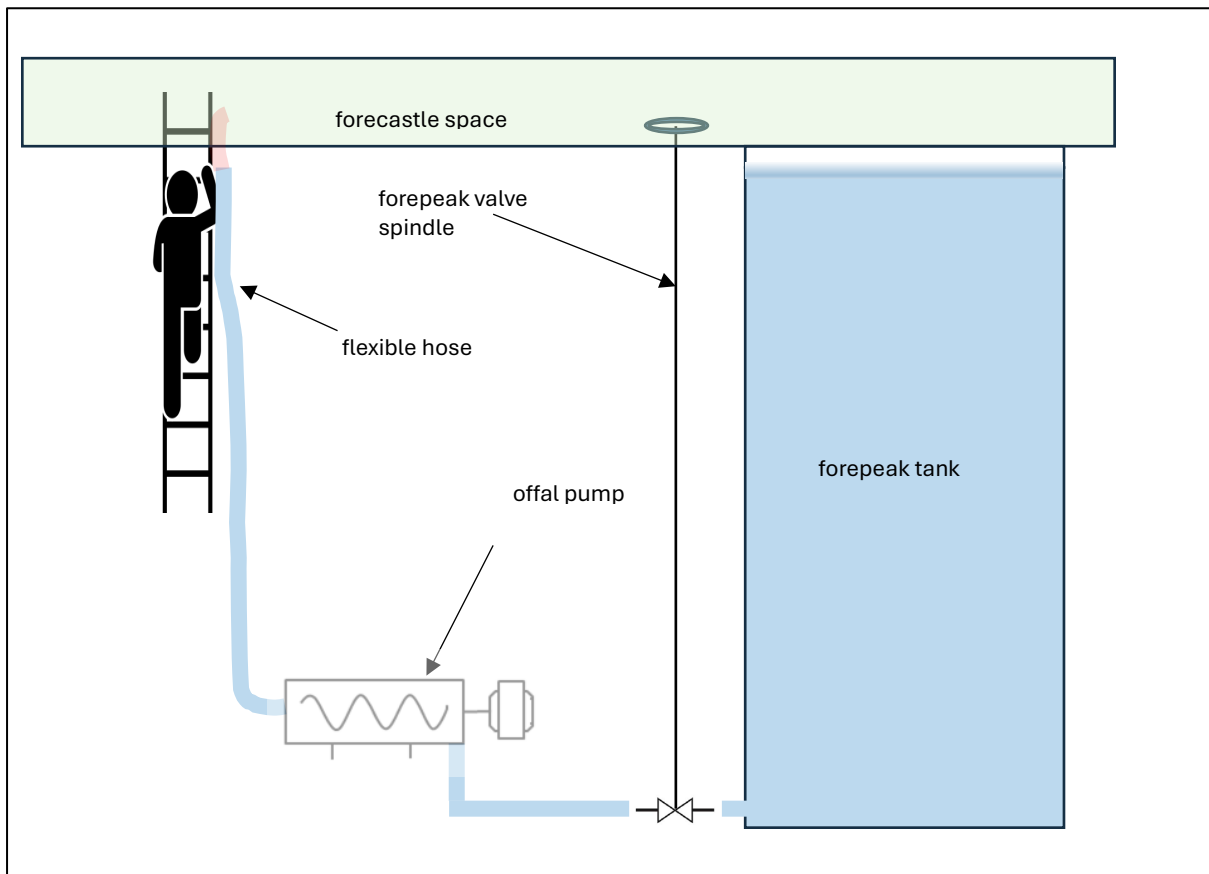
**Figure 12: Water levels in forepeak tank and hose in bow thruster room**

- 3.6 With the forepeak tank suction valve left open, had the red hose dislodged and fallen to the bottom of the bow thruster room, liquid from the forepeak tank would have flowed through the pump and into the bow thruster room at a rate dependent on the condition of the seals in the offal pump.

- 3.7 Further, starting the offal pump would cause liquid to flow from the open end of the flexible red hose into the bow thruster room. It is **virtually certain** that this is what happened on the *Antarctic Discovery*.

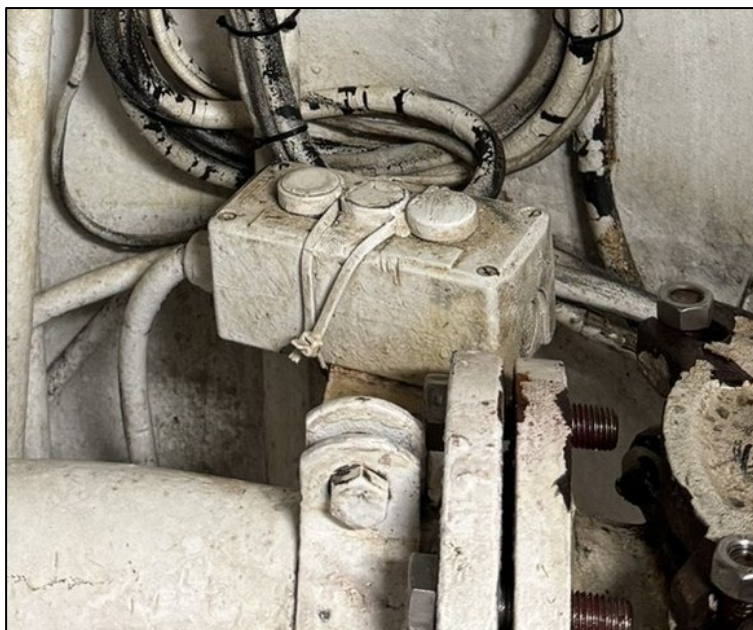
**Figure 13: Local pump control with buttons and light covered in paint**

- The fitters could have unintentionally pressed the start button on the local pump control. The Commission found this to be the most likely cause. They were working directly adjacent to the local pump control, and, when interviewed, one fitter stated it was possible they either leaned or placed a tool on the start button.

labels indicating the buttons' functions, and the indicator light showing that the pump was running, would not have been visible (see Figure 13).

- 3.10 The Commission found it was **about as likely as not** that the pumping of foul water was caused by one of the fitters unintentionally pressing the pump's start button.
