Transport Accident  
Investigation  
Commission

# **Final Interim report**

***Maritime inquiry MO-2026-201***  
***Passenger vessel, Black Cat***  
***Grounding***  
***Entrance to Akaroa Harbour, New Zealand***  
***31 January 2026***

**August 2026**

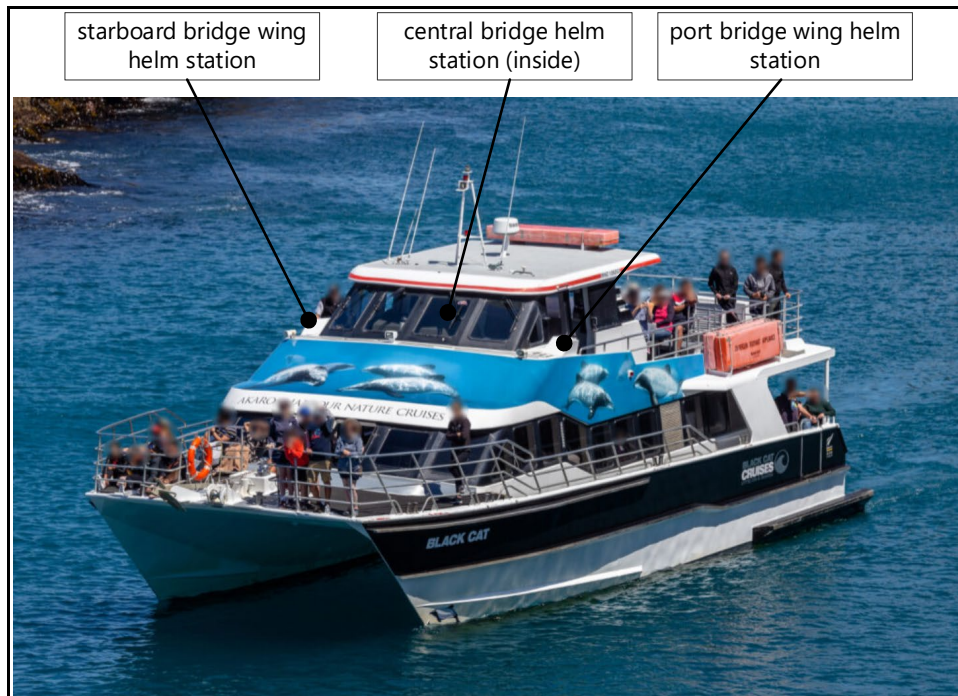
**Figure 3: Location of *Black Cat*'s helm stations**  
(Credit: Michal Klajban;<sup>2</sup> image edited to blur people's faces)

- 2.4. The master operated the *Black Cat* from the central bridge helm station (see Figure 3) and navigated south, following the eastern coast of Akaroa Harbour (see Figure 4). At about 1104, the *Black Cat* arrived at Spotted Shag Rookery and spent about 13 minutes there while the master delivered commentary for the passengers regarding the area and what could be seen.

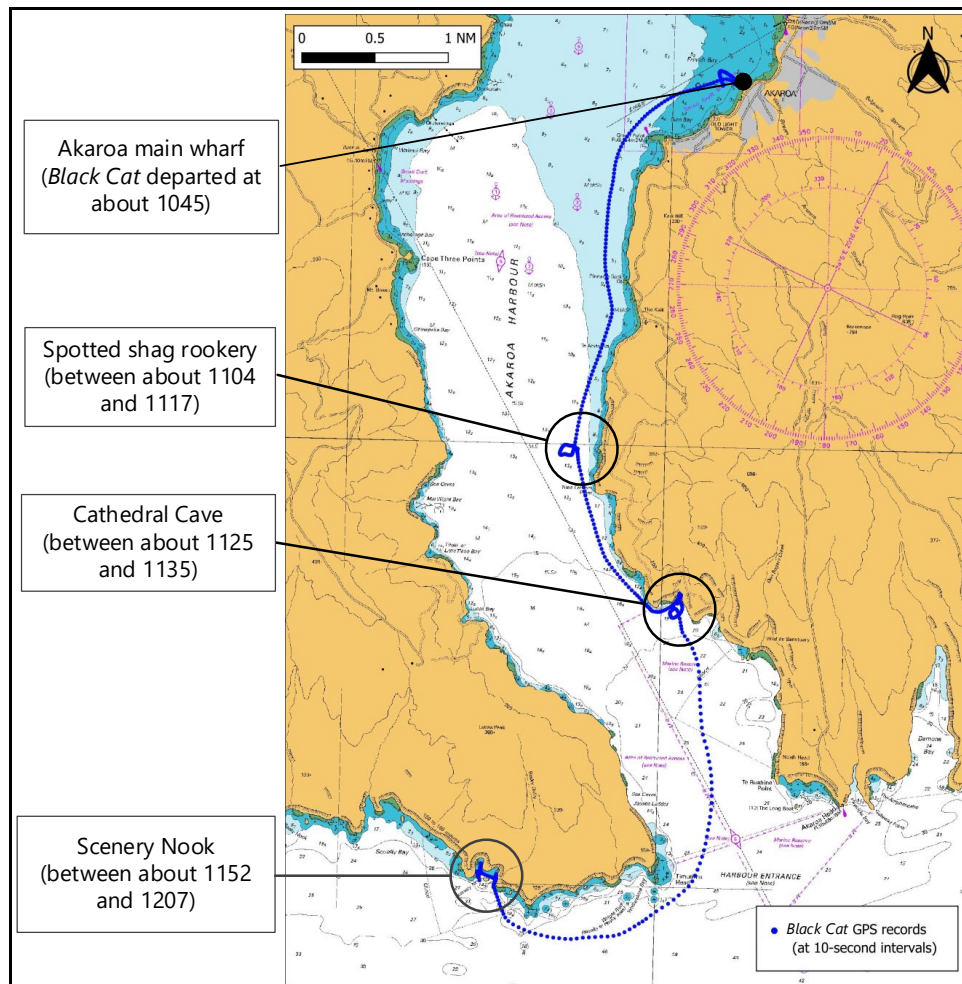
**Figure 4: *Black Cat*'s track from Akaroa main wharf to Scenery Nook**

- 2.6. The weather was calm and the master decided to navigate outside Akaroa Harbour and visit Scenery Nook, on the south coast (see Figure 4). The *Black Cat* exited the Akaroa Harbour heads and arrived near the entrance to Scenery Nook at about 1152.

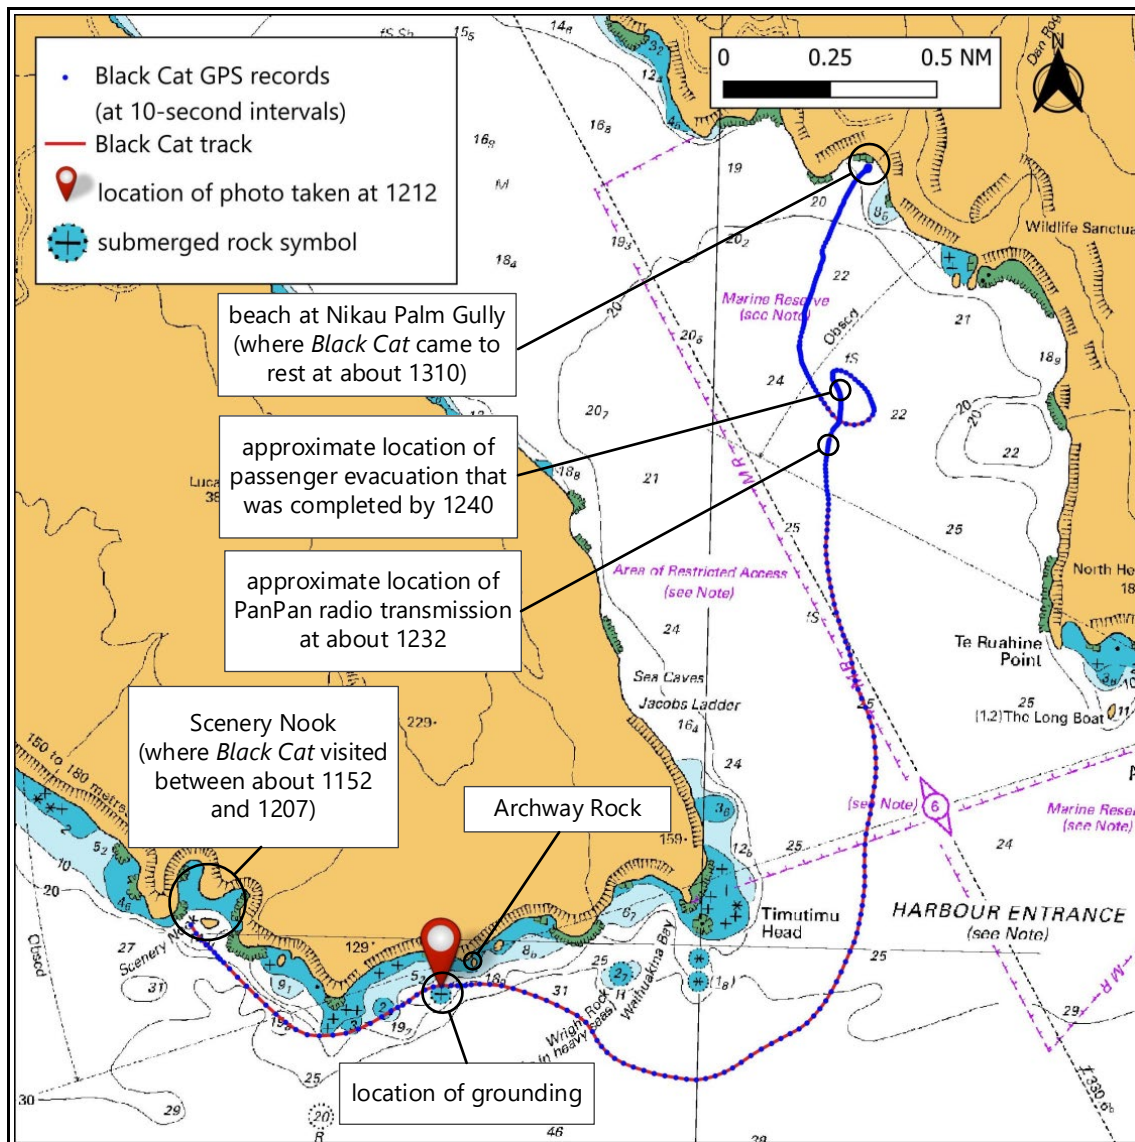
**Figure 5: Black Cat's track from Scenery Nook to the beach at Nikau Palm Gully**

- 2.10. At about 1212, C2 used their mobile phone to take photos<sup>3</sup> of Archway Rock. A few seconds later a bump was felt and there was a scraping sound. C2 immediately went to the bridge to join the master and C1 to discuss the event. The geo-location data<sup>4</sup> aligned with a submerged rock of an unknown depth on the chart<sup>5</sup> (see Figure 5).

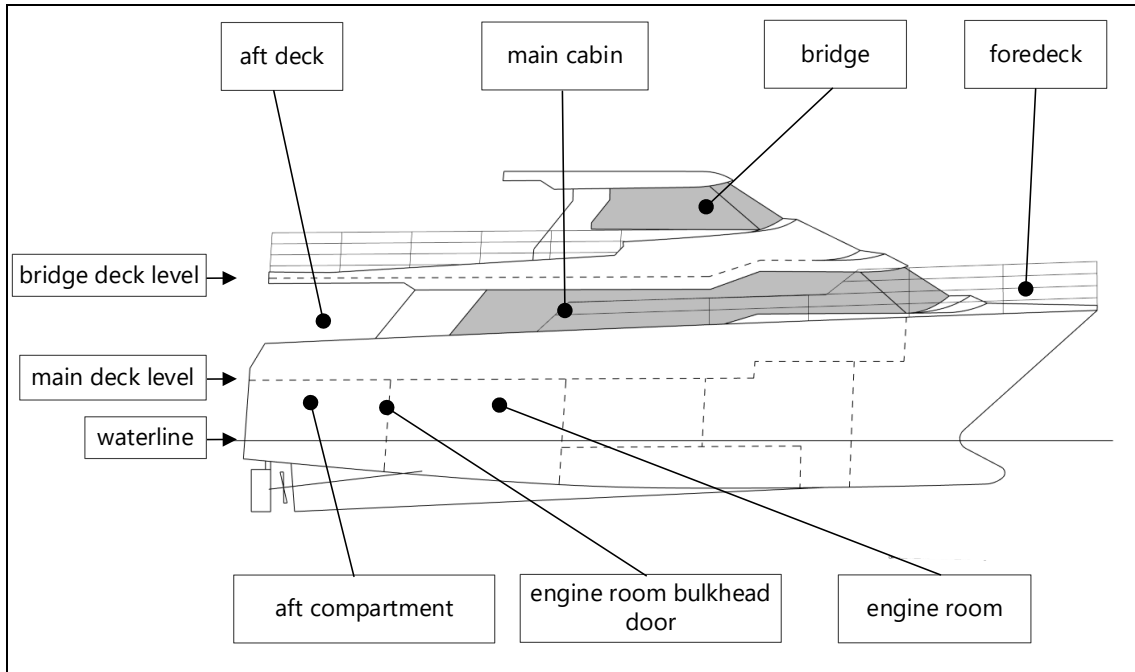
**Figure 6: Profile of the *Black Cat***

- 2.9. At about this time, C1 and C2 were talking in *Black Cat's* main cabin (see Figure 6). While looking out the window, C1 noticed that the vessel was approaching Archway Rock from an unusual direction. They told C2 they were going to the bridge to discuss their concern with the master. Meanwhile, C2 went to the vessel's foredeck to meet with passengers and take photos of the view.

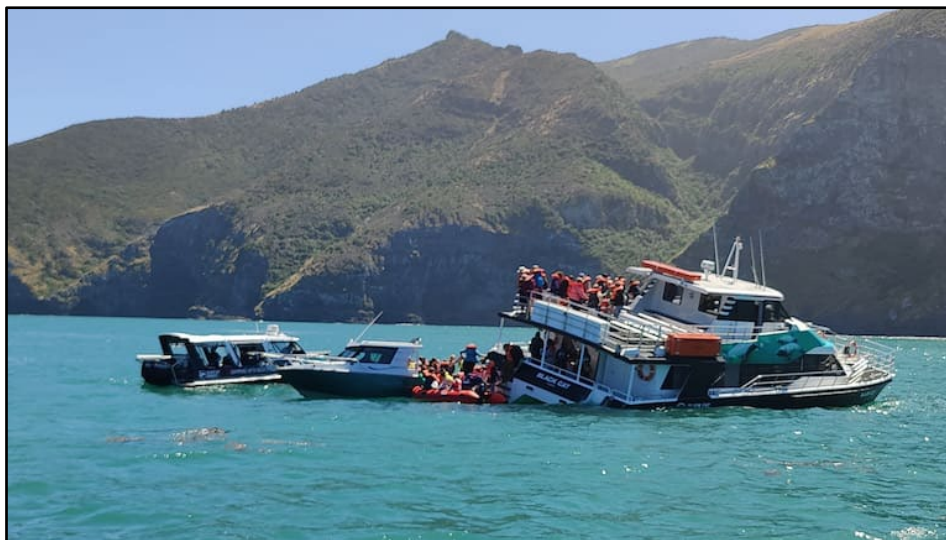
**Figure 8: Evacuation of passengers from the *Black Cat***

- 2.21. The master instructed the crew to move the passengers down onto the main deck in preparation to evacuate the vessel. The evacuation began shortly after (see Figure 8).

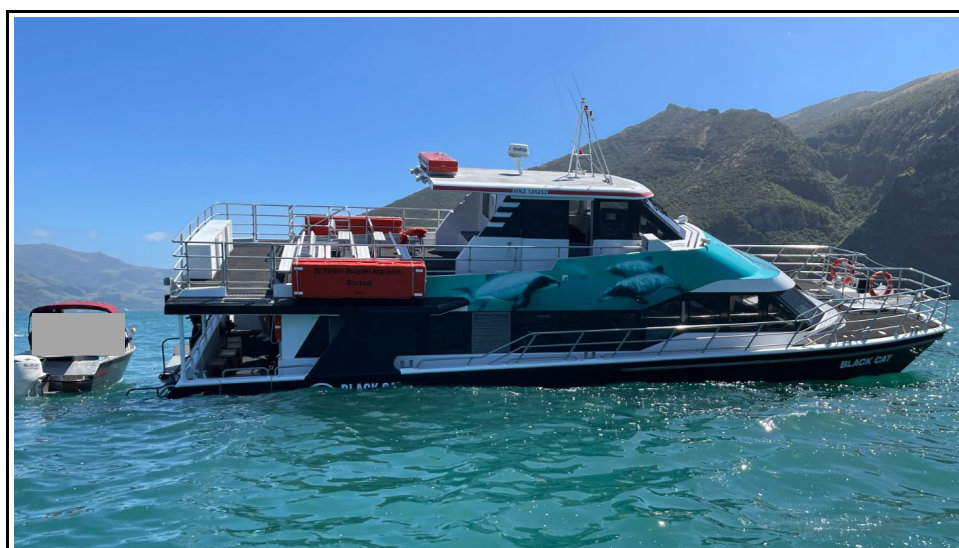
**Figure 9: The *Black Cat* shortly after the passengers were evacuated**

- 2.25. The Coastguard crew noticed that the *Black Cat* was settling lower in the water (see Figure 9). The *Ihenga Rescue* carried a portable petrol-powered water pump, which the Coastguard master decided to use onboard the *Black Cat* to help clear water from the vessel.
