Transport Accident  
Investigation  
Commission

# **Final report**

***Rail inquiry RO-2025-105***  
***Freight train MP8***  
***Collision with hi-rail vehicle***  
***72.28 km East Coast Main Trunk line***  
***Near Kaimai Tunnel***  
***06 April 2025***

**August 2026**

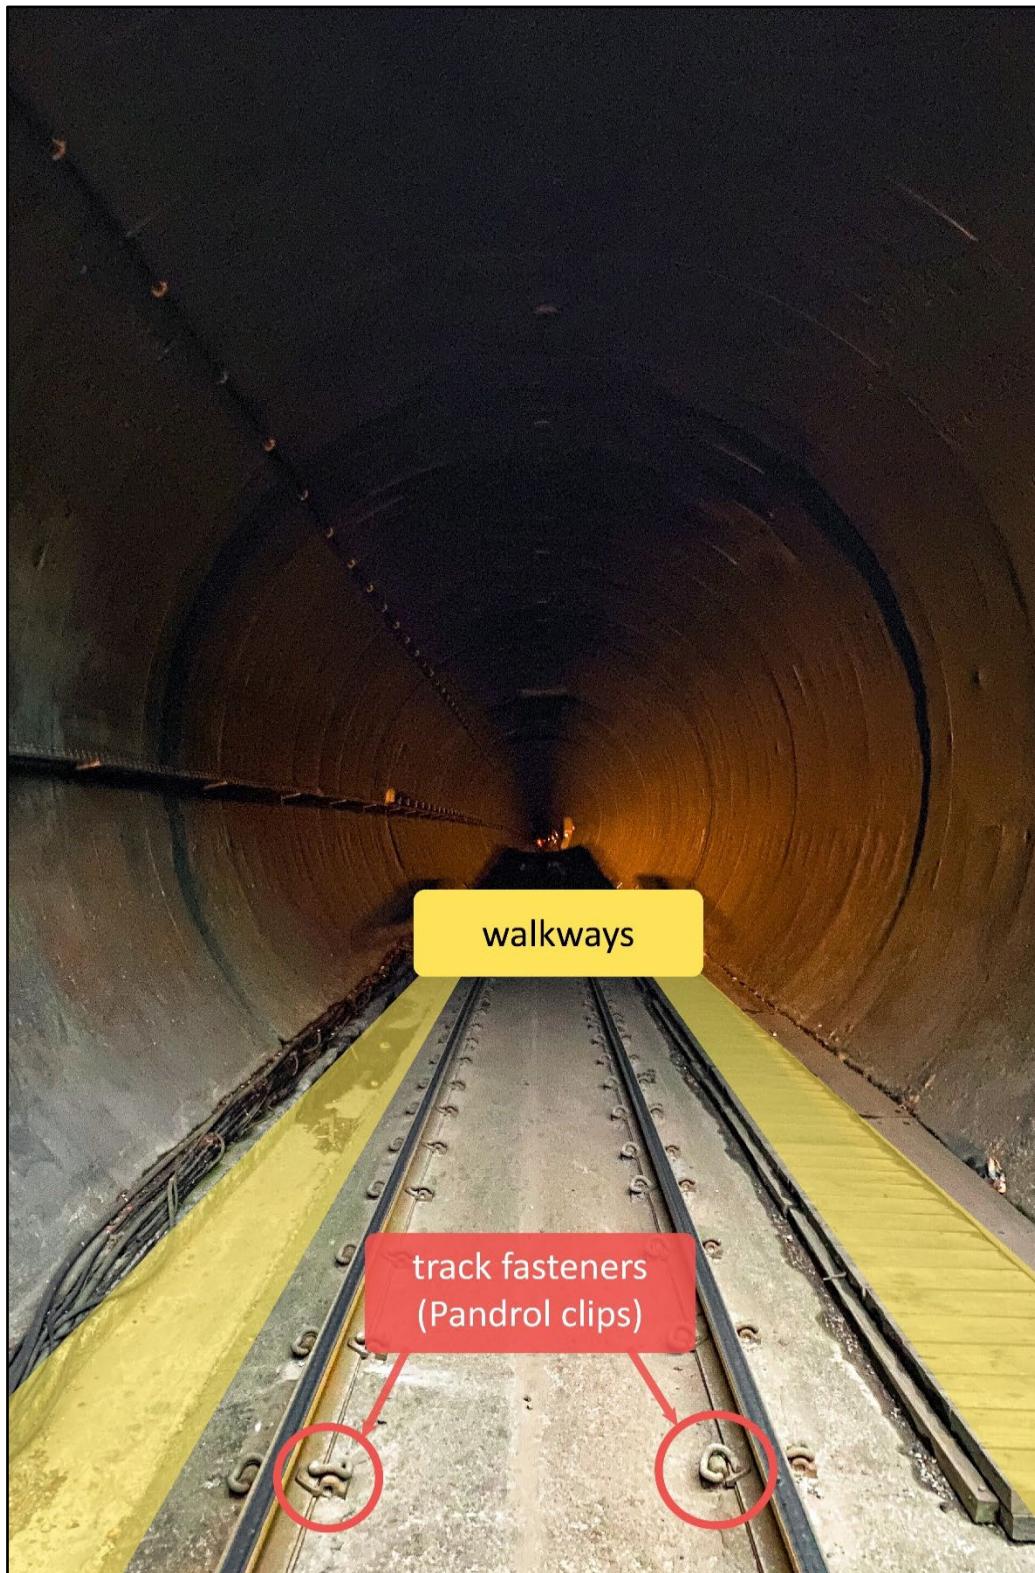
**Figure 4: View into tunnel from eastern portal**

- 2.3. The tunnel is concrete, lined with walkways on either side of the track (see Figure 4). There are 28 refuges<sup>9</sup> on the northern side of the tunnel wall, spaced at intervals of roughly 400 m, and 21 trolley refuges on the southern side.
- 2.4. Phones to contact train control were placed in 11 of the 21 trolley refuges but these are no longer operational. The phones have been replaced by continuous radio coverage on both very high frequency (VHF) and ultra high frequency (UHF) within the tunnel.

- 2.10. Track fastening renewal work required the use of power tools to remove and replace 'Pandrol' clips<sup>14</sup> (see Figure 4). WG1 used lighting from the two HRVs for illumination while the track workers were on the ground inside the tunnel.
- 2.11. Work group two (WG2) was initially working clear of the track at Whatakao and did not require electronic protection.

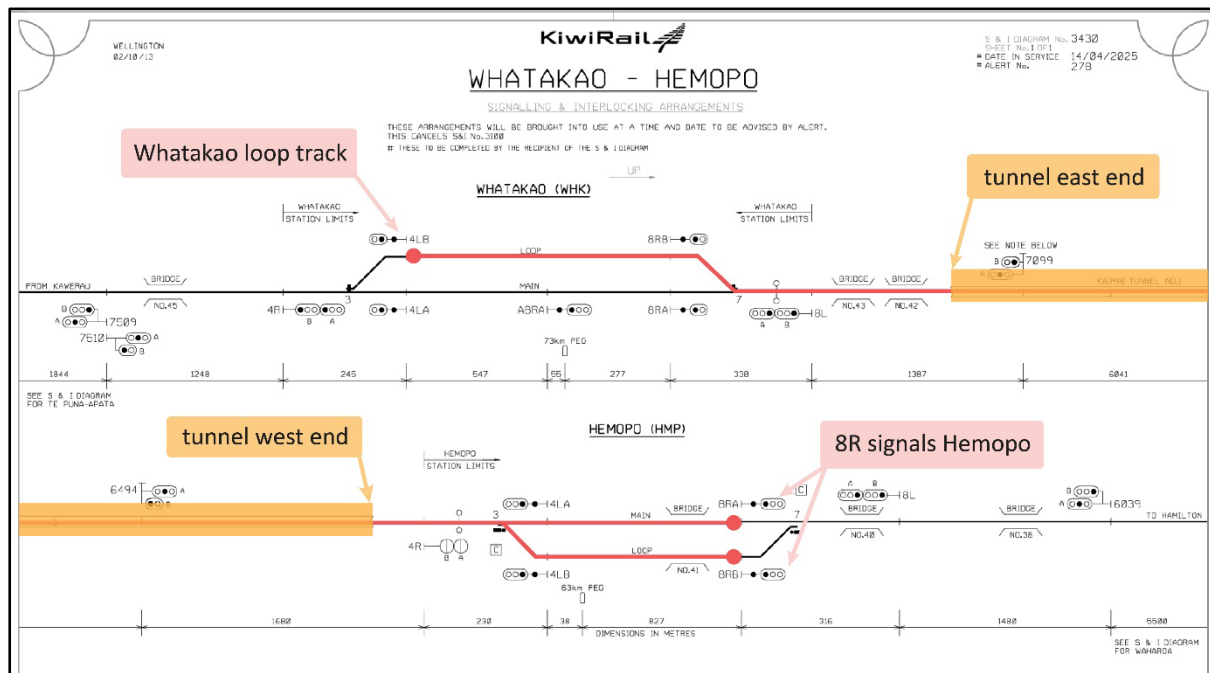
**Figure 7: Red line shows limits of WG1 work area**

vehicles<sup>13</sup> (HRVs) at Whatakao loop, and travel into the tunnel to carry out the required work (see Figure 7).

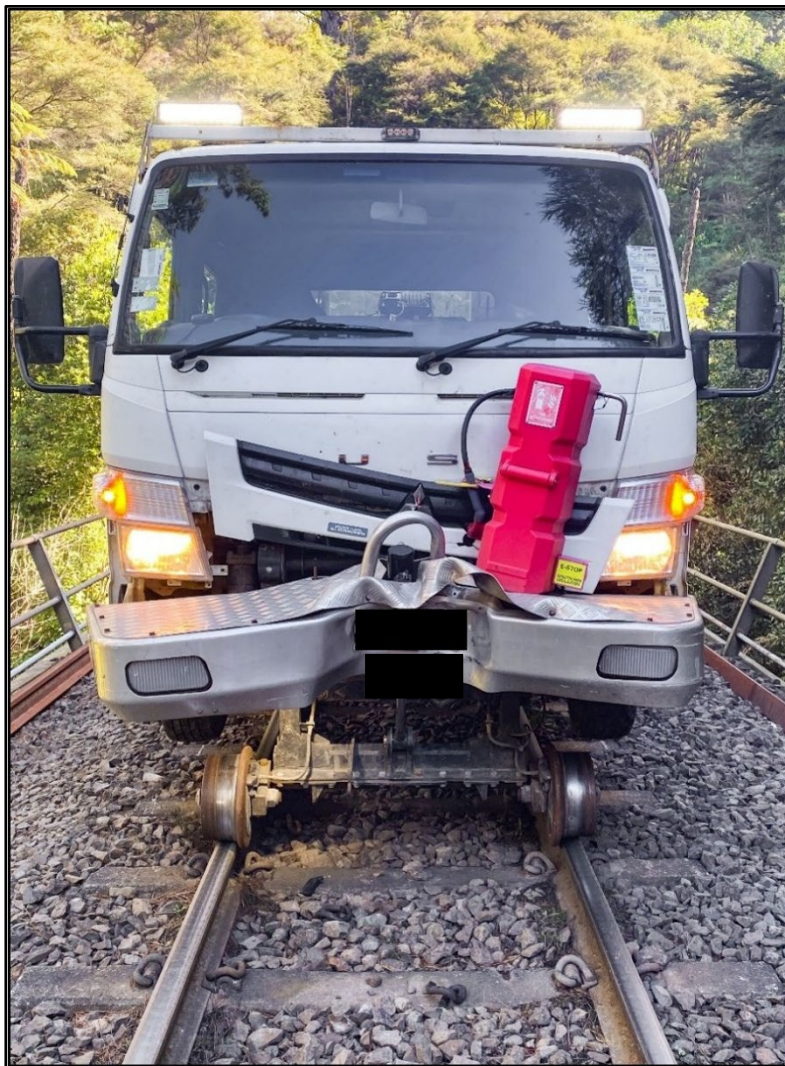
**Figure 8: HRV involved in the collision**  
(Credit: KiwiRail)

- 2.17. The HRV involved in the collision was a 2014 Mitsubishi Fuso truck fitted with retractable rail wheels. It was being used by WG1. It received substantial damage to its front extended bumper and to the front rail wheel configuration (see Figure 8). The HRV was certified to be operated in a tunnel environment. There was no indication or evidence to suggest that any mechanical fault contributed to the accident.

***Damage*** substantial damage to one Mitsubishi Fuso HRV

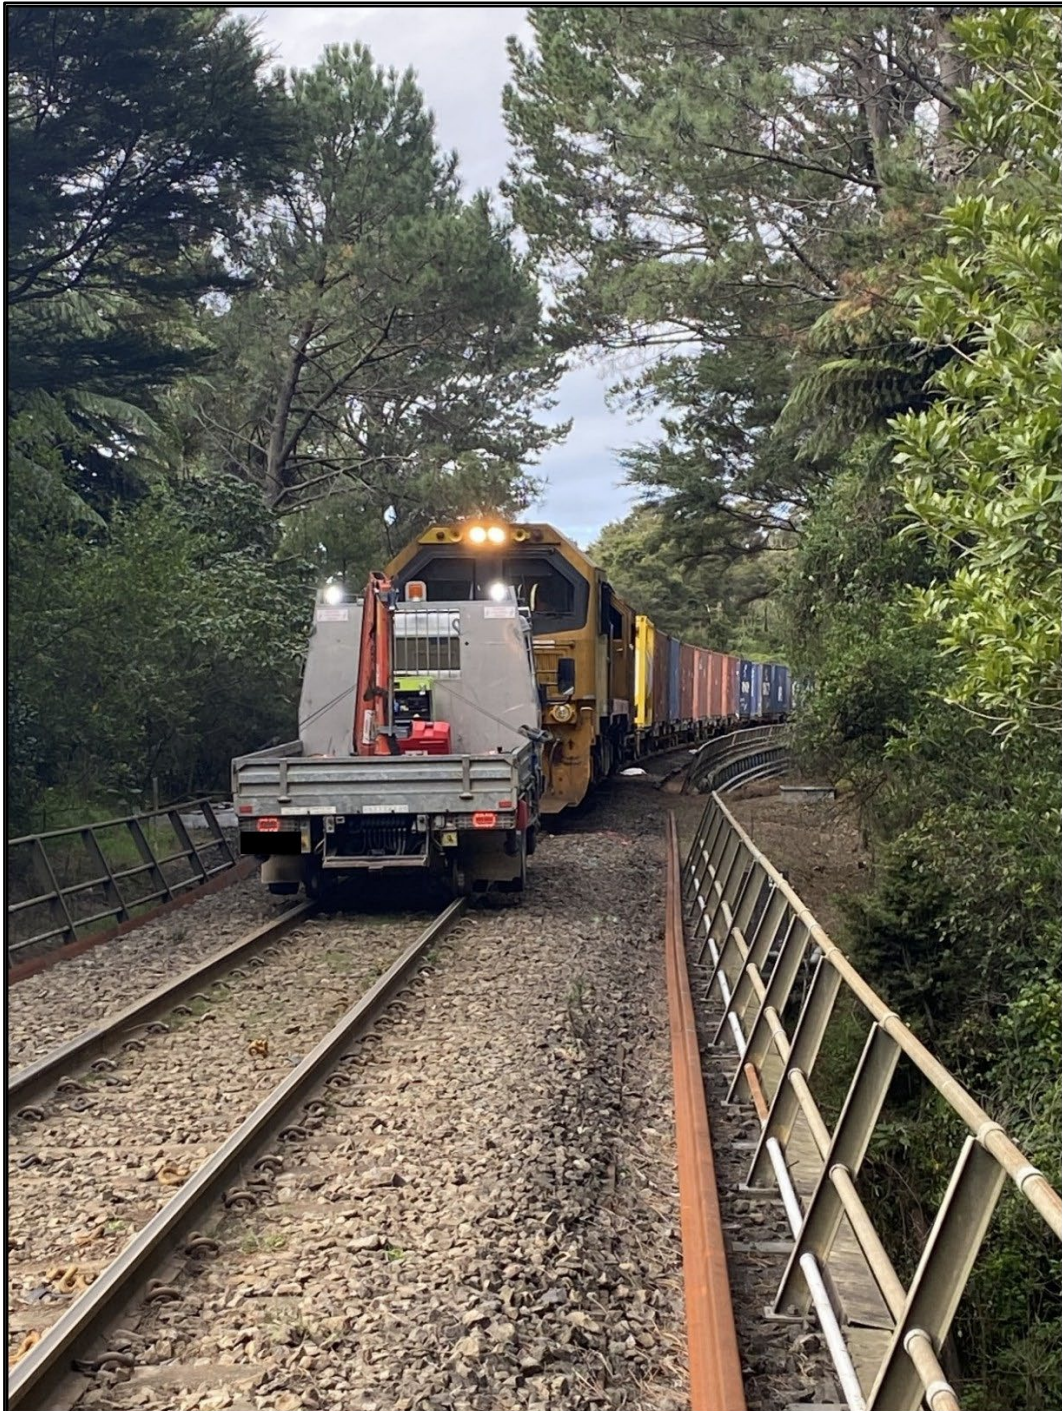
**Figure 9: Train MP8 at collision location after the accident**

- 2.18. Train MP8 (the train) was powered by a single DL-class locomotive (DL 9360). It weighed 1554 tonnes (t) and was 716 m long. The train was made up of 18 heavily loaded vehicles at the front (most around 70 t each) with another 22 empty wagons behind (see Figure 9). The train was running about 70 minutes ahead of its scheduled trip from Tauranga to Hamilton.

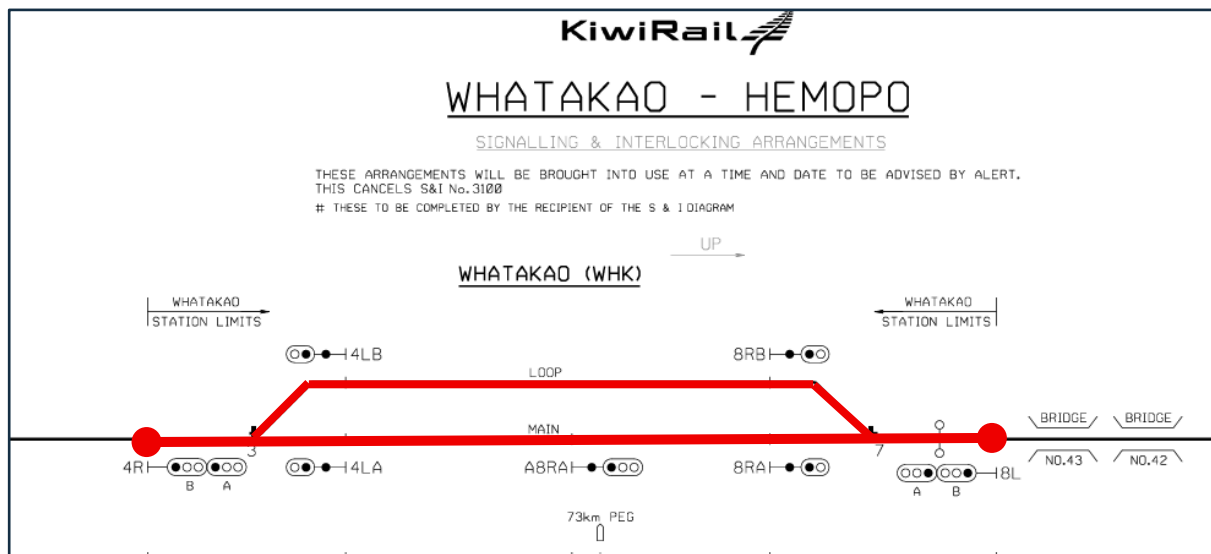
**Figure 10: WG2 protected work area at Whatakao**

- 2.39. While Train MP1 was clearing the Whatakao area, RPO2 contacted train control by radio to establish protection for WG2. At 1040, train control authorised RPO2 to work between the 4R and 8L signals at Whatakao, with blocking established for WG2 at

those locations (see Figure 10). RPO2 was given a clearance time of 1330, which was when the next train was expected.

- 2.40. RPO1 stated in interview they recalled a mobile phone discussion with RPO2 confirming that blocking was organised until 1330.
- 2.41. This led to a misunderstanding between the two RPOs about who was included in the safety-critical protection arrangements. As a result, WG1 entered the tunnel and conducted work without any form of protection for the next two hours.

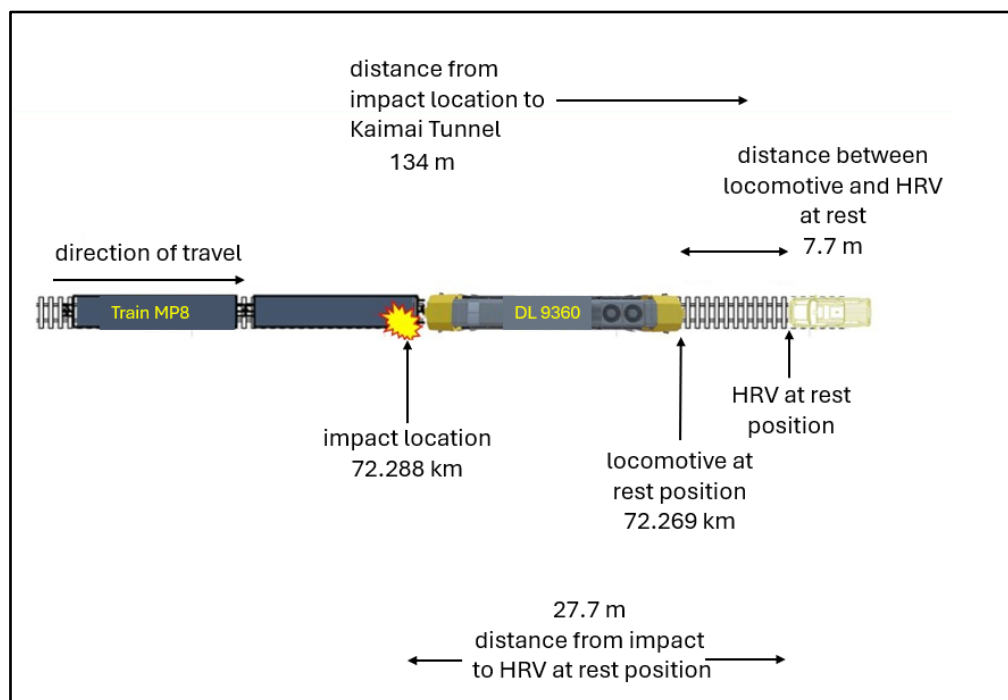
**Figure 11: Diagram of collision sequence**

- 2.52. At 1242:29 the train was travelling at 19.3 km/h when it struck the lead HRV at the 72.288 km mark. The collision pushed the HRV back 27.7 m along the track towards the tunnel (see Figure 11). The HRV that RPO1 was operating was not impacted.
