# **Final report**

***Aviation inquiry AO-2023-007***

***DHC-8-311, ZK-NEM***

***Descent below minimum safe altitude, Timaru***

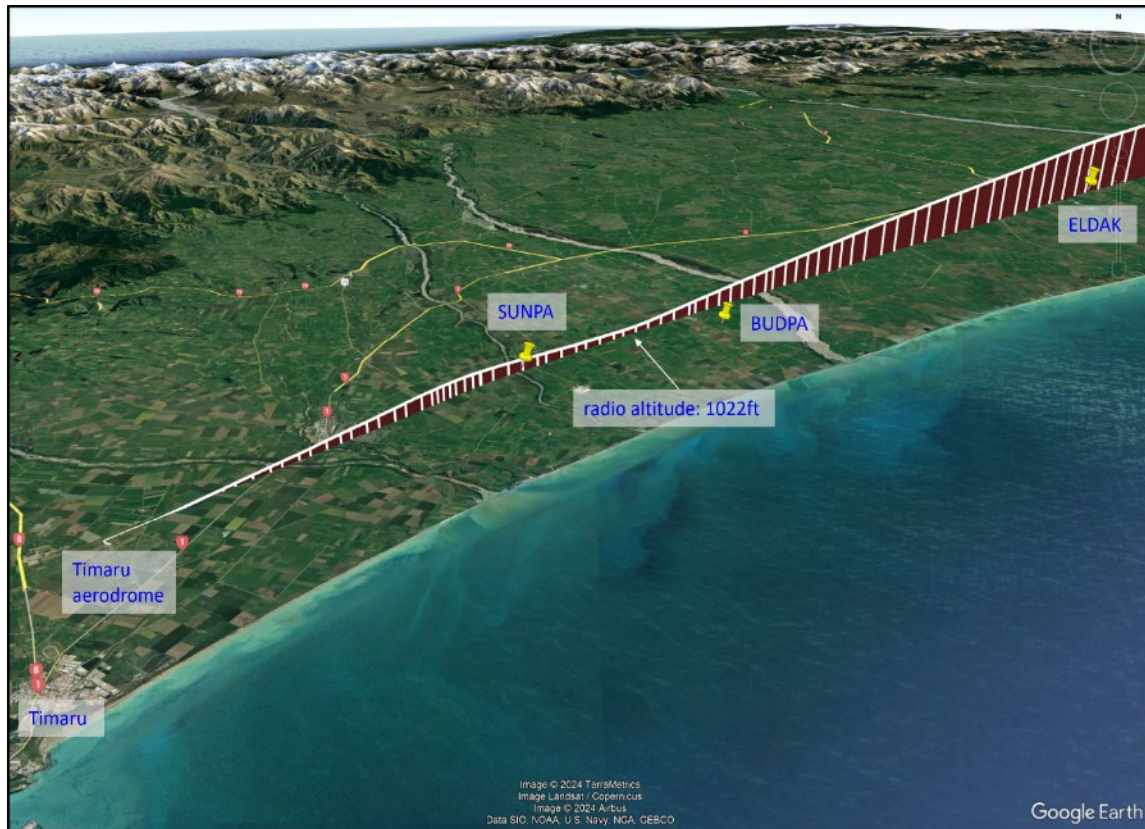
**Figure 3: Map of NZ8199's flight path into Timaru**

- 2.13. Upon realising that they were below the approach profile (at this point close to 2500 ft below), the captain levelled the aeroplane. Information from the flight data recorder (FDR) shows that the autopilot was disconnected at 1908:14 and approximately two seconds later engine torque increased. The aeroplane continued to descend to a lowest recorded altitude of 1156 ft (1022 ft above ground level) and then began a gentle climb. As the aeroplane was climbing, the captain sighted the PAPI and elected to continue the approach.
- 2.14. During the climb to re-establish the correct descent profile, the aeroplane crossed SUNPA at an altitude of 1668 ft (see Figure 4). The captain continued the climb to 2000 ft, where the correct profile was regained, and proceeded to land without incident, touching down at 1913.

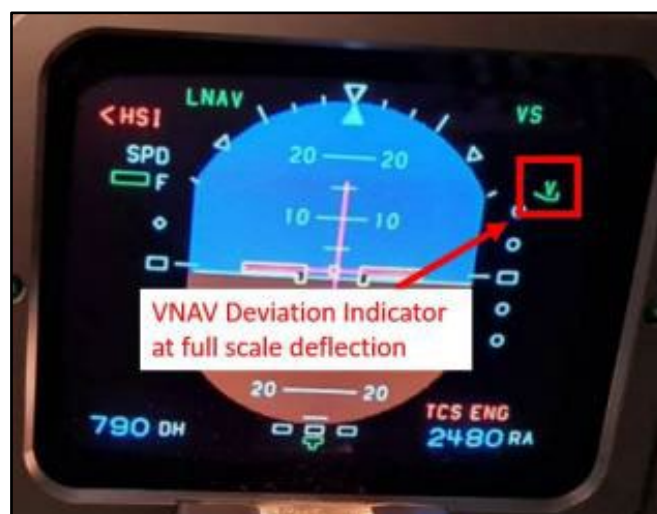
**Figure 8: FMS is in V/S mode and vertical deviation annunciator is at full deflection**

- 2.41. When the aeroplane is significantly below profile, the vertical deviation annunciator will remain displayed at the maximum scale deflection. However, the box around the 'V' symbol is only a half depiction (see Figure 8).

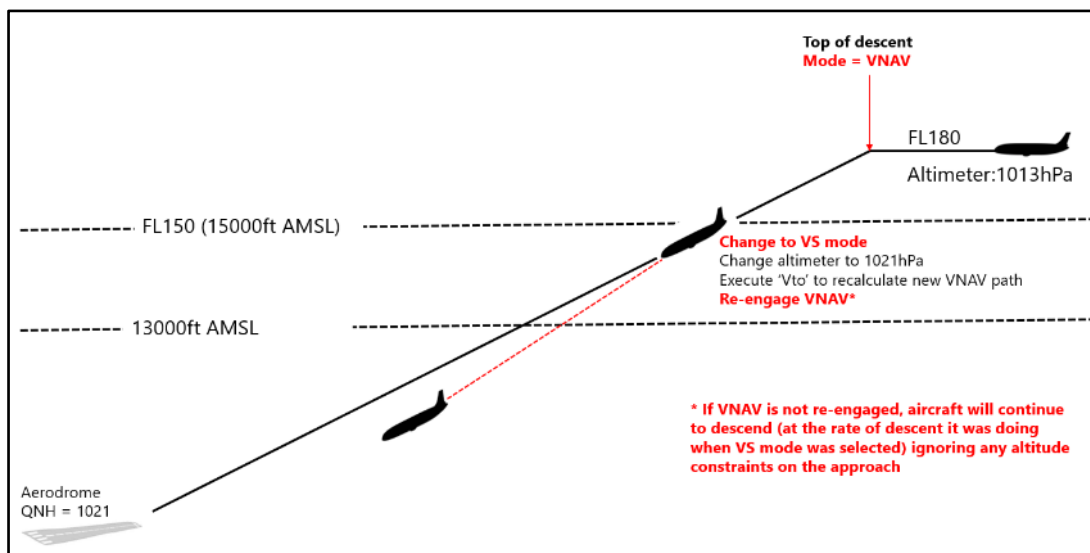
**Figure 12: Mode changes through transition**

- 2.46. To avoid this occurring during descent, Q300 flight crew would temporarily engage V/S mode while the altimeter subscales were changed through transition. This allowed the aeroplane to remain at its current rate of descent without reacting to the change in altimeter setting. Once the local QNH was set, the crew could then execute a 'VERTICAL TO' (Vto) function on the FMS. This action would recalculate the VNAV descent profile from the aircraft's current position/altitude. VNAV could then be re-engaged without any pitch up or down (see Figure 12).

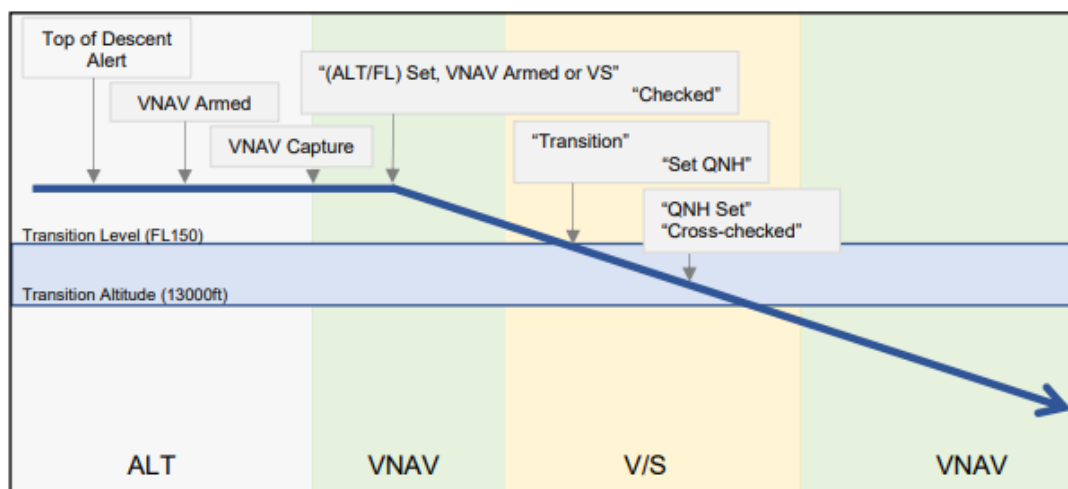
**Figure 15: Automation mode changes and transition calls**

- 3.56. To avoid abrupt pitching movements during large QNH changes at transition, the practice of changing from VNAV to V/S while the crew reset the altimeters was used on the Q300 fleet. The SOP prescribed for transition required flight crews to verbalise that the QNH had been set and cross-checked. However, aside from the overarching 'Verbalise, Verify and Monitor' philosophy for flight mode changes, which was not followed here, there was no specific requirement within the transition SOP to ensure that the aeroplane was back in the correct descent mode. This was highlighted in the operator's internal safety investigation report following the serious incident in Rotorua in 2022 (see Figure 15).

- 3.57. The operator's safety investigation report for the Rotorua incident in 2022 drew attention to the fact that flight crew having to remember to reselect VNAV was reliant on prospective memory (Air New Zealand, 2022). The report pointed out that prospective memory is the least reliable part of human memory and noted that a 2006 study attributed 20 per cent of airline accidents to failures of prospective memory (Dismukes, 2006). The report noted parallels to an Australian Transport Safety Bureau (ATSB) investigation into an A320 that descended below altitude constraints (Australian Transport Safety Bureau, 2014).
