Transport Accident  
Investigation  
Commission

# **Final report**

***Aviation inquiry AO-2024-006***  
***ATR72-600, ZK-MVL***  
***Engine fire and evacuation***  
***Wellington***  
***1 September 2024***

**September 2026**

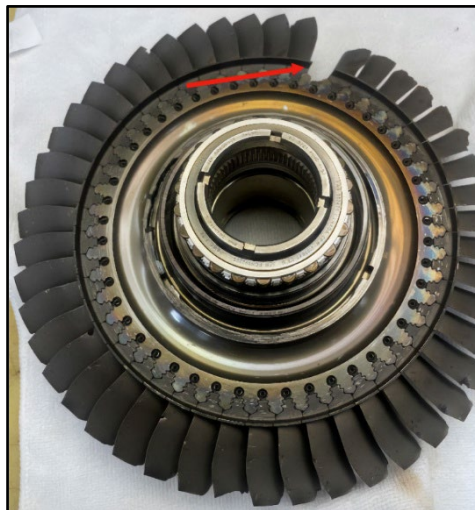
**Figure 9: Low-pressure turbine disc showing location of failed blade**  
(Credit: P&WC)

- 2.39. When the power turbine assembly was removed, an LPT blade fragment was visible behind the first-stage power turbine assembly. Removal of the low-pressure disc revealed that an LPT blade had fractured and separated near the root. The blade was identified as serial number HWTE3998. Initial assessment of the fracture surfaces suggested the blade had failed because of fatigue. There was also damage on the upstream face of the LPT disc (see Figures 9 and 10). The LPT disc is fitted with 47 LPT blades. An examination of a sample of the remaining 46 blades by 'fluorescent penetrant inspection'<sup>23</sup> identified no similar evidence of fatigue cracking.

*Safety issue 1: A low-pressure turbine blade failed because of fatigue. The engine manufacturer's quality assurance procedures during the recent engine overhaul did not identify the issue, increasing the risk of other similarly faulty turbine blades re-entering service.*

- 3.20. The presence of fatigue in the two LPT blades should have been identified as part of the engine overhaul procedure. This safety issue needs to be addressed to ensure there are no repeat failures. Therefore, a recommendation has been made to P&WC, and given notice to the Canadian regulator, to ensure their quality assurance procedure for engine overhaul is capable of identifying any fatigued LPT blades to ensure they do not enter service.

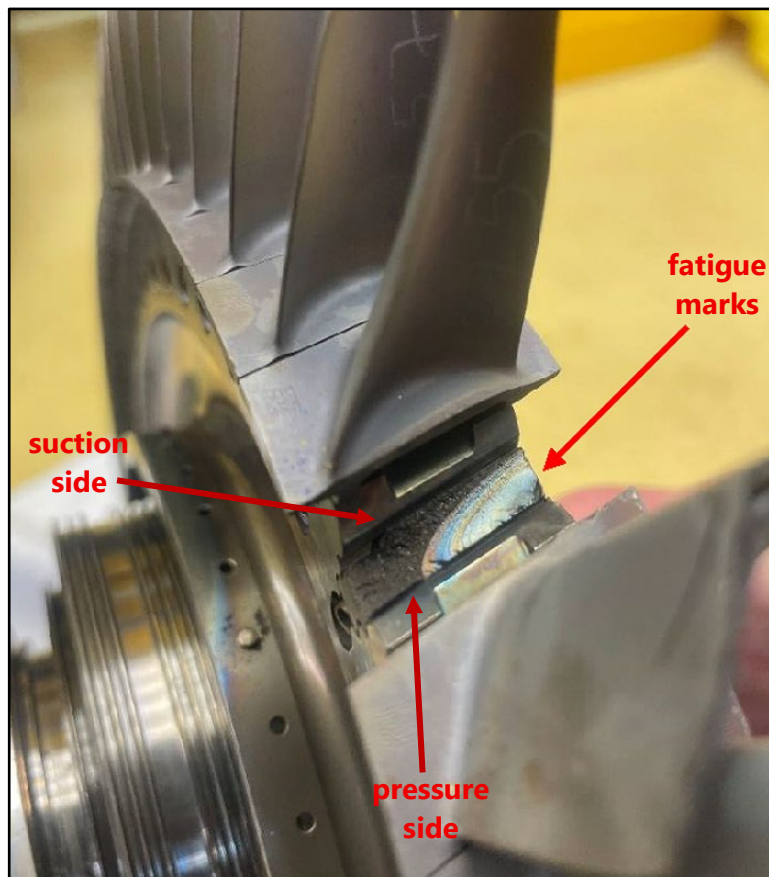
**Figure 10: Lower portion of the failed LPT blade**

The reported engine distress [fire] was caused by the liberation of a low pressure turbine blade. The unbalance caused by the blade liberation have induced an unbalance causing deterioration of some air seals who likely contributed to the reported smoke in cabin. [sic]

1. The liberated LP[T] blade failed as a result of fatigue cracking developed in the blade root.
2. The fatigue crack has likely been present since the blade entered service and was likely present at the time of the engine overhaul.
3. The damage to the upstream edge of the blade root occurred after the fatigue crack had propagated and the blade had failed in overstress.
4. Wear marks on the suction side of the blade platform hinder the ability to read part numbers of in-service blades.
5. The wear mark on the failed blade was not associated with fatigue crack initiation and propagation.
6. The serial numbers of two blades were reversed. It could not be determined if they were reversed during overhaul or during the P&WC investigation.<sup>24</sup>

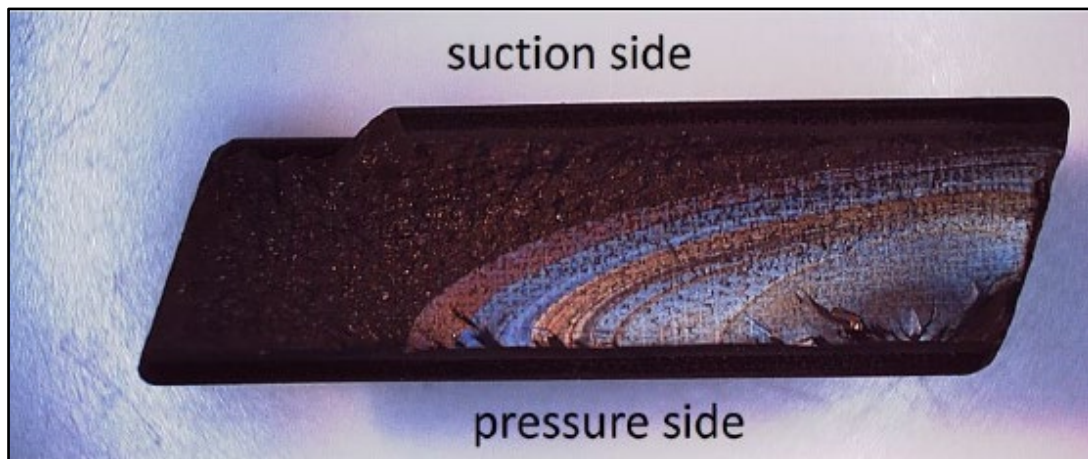
**Figure 11: Macroscopic image**

The macroscope acquired image [of the failed LPT blade] shows a fracture surface indicative of fatigue with a well-defined fatigue origin and at least five distinct progression zones. Usually, such zones reflect changes in service conditions; for example, the marks left between zones may respond to prolonged downtime, engine start-ups or engine overhauls/inspections. In this case, it is not known what caused each of the progression zones on the fracture surface [see Figure 11].

The origin location [of the fatigue crack] had a faceted appearance typical of stage 1 [initial] fatigue. No surface defects were noted that could have initiated the fatigue crack.

The progression zones were also visible under SEM examination. The progression zones closest to and adjacent the origin have a notably different topography as compared to progression zones closest to the crack front.

Features typical of overstress are visible beyond the fatigue areas of the fracture surface.

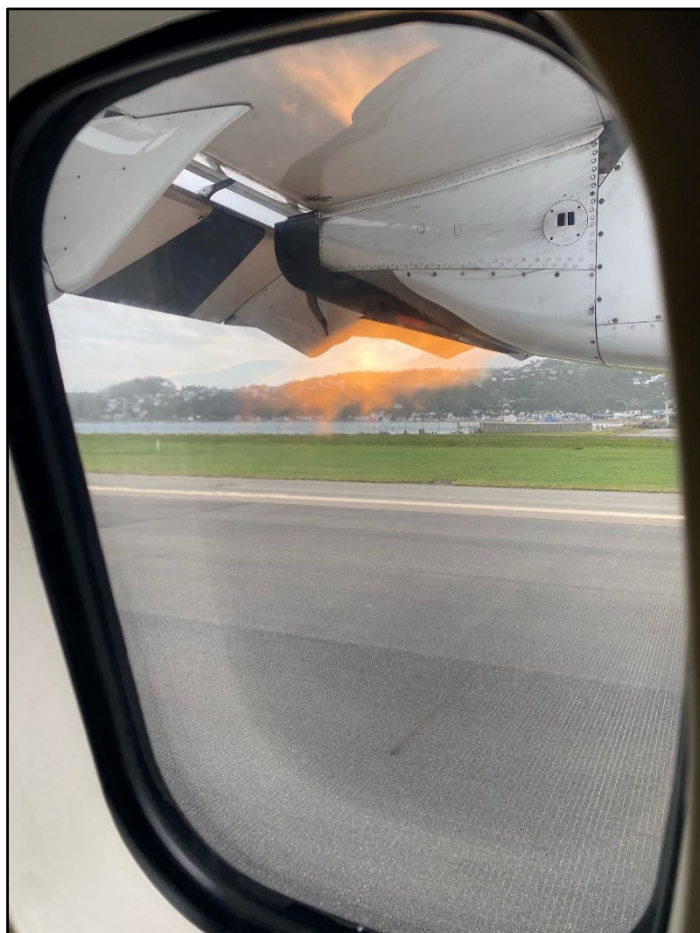
**Figure 12: Flame coming from engine exhaust**  
(Credit: Lauren Crawford Flett)

- 3.4. The engine fire warning was initiated by a failure of an LPT blade, which resulted in a vibration in the engine that caused deterioration to some air seals, allowing oil to leak directly into the engine. The resulting low oil pressure in the left engine caused the caution light to illuminate. The combustion of the oil that had seeped onto the engine produced a large volume of smoke, and the temperature within the engine nacelle increased to the point that the fire detection warning was activated.

- 3.5. The burning oil also resulted in flames and a large volume of smoke coming from the engine exhaust. This is what the tower controller saw when issuing the 'conditional line-up clearance' to an aeroplane preparing for take-off. Several passengers seated on the left side of the ATR also saw the flames and smoke coming from the engine (see Figure 12) and alerted the flight attendants. Smoke or haze was observed in the cabin at the same time. This slowly dissipated.

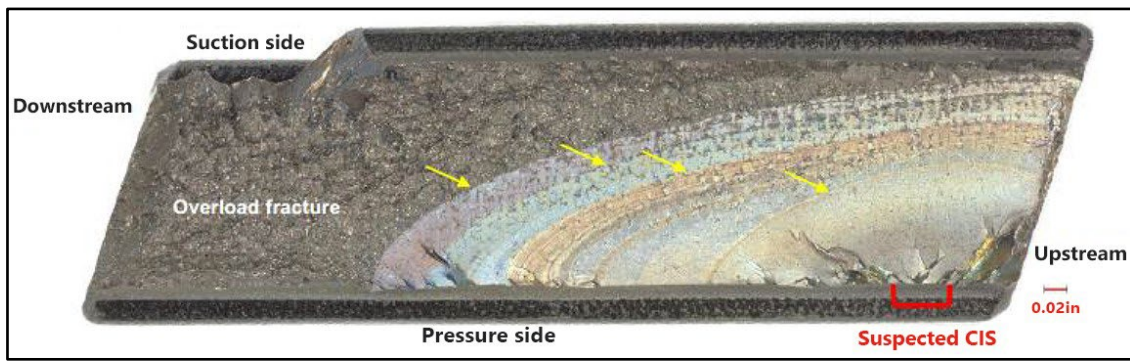
**Figure 13: Failed LPT blade**

- 3.10. Examination of the remaining 46 LPT blades from the same low-pressure disc by P&WC identified one further blade with a crack at around the same height, but on the opposite side to the failed blade (see Figures 13 and 14). This blade was located six positions away from the failed blade. When forced open, the crack revealed a similar metallurgic feature to the failed LPT blade.

- 3.12. P&WC determined that the fatigue was initially high cycle<sup>27</sup> but the fatigue crack spread rapidly to the point of failure over a low number of engine cycles. P&WC considered there to be eight such bands<sup>28</sup> within the area of fatigue. P&WC concluded that the degree of oxidation on the surface of the cracks and the absence of evidence of the fluorescent penetrant used during the recent overhaul inferred that the cracking occurred in the four flying hours and five cycles.<sup>29</sup> Further, the two non-adjacent blades – the failed blade and the second cracked blade – had been 'exposed to a similar unidentified cyclic loading stress', the exact cause of which could not be determined.

- the amount and different types of fatigue (high and low cycle)
  - the origin of the fatigue
  - the absence of any surface defects
  - a lack of evidence of any design, maintenance or operating abnormalities.

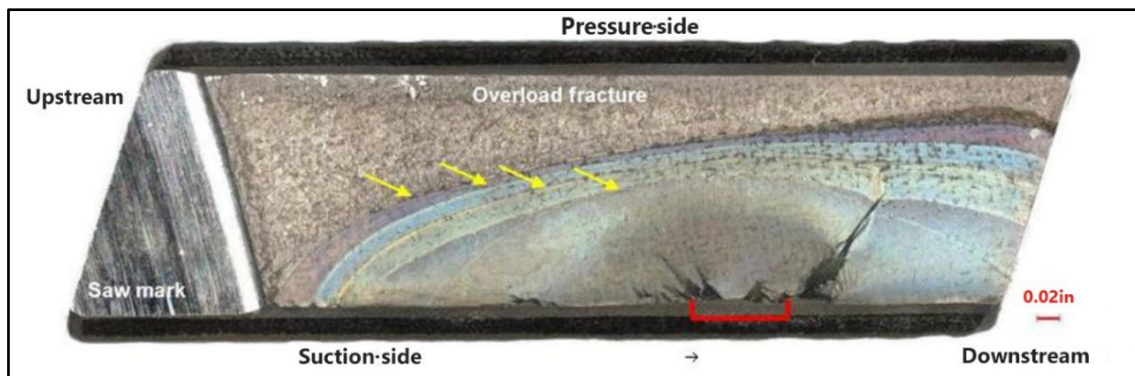
**Figure 14: Second LPT blade**

- 2.47. The second LPT blade, identified as serial number HWTE7693, was located six positions away from the liberated or failed LPT blade, serial number HWTE3998. Upon re-examination of the remaining 45 LPT blades, P&WC found no evidence of crack initiation.

- 3.18. The Commission also found that a second LPT blade on the engine had evidence of fatigue similar in nature to the failed blade. That fatigue was on the opposite face of the blade to the failed blade. These two blades had significantly different serial numbers, indicating they were not manufactured in the same batch.

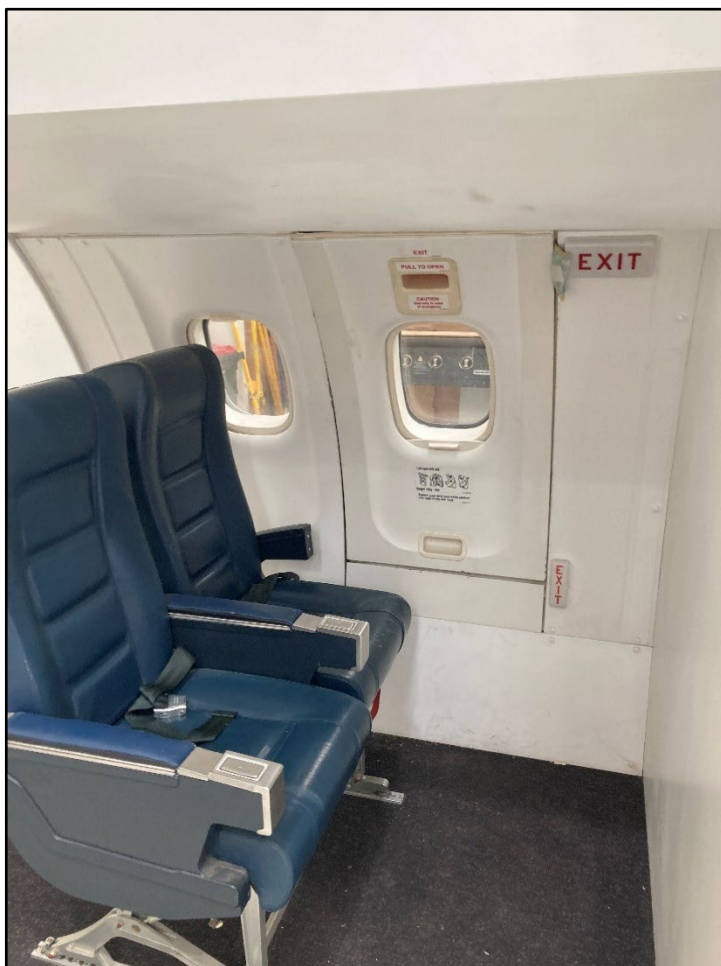
**Figure 15: Type III exit installed in cabin trainer**

- 3.48. The passenger seated near the forward-right emergency exit stated that they found the exit hatch heavier than expected, and its removal and disposal was not a simple task. Other passengers said they were surprised by the small size of the exits, the difficulty in using them, including having to step up onto the bottom lip of the door and then jump nearly 1.83 m (6 ft) to the ground.<sup>37</sup> One passenger thought that there would be a slide available.

- 3.52. Civil Aviation Rules (CARs) require the opening of the emergency exits to be simple and obvious and not require exceptional effort. The operation of the hatch is required to be displayed on or next to the hatch, which it was. The information was also presented on the passenger briefing cards.
- 3.53. The videos of the evacuation show several passengers hesitating at the forward exits and requiring time to either pass or throw out their carry-on baggage and position themselves for the jump down. The passengers interviewed said the size of the exits, access challenges and the height above the ground all combined to slow the rate of egress through the two forward exits. While several passengers who had evacuated stayed next to the exits to assist, the queue inside soon slowed. This delay gave other passengers time and opportunity to access their carry-on baggage.

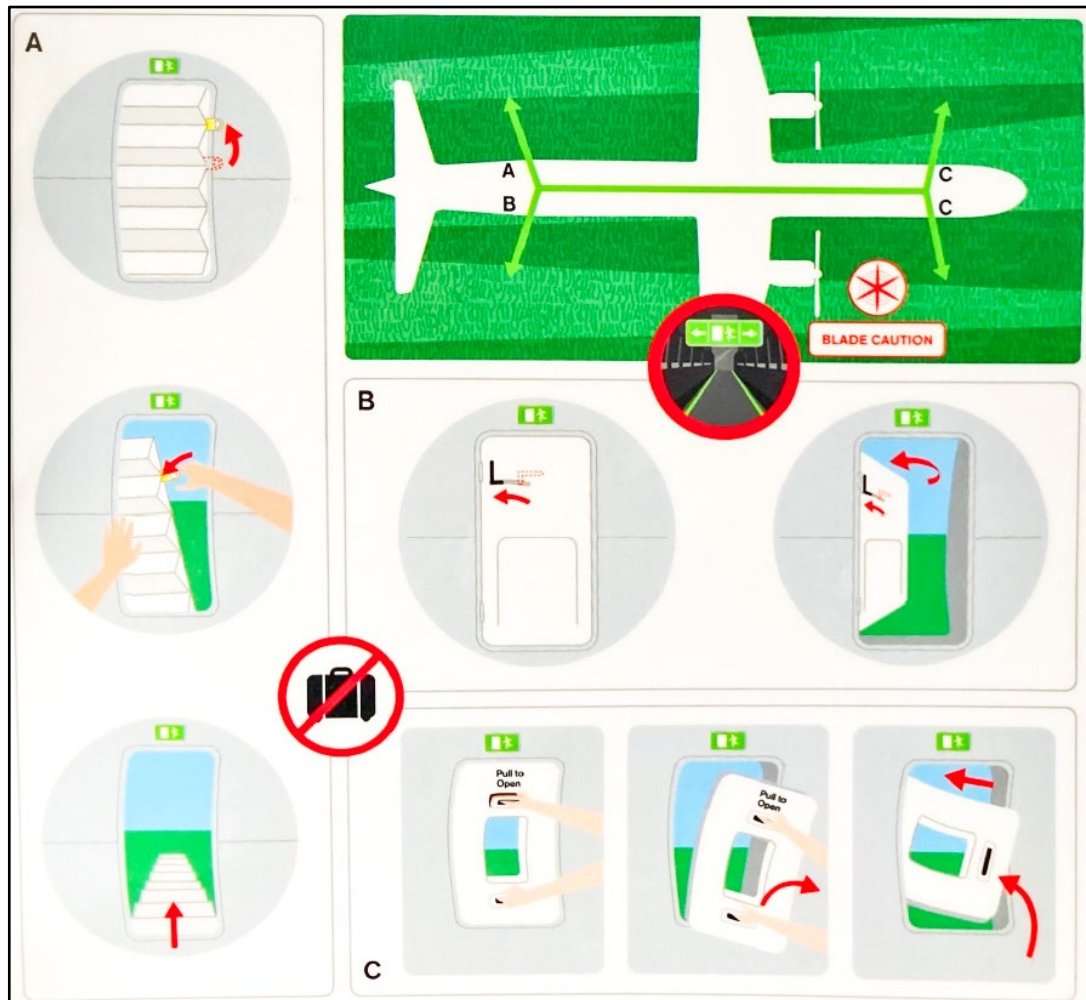
**Figure 16: Passenger safety briefing card**

- 3.74. Since the incident, the operator has amended the passenger safety briefing card for its ATR72 aeroplanes by adding a caution regarding the engine and propeller blades.

The diagram now clearly describes the direction in which passengers should leave the aeroplane. It also includes a symbol to remind passengers not to take baggage (see Figure 16).

- 3.75. A recommendation was made to the operator in Section 6 that they review the lessons identified in this final report to ensure pre-departure safety briefings given to passengers are effective in ensuring passengers are as fully prepared as possible to deal with an emergency.
