Transport Accident  
Investigation  
Commission

# **Final report**

***Rail inquiry R0-2025-106***  
***Train DT80***  
***Near miss with track workers***  
***Plimmerton***  
***8 May 2025***

**September 2026**

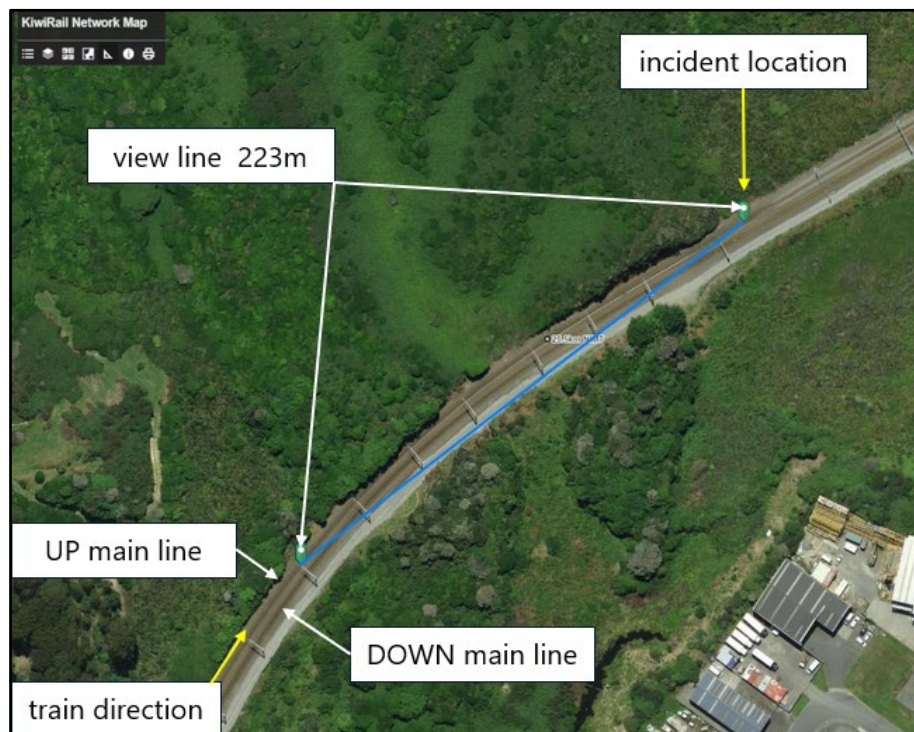
**Figure 3: Incident location and view line distance**

- 2.1. The incident occurred on the NIMT, north of Plimmerton, Wellington, at the 25.65 kilometre (km) location. The track layout consisted of two tracks: the UP main for rail traffic travelling towards Auckland and the DOWN main for rail traffic travelling towards Wellington.
- 2.2. The track leading into the incident area featured a slight upward gradient and a right-hand curve rated for a maximum speed of 70 kilometres per hour (km/h). Visibility along this curve was restricted; line of sight was limited to approximately 223 metres (m) from the approach to the incident location on the UP main line (see Figure 3).

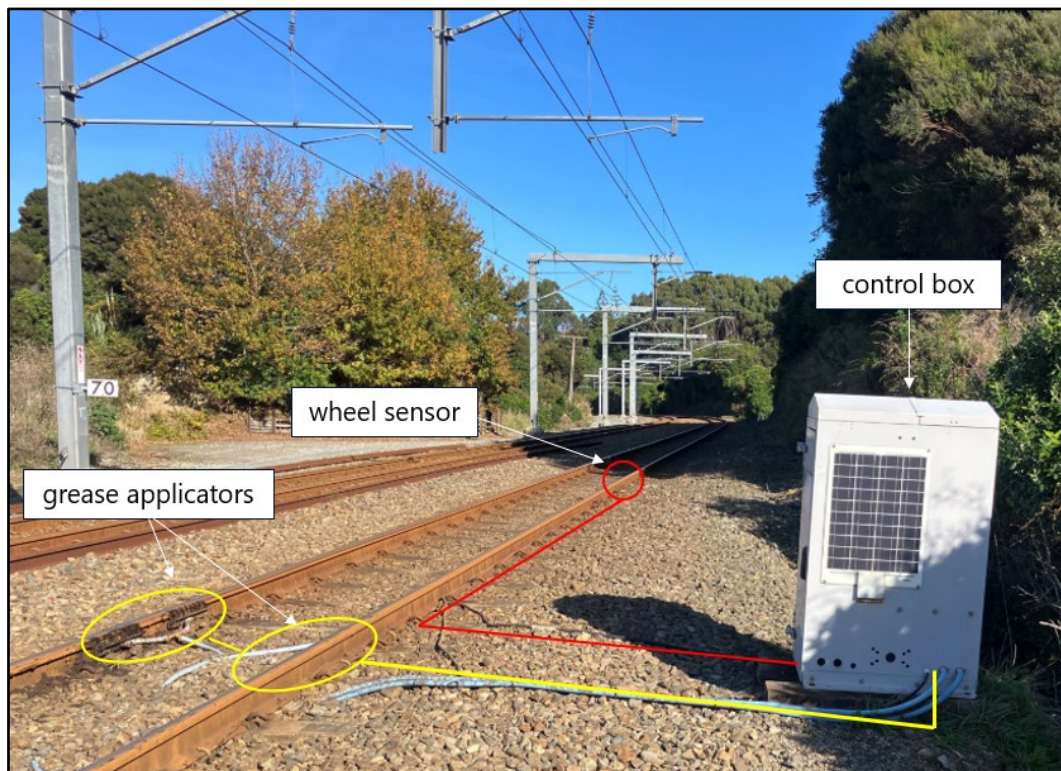
**Figure 4: Worksite and equipment**

- 2.3. The worksite included an automatic grease-dispenser control box, a track grease applicator and a train wheel sensor. The wheel sensor was positioned 8 m south of the track grease applicator (see Figure 4).
- 2.4. The automatic grease-dispenser system was fitted in October 2014 by Industrial Lubricants and Services Limited (ILS).

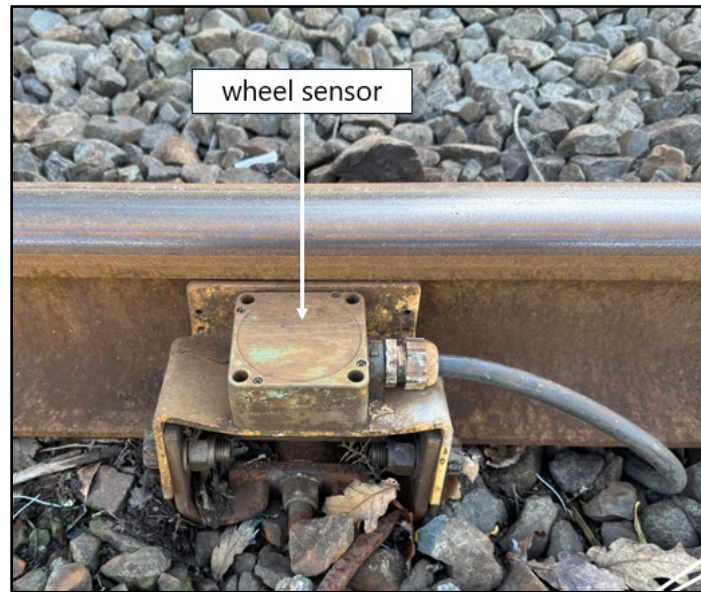
**Figure 8: Trackside wheel sensor**

- 2.23. SC2 installed the missing components and saw that when the last train passed over the track grease dispenser it had failed to activate. They spoke to SC1 about the fault and continued with additional checks of the solar panel on the side of the control box.
- 2.24. SC1 walked south, away from the control box, alongside the UP main line outer track. They were inspecting for damage to the wire that ran from the control box to the wheel sensor (the sensor), approximately 8 m away.
- 2.25. On arriving at the sensor, they determined that the supporting bracket had dropped downwards. This meant the sensor was not functioning correctly when train wheels passed over it (see Figure 8).

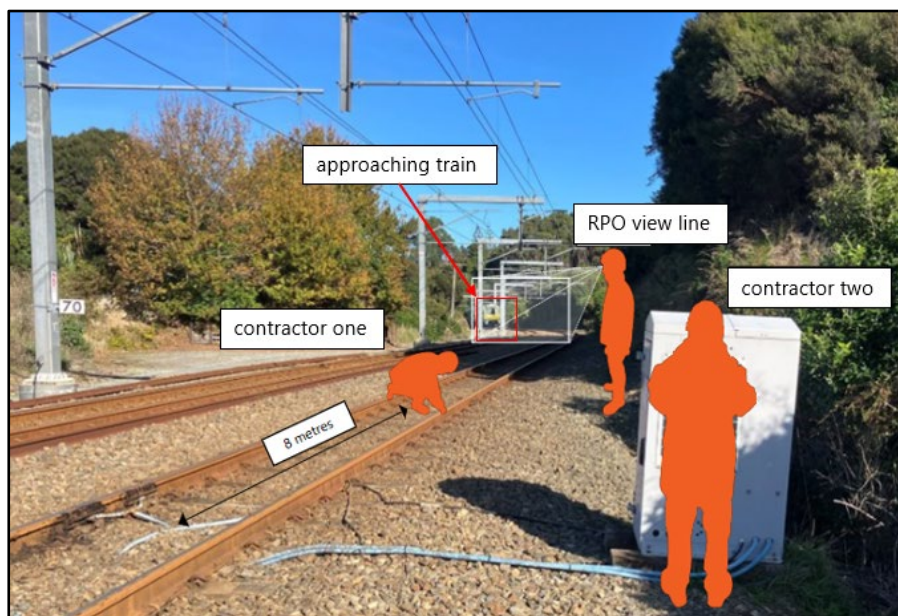
**Figure 9: Track worker locations and approaching train**

- 2.26. SC1 walked back to the control box and retrieved the tools needed to lift the sensor to the correct height.
- 2.27. On arriving back at the sensor, SC1 knelt between the tracks and started lifting the sensor into its correct location. As they were doing this, a northbound empty passenger train (DT80),<sup>12</sup> operated by Transdev Wellington, approached the worksite on the UP main track.
- 2.28. The train was travelling at 62 km/h and rounded the curve approximately 220 m away from SC1's location (see Figure 9).

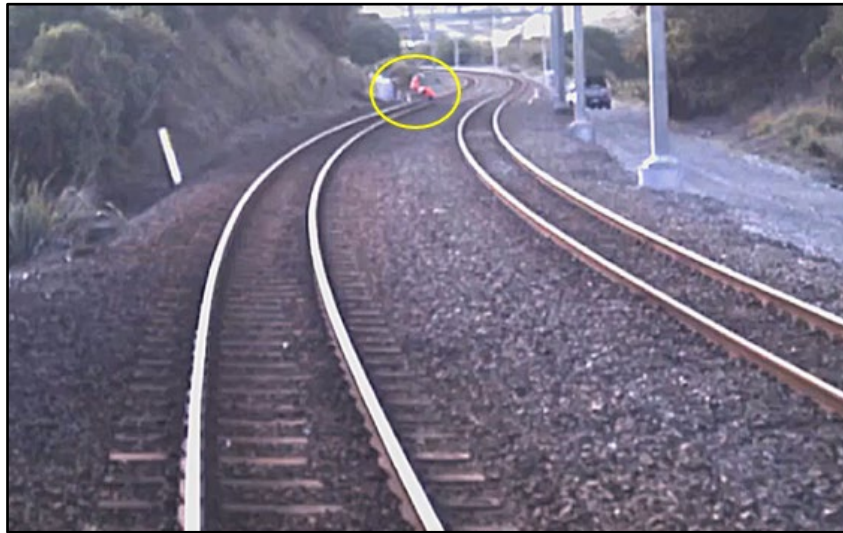
**Figure 10: Train forward-facing video footage of track workers on track**

- 2.29. The RPO saw the train approaching and called out to alert SC1. SC1 did not respond because they were focused on removing a ring spanner that had become stuck vertically on the sensor equipment. The RPO moved towards SC1 to get their attention.
- 2.30. The trainee locomotive engineer<sup>13</sup> (TLE) of *DT80* saw the two workers wearing orange high-visibility vests in the middle of the UP mainline (see Figure 10). At 1014:55 the TLE took swift action and applied the train's emergency brake, approximately 180 m from the workers' location.

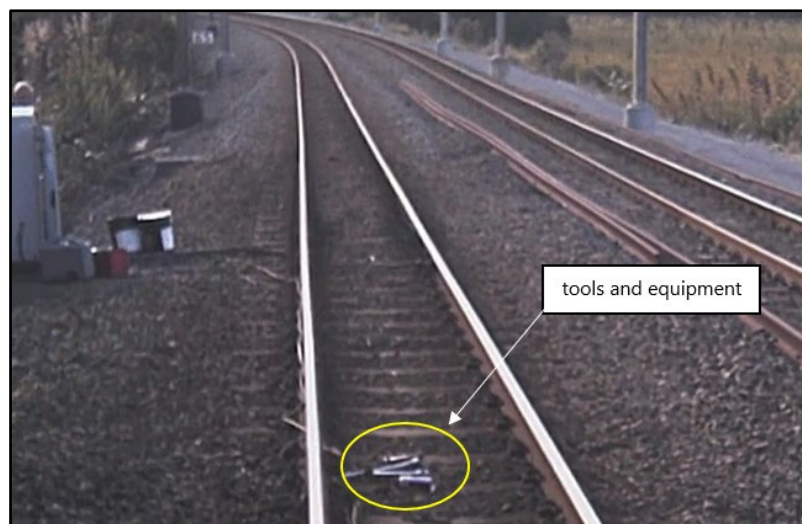
**Figure 11: Train forward-facing video footage once stopped**

- 2.31. The RPO reached SC1 and pulled them upward and away from the track. At the same time the ring spanner was dislodged.
- 2.32. At 1015:11, the train stopped approximately 5 m before where SC1 had been working. Their tools and equipment remained in the centre of the track (see Figure 11).

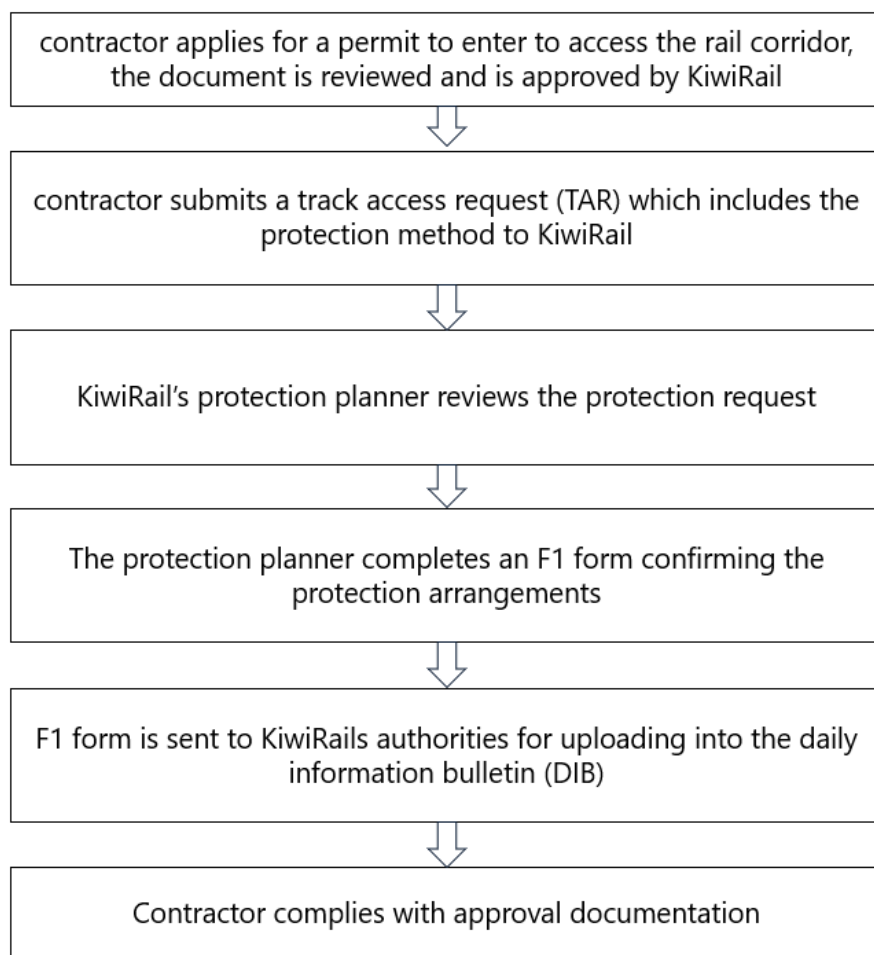
**Figure 13: KiwiRail's protection request and approval process**

- 3.3. The selection of appropriate worksite protection requires effective planning. Having clear rules and procedures in place to support this process is important to ensure the safety of all personnel working within the rail corridor.
- 3.4. All contractors working in the rail corridor must complete KiwiRail's six-stage protection request and approval process before the work can be undertaken (see Figure 13).

- 6.3. On 30 July 2026, the Commission recommended that the chief executive of KiwiRail review and improve the protection planning process to ensure all associated risks controls are applied and the practicality of the protection is considered when selecting the worksite protection method. **[024/26]**
- 6.4. On 18 August 2026, KiwiRail replied:

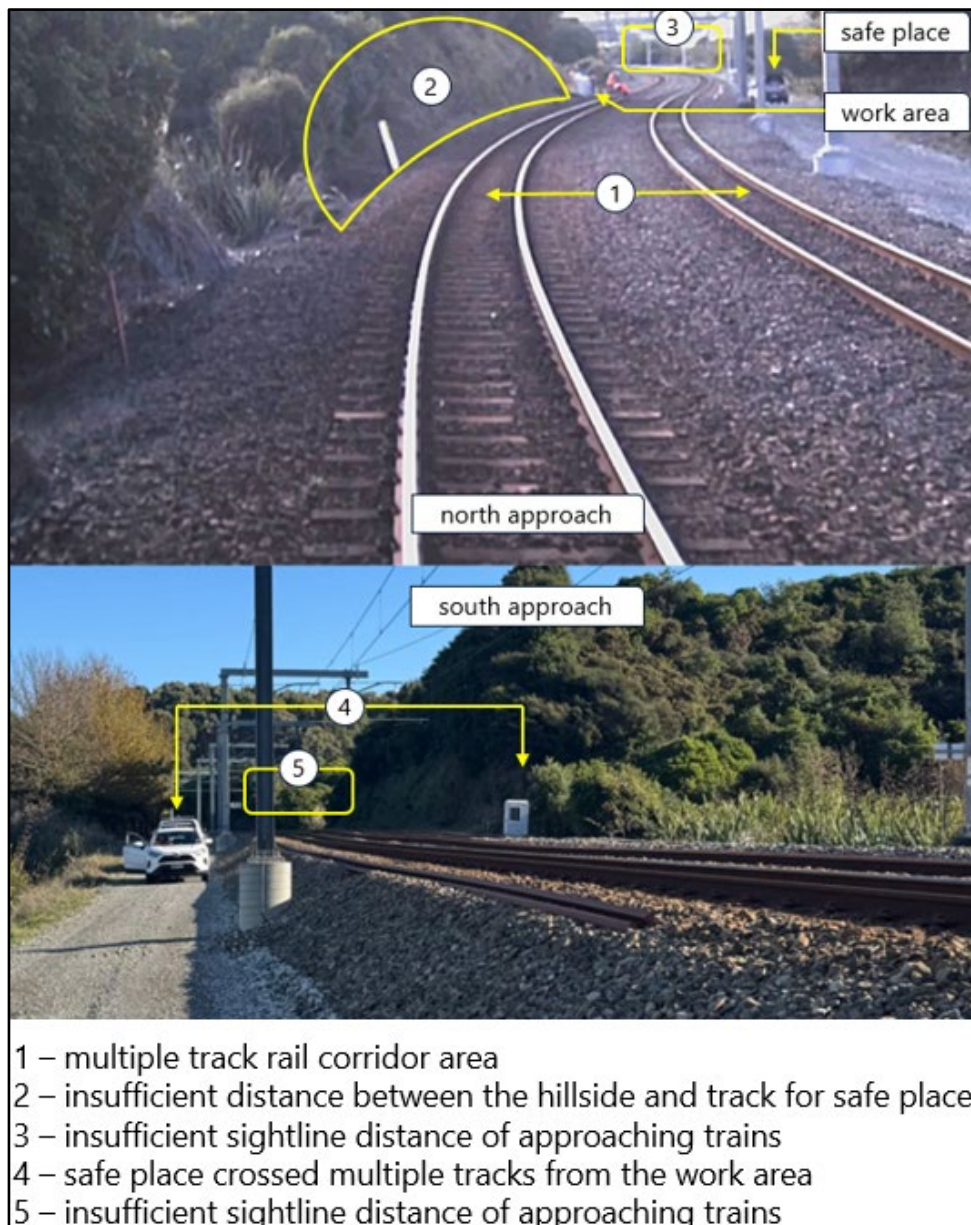
**Figure 16: Why ITD was not allowed at the worksite**

- 3.16. The location of the worksite did not allow the use of ITD, and this was known to the RPO (see Figure 16).
- 3.17. In addition, when using ITD the RPO is required to have a sounding device, such as a whistle or air horn. The RPO informed Commission investigators during their interview that they had carried a whistle, but did not use it on the day of the incident.

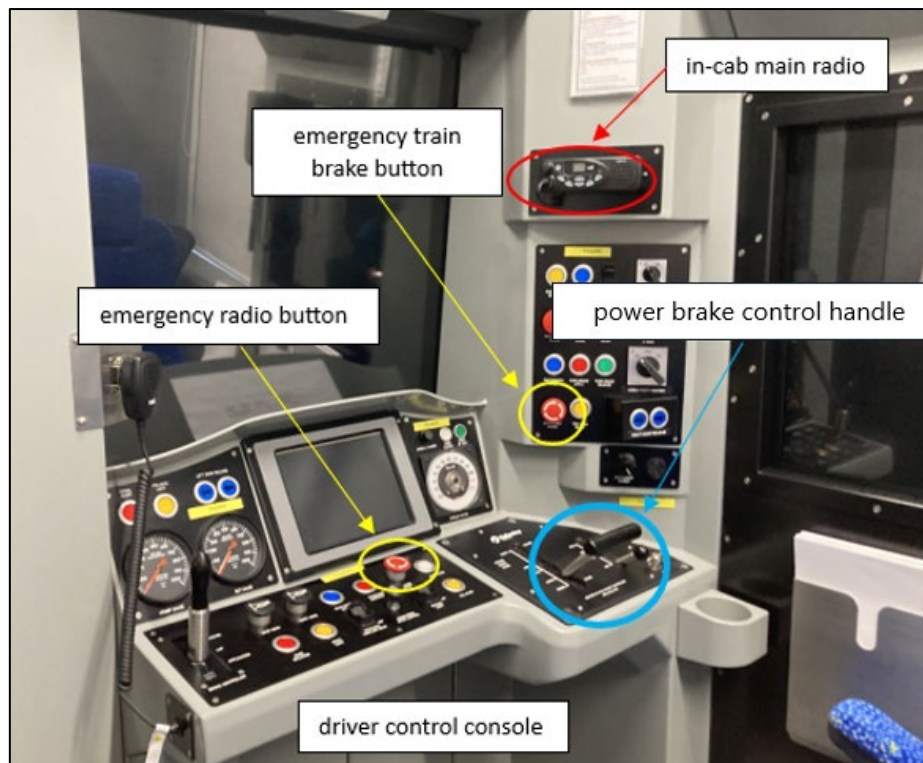
**Figure 20: Driver's in-cab equipment positions**

- 3.53. Engineering controls are mechanisms that respond when human performance and time-based controls are insufficient. An example of an engineering control is an automatic emergency alert (such as an automatic radio emergency response alert)<sup>24</sup> to train control when a train's emergency brake is applied.
- 3.54. Automatic emergency alerts are widely used elsewhere in the rail industry, both in New Zealand and internationally. The absence of such systems on metropolitan passenger trains could delay an emergency response and notification to other rail vehicles operating on the same network.
- 3.55. At the time of the incident, Wellington metropolitan passenger trains were equipped with a manually activated emergency radio button (the button) located on the LE's control console (see Figure 20). Activation required the LE to intentionally depress the button during an emergency.

- 3.56. In this incident, after the TLE applied the emergency brake, they did not activate the emergency radio button, nor were they instructed to do so by the LES. As a result, train control was not immediately alerted to the incident, and the appropriate post-incident procedures were not initiated.
- 3.57. When the Transdev Wellington staff member on board the train contacted train control by mobile phone, there was initial confusion about which work group was
