Transport Accident  
Investigation  
Commission

# **Final interim report**

***Rail inquiry RO-2026-105***  
***Transdev Wellington Train 9379***  
***Signal passed at danger and***  
***collision with stop block***  
***Khandallah, 7.74 km Johnsonville Line***  
***6 June 2026***

**October 2026**

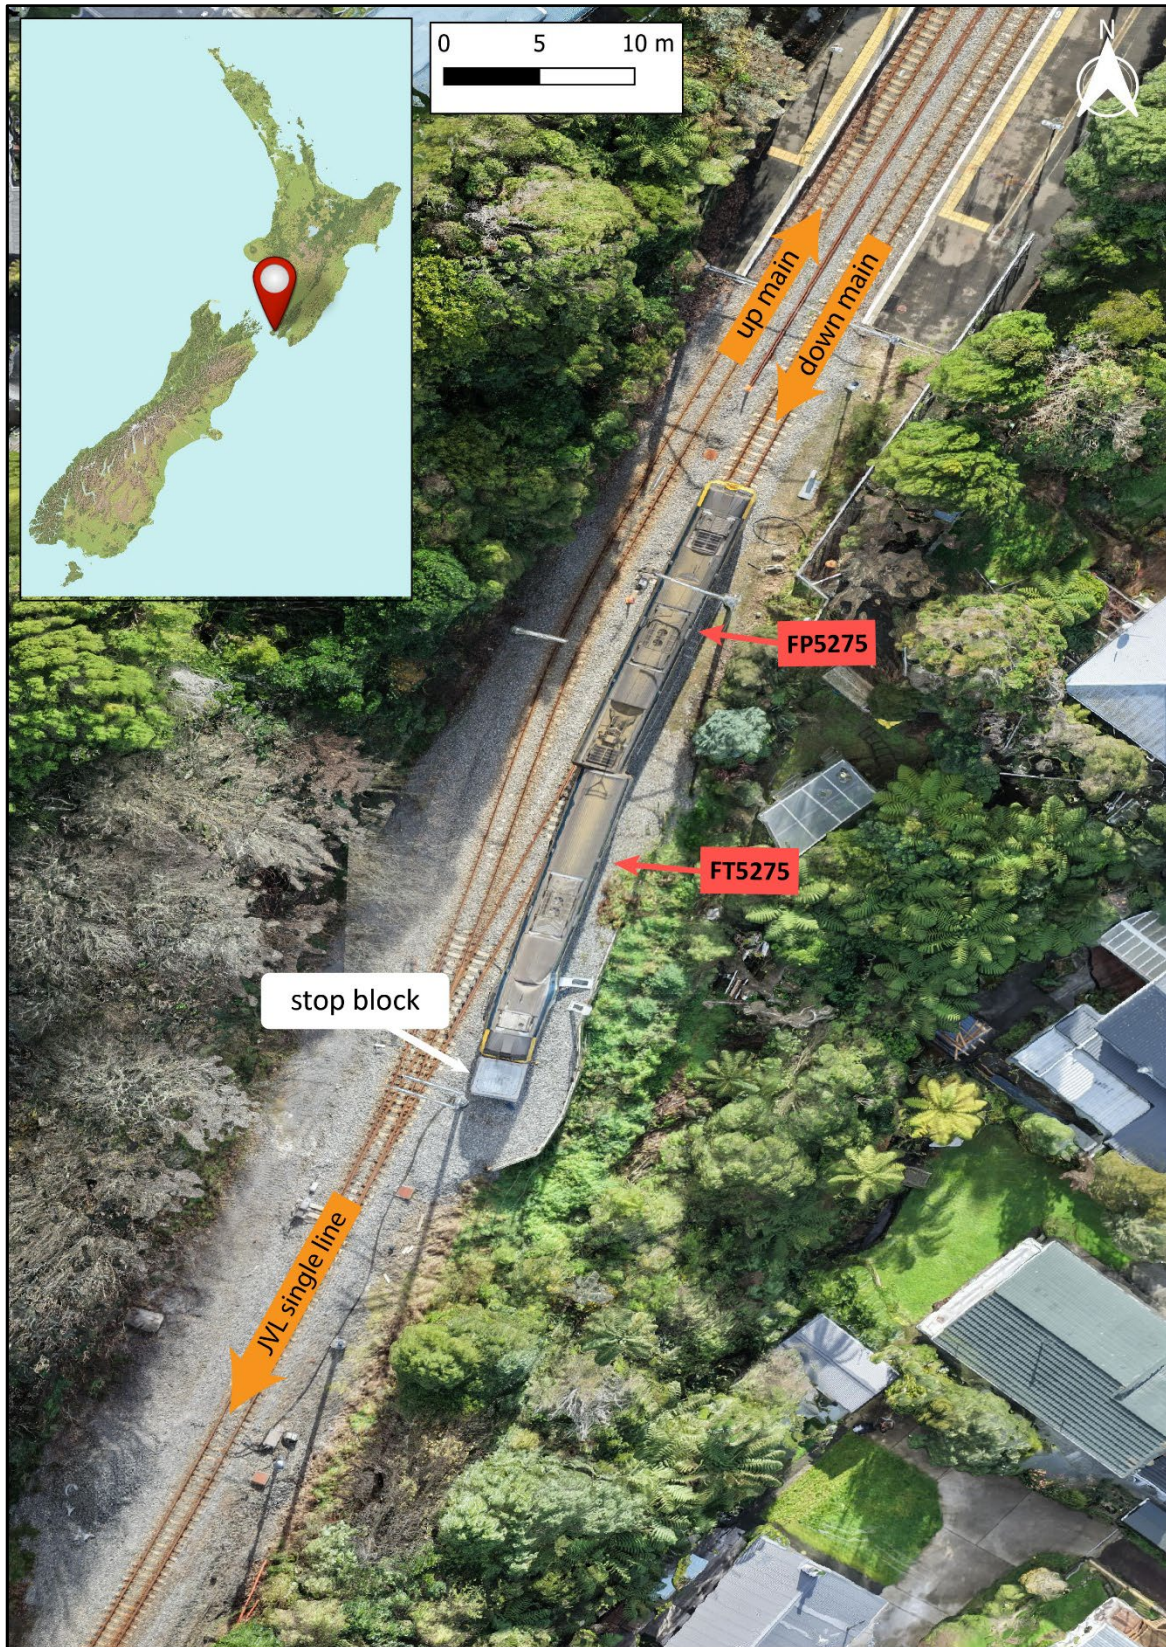
**Figure 2: Collision location on runaway track south of Khandallah Station**  
(Credit: Scene reconstruction by TAIC using KiwiRail drone images)

- 1.23. At 1906:12, the emergency brake was activated.
- 1.24. Because the departure signal was at stop (red), the track in front of the train diverted to the left onto a runaway line. The runaway line diversion was designed to prevent trains from entering the JVL single line in potential conflict with another train coming from the opposite direction (see Figure 7).

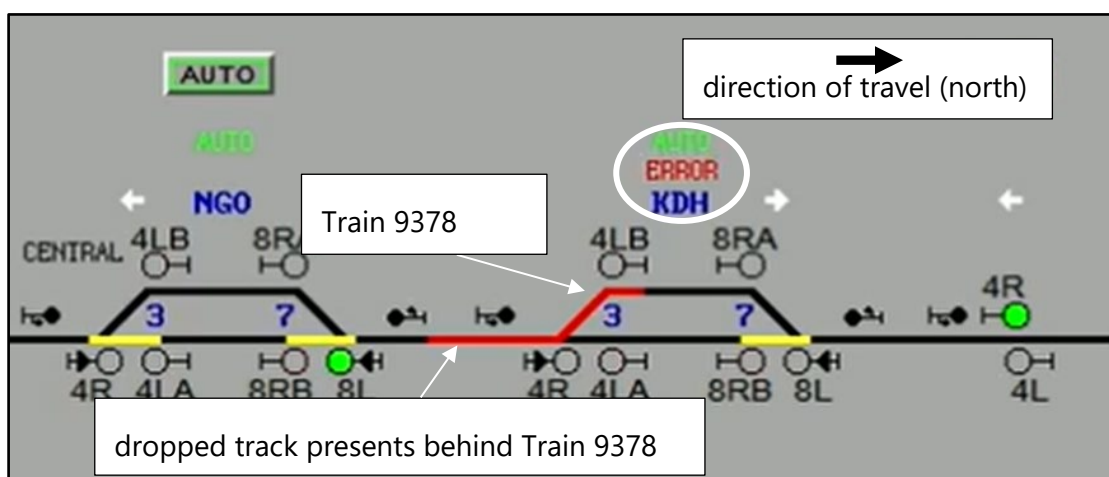
- 1.11. At 1850:31<sup>8</sup> as Train 9378 was approaching Khandallah Station heading north towards Johnsonville, the train control system registered a 'dropped track',<sup>9</sup> which occurs when the signalling system interprets the track as being occupied. The dropped track caused the signalling system to determine that there were multiple trains in the same section, and this resulted in an error message being displayed on the train control mimic screen<sup>10</sup> (see Figure 3).

- 1.12. The error message was a visual warning only and did not generate an audible alarm to alert the train controller. (Note: to reduce visual clutter on the train controller's mimic screen, signals at red display as grey on the mimic screen and signals at yellow or green display as green on the mimic screen.)

**Figure 3: Mimic screen displaying error message as the train entered Khandallah Station**  
(Credit: KiwiRail, annotated by TAIC)

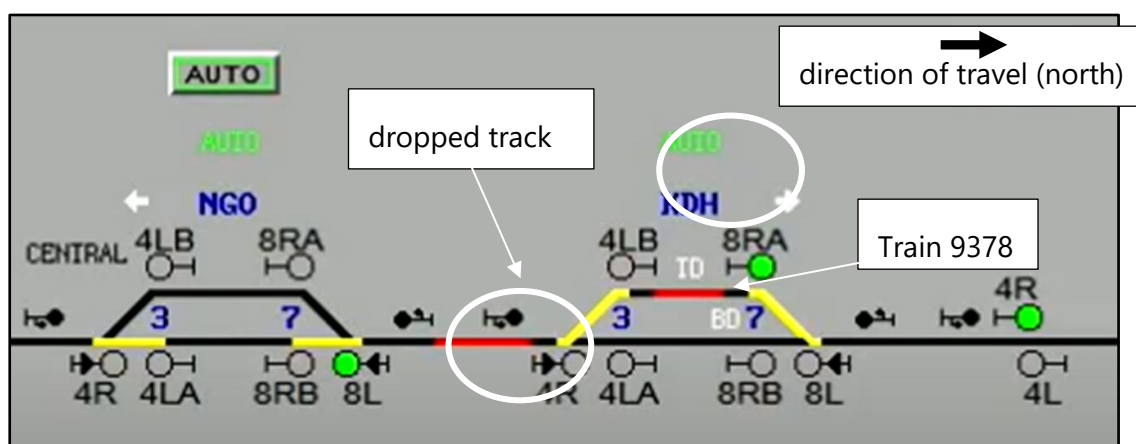
- 1.13. The error message remained visible for 25 seconds until, at 1850:56, Train 9378 entered Khandallah Station. The error message then stopped displaying on the mimic screen because the system no longer detected multiple trains in one section.
- 1.14. However, because of the dropped track, the signalling system was still interpreting the section south of Khandallah as being occupied by a train (see Figure 4).
- 1.15. As a result, the signalling system interlocking<sup>11</sup> acted as designed, holding all signals governing entry into the occupied section at stop (red).

**Figure 4: Mimic screen with error message no longer displaying and dropped track south of Khandallah Station**

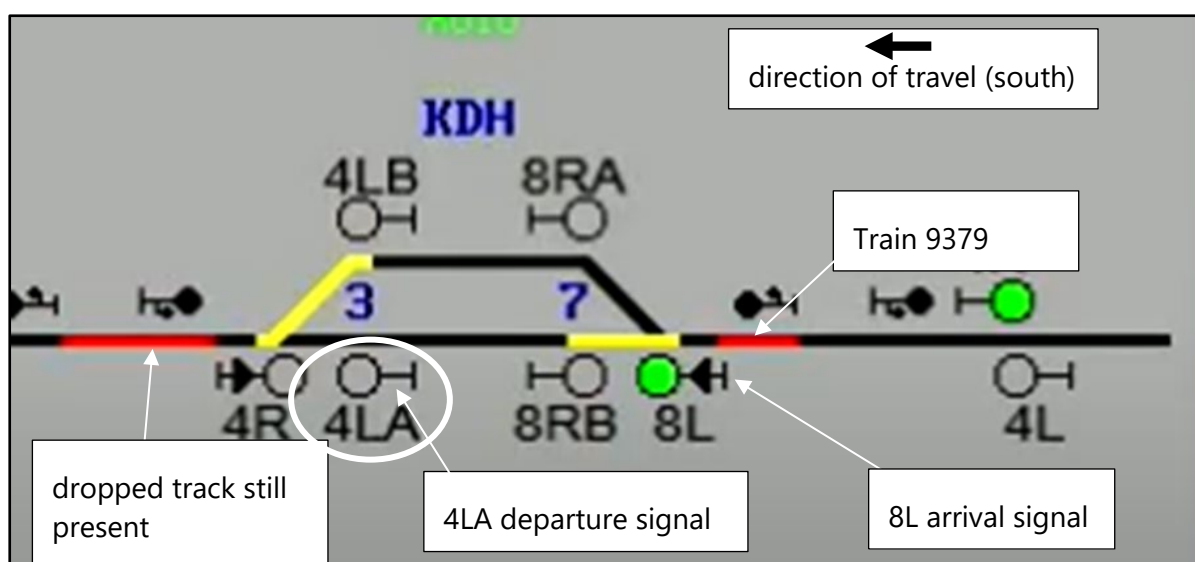
- 1.16. At about 1856, Train 9378 arrived at Johnsonville Station. The LE left the driver's cab in the FP unit and walked to the driver's cab in the FT unit at the southern end of the train in preparation for the return journey to Wellington. As the train was now southbound, the service number<sup>12</sup> changed from Train 9378 to Train 9379 (the train).
- 1.17. After departing Johnsonville Station on schedule at about 1858, the train stopped briefly for passengers at Raroa Station at 1902, before travelling to Khandallah Station. The train passed the 8L arrival signal<sup>13</sup> showing a 'caution to stop'<sup>14</sup> (see Figure 5), entering the down main at Khandallah Station at about 1905.

**Figure 5: Mimic screen showing Train 9379 approach to Khandallah Station**

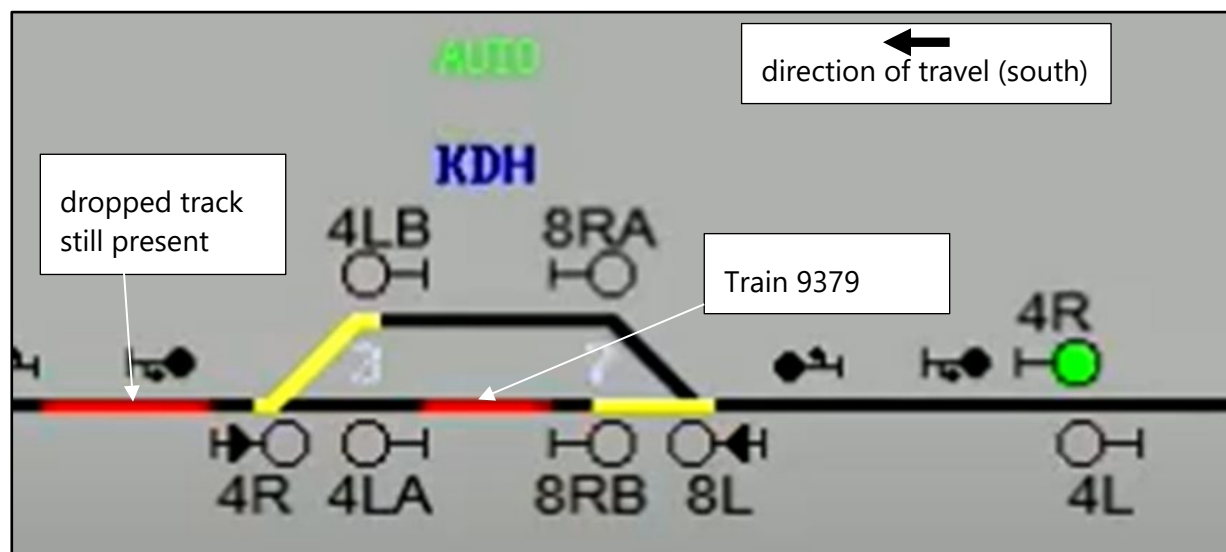
- 1.18. Because of the dropped track south of the station, the interlocking system held the 4LA departure signal at stop ahead of the train. Because the signal was at stop, the track in front of the train was automatically set for the runaway line at the southern end of Khandallah Station (see Figures 6 and 7).

**Figure 6: Mimic screen showing Train 9379 at Khandallah Station platform**

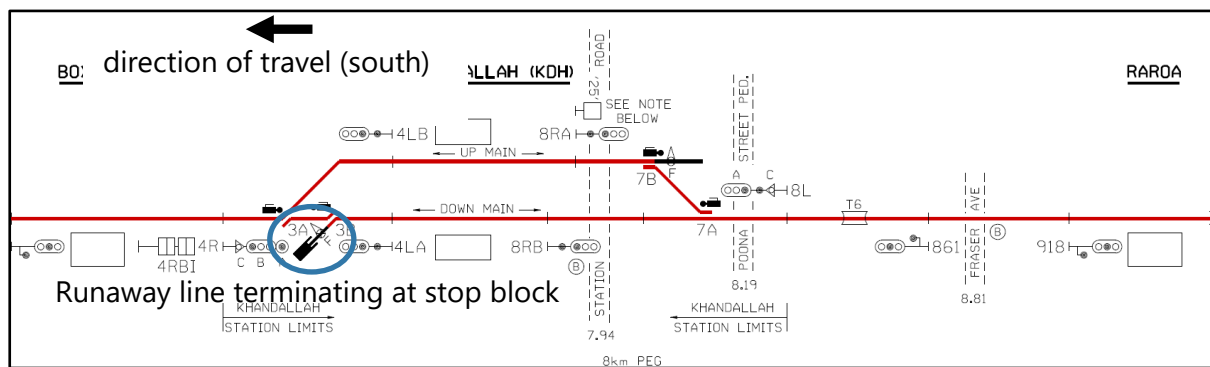
| <b>Figure 7: Signals and interlocking diagram of Khandallah Station, showing runaway line (circled) dated 24 June 2026 .....</b> | <b>5</b> |
