Transport Accident
Investigation
Commission

Final interim report

Aviation inquiry AO-2024-007
Airbus A320neo, ZK-NHA
Uncommanded engine shutdown
Wellington–Sydney enroute
1 December 2024

November 2025

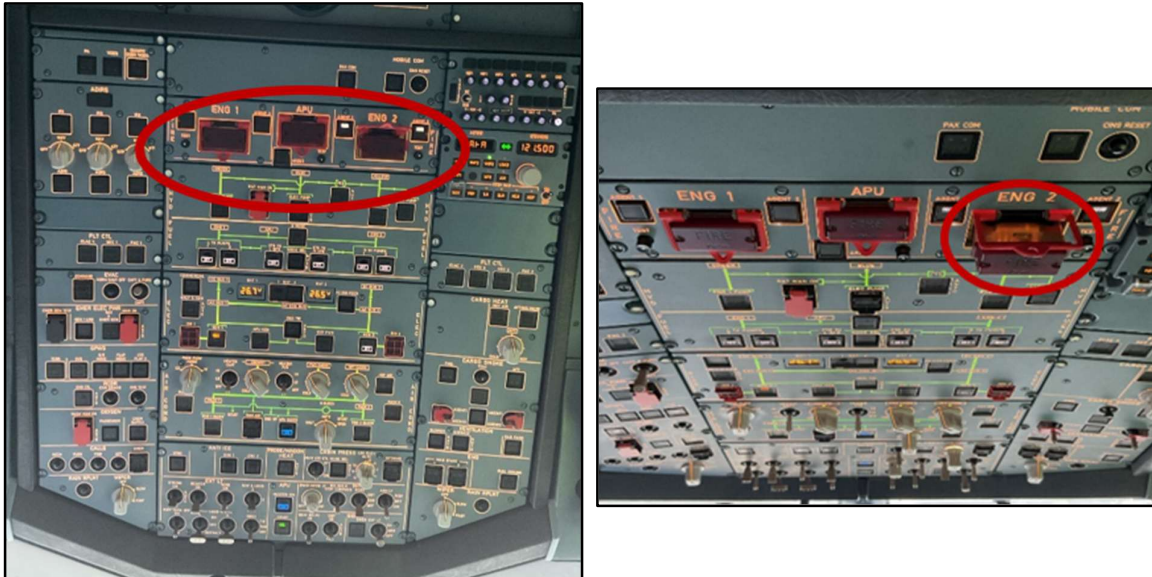
- 1.6. The flight was met in Auckland by the duty management pilot, a union support pilot and an engineer. The people entering the flight deck noticed that the fire push button switch (PB-SW)⁸ for the number two engine on the overhead fire panel was in the activated position and pointed this out to the flight crew. Neither pilot recalled activating the fire switch and none of the checklists used by the crew required activation of this fire switch.

Figure 3: Overhead panel of ZK-NHA after shutdown, showing the activated fire switch for number two engine

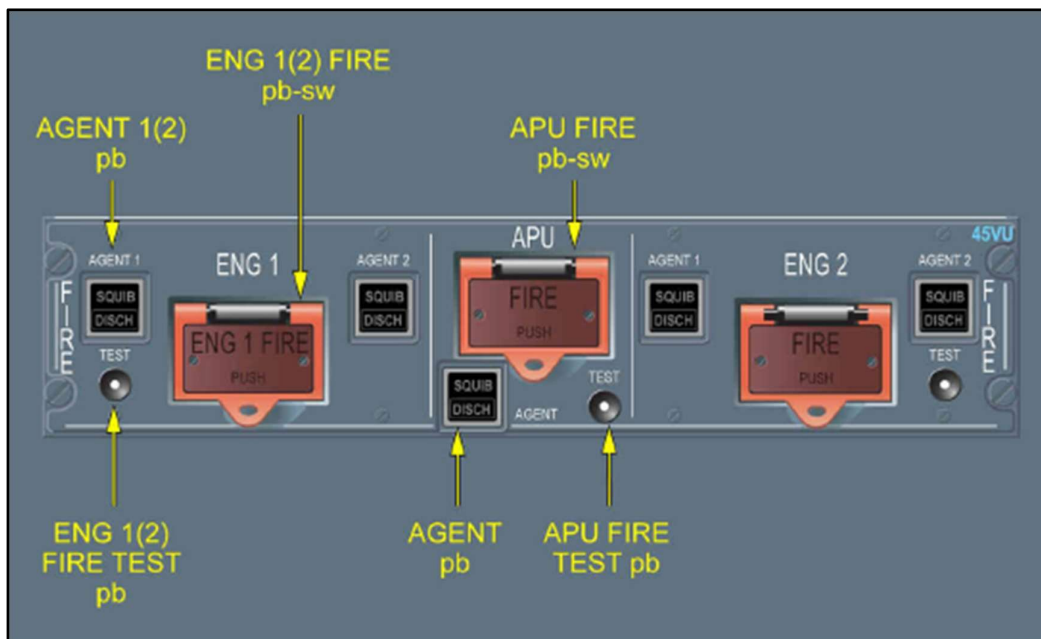
Figure 4: A320 fire panel

- 1.8. The fire panel is located at the rear of the overhead panel on the flight deck, behind the flight crew's heads (see Figure 3). The panel is comprised of three fire switches: one for each engine and one for the auxiliary power unit (APU).¹⁰ The fire panel also has buttons to action the fire-extinguisher squibs¹¹ and fire-system test buttons (see Figure 4).

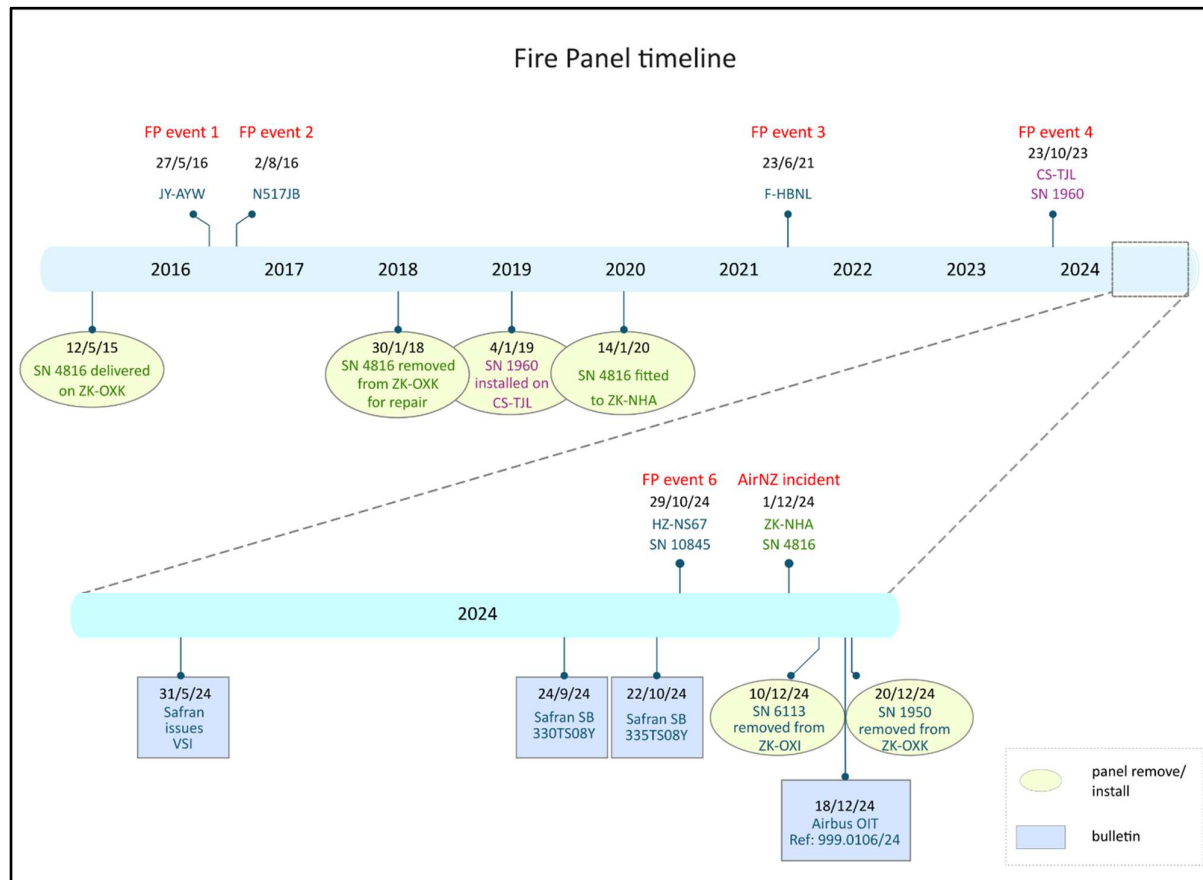
Figure 5: Timeline of known fire-panel incidents, May 2015 to December 2024

- 1.24. BEA advised the Commission of a further incident of an uncommanded fire switch activation that occurred in October 2024. The Commission noted from a subsequent Airbus document that the fire panel involved had indications of damage on the housing panel and a bent locking pin. The serial number for this fire panel was not one of the fire panels identified in the two Safran ED vendor SBs. This incident is referred to as FP event 6 in Figure 5.

- 1.25. The fire panel installed on the Air New Zealand aeroplane was manufactured in 2015 and installed on another A320 aeroplane delivered to the operator that year. The fire panel was removed from that aeroplane in 2018 to replace an unrelated unserviceable light within the fire panel. The fire panel was sent to the Zodiac Aero Electric²² repair shop based in Niort (France) for repair and then returned to the operator where it remained in stores. It was installed in the aeroplane in 2020 and operated with no reported defects until this incident. This fire panel is designated SN 4816 in Figure 5.

- 1.26. The incident covered in paragraph 1.13, investigated by GPIAAF and involving Airbus A321 CS-TJL, is depicted as event 4 in Figure 5. The two events in 2016 referred to in paragraph 1.16, involving aeroplanes JY-AYW and N517JB, are depicted as FP events 1 and 2. The third event, in 2021 and involving aeroplane F-HBNL, is depicted as FP event 3. The event covered in paragraph 1.24, involving aeroplane HZ-NS67, is depicted as event 6. The Commission received notification of event 6 after this investigation commenced.

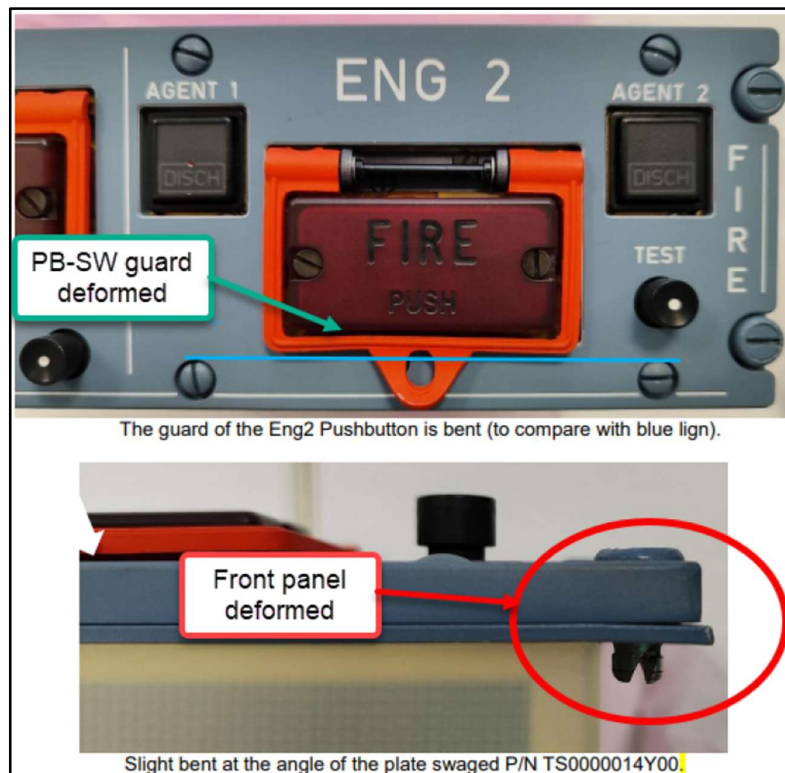
Figure 6: Fire-panel testing

- 1.27. The fire panel was removed from the aeroplane under the supervision of a Commission investigator and taken to Safran ED in France for examination. The examination was conducted by Safran ED at Roissy (France) and overseen by a Commission investigator.
- 1.28. Safran ED staff were immediately able to identify external damage to the fire switch guard that surrounds the fire switch and deformation on the front panel (see Figure 6).²³ The retention pin within the fire switch was misaligned by 2.73° (tolerance specification is $\pm 1^\circ$) and there was evidence of chamfer on the pin (see Figure 7). Safran ED concluded that the damage to the panel was very likely caused when the fire panel was dropped at some stage.
