# MARINE OCCURRENCE REPORT

03-203 jet boats *Wilderness Jet 3* and *un-named private jet boat*, collision, 2 February 2003 Dart River, Glenorchy, Queenstown, New Zealand

# Report 03-203

### jet boats Wilderness Jet 3 and un-named private jet boat

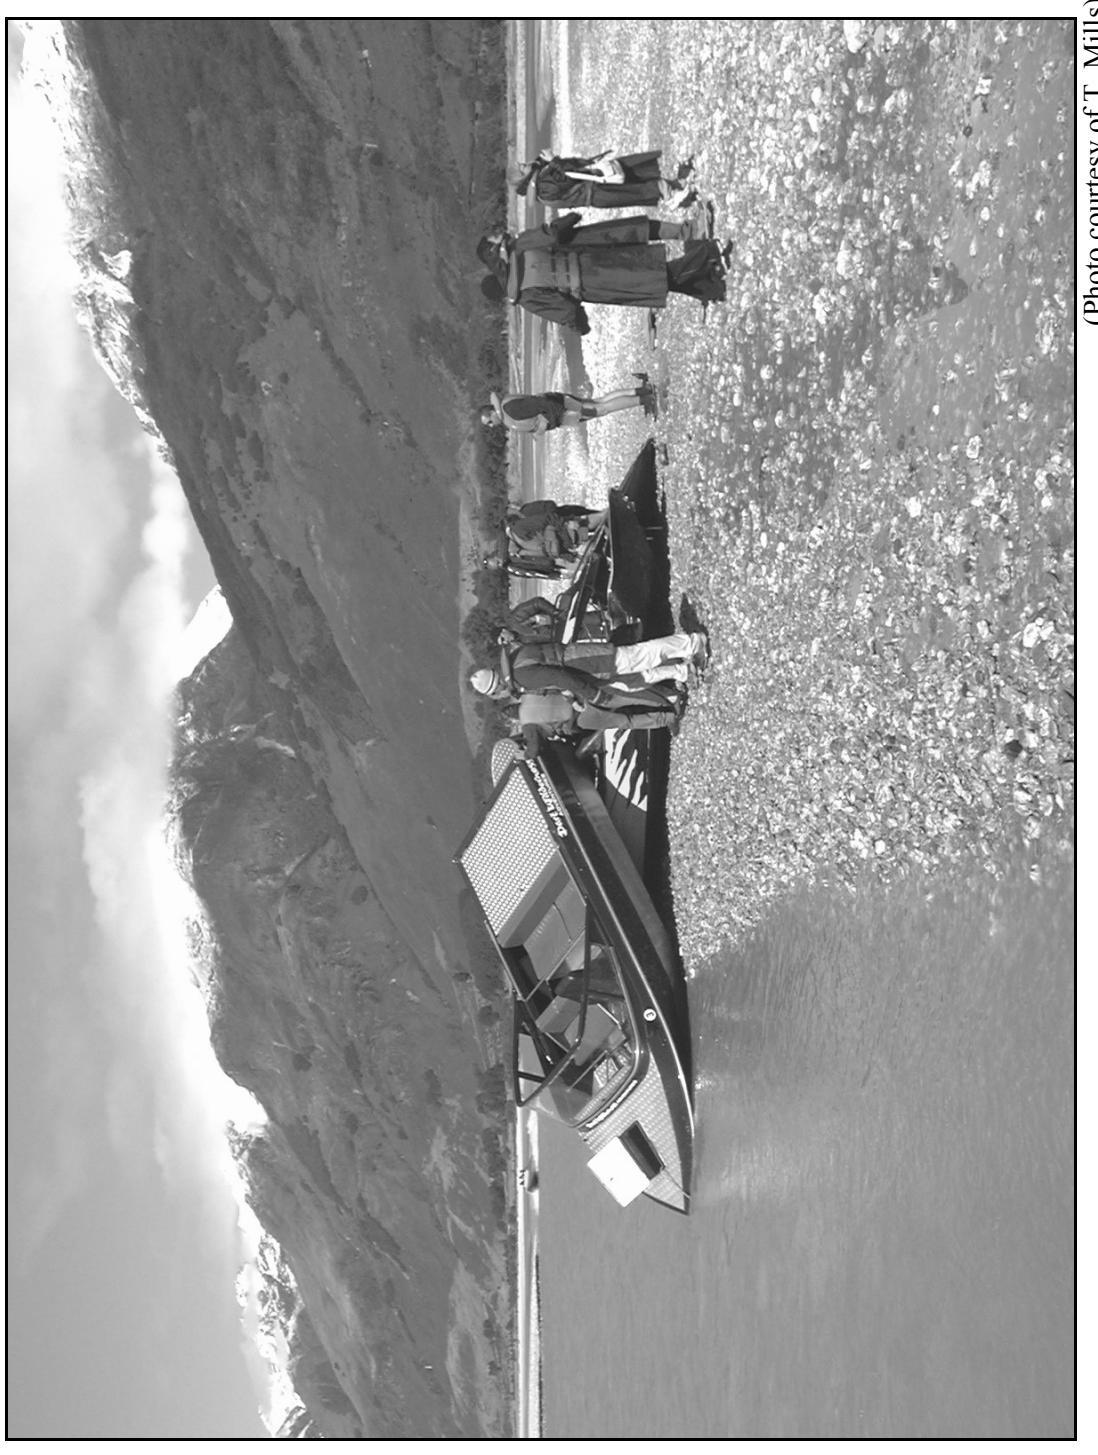
The Wilderness Jet 3 and the Private Jet Boat at the accident site

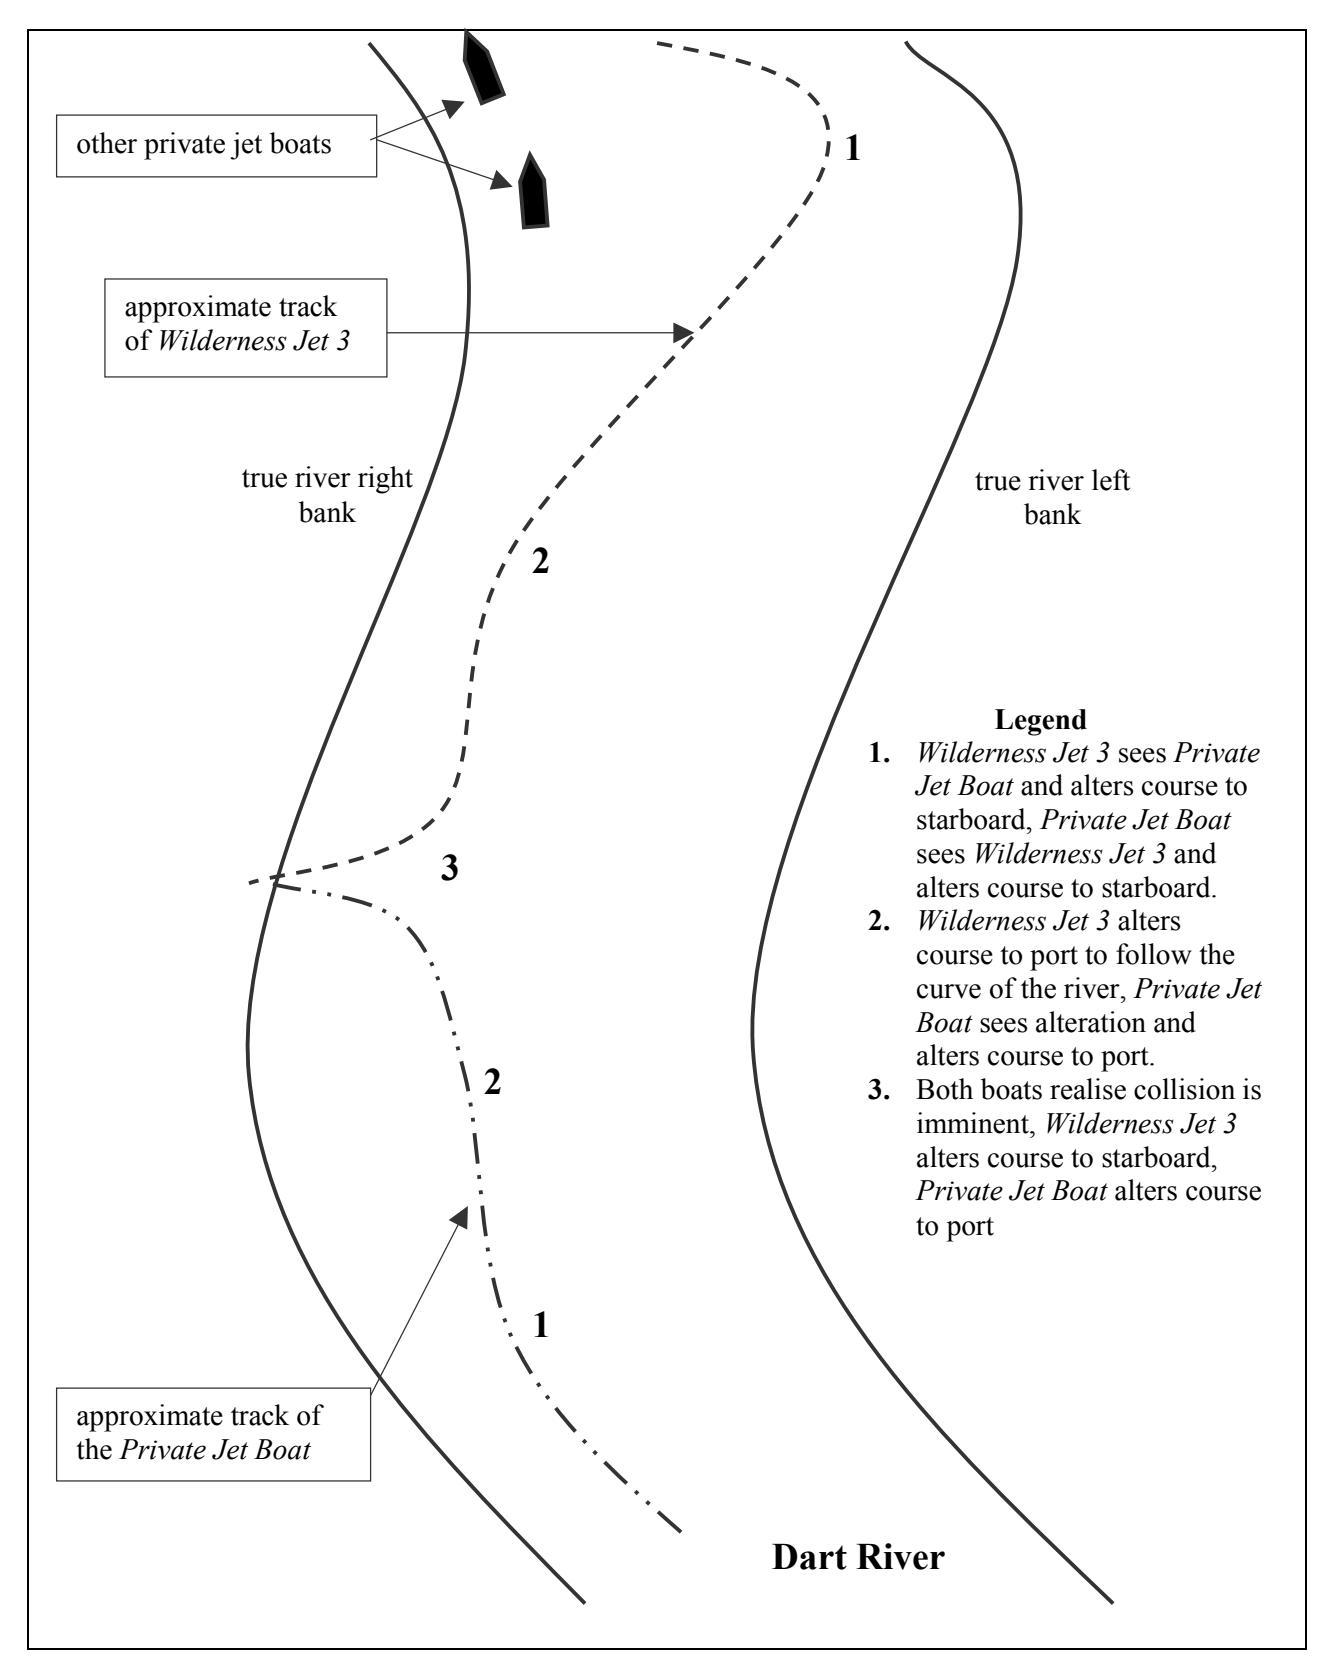
Figure 2 Approximate tracks of the *Wilderness Jet 3* and the *Private Jet Boat* (not to scale)

- 1.1.12 The driver of *Wilderness Jet 3* started to slow his boat by reducing the throttle. He stated that as the boat came off the plane, and settled in the water, he felt the stern of the boat just touching the riverbed and heard the water intake starting to pick up gravel. He increased the throttle so the boat would go back on the plane and maintain directional control.

- 1.1.13 The driver of the *Wilderness Jet 3* realised that he was in danger of colliding with the *Private Jet Boat*, so he took evasive action by going hard to starboard intending to beach the boat on the shingle bank.

- 1.1.14 At the same time, the driver of the *Private Jet Boat* also realised that collision was imminent so he took similar evasive action by altering course to port, also intending to beach his boat on the shingle bank.

- 1.1.15 Just prior to beaching, the port bow of *Wilderness Jet 3* collided with the starboard bow of the *Private Jet Boat*. The force of the collision and the rotational force induced by its driver going hard to starboard caused the *Wilderness Jet 3* to spin; its stern being forced up out of the water before coming to rest on top of the stern of *Private Jet Boat*.

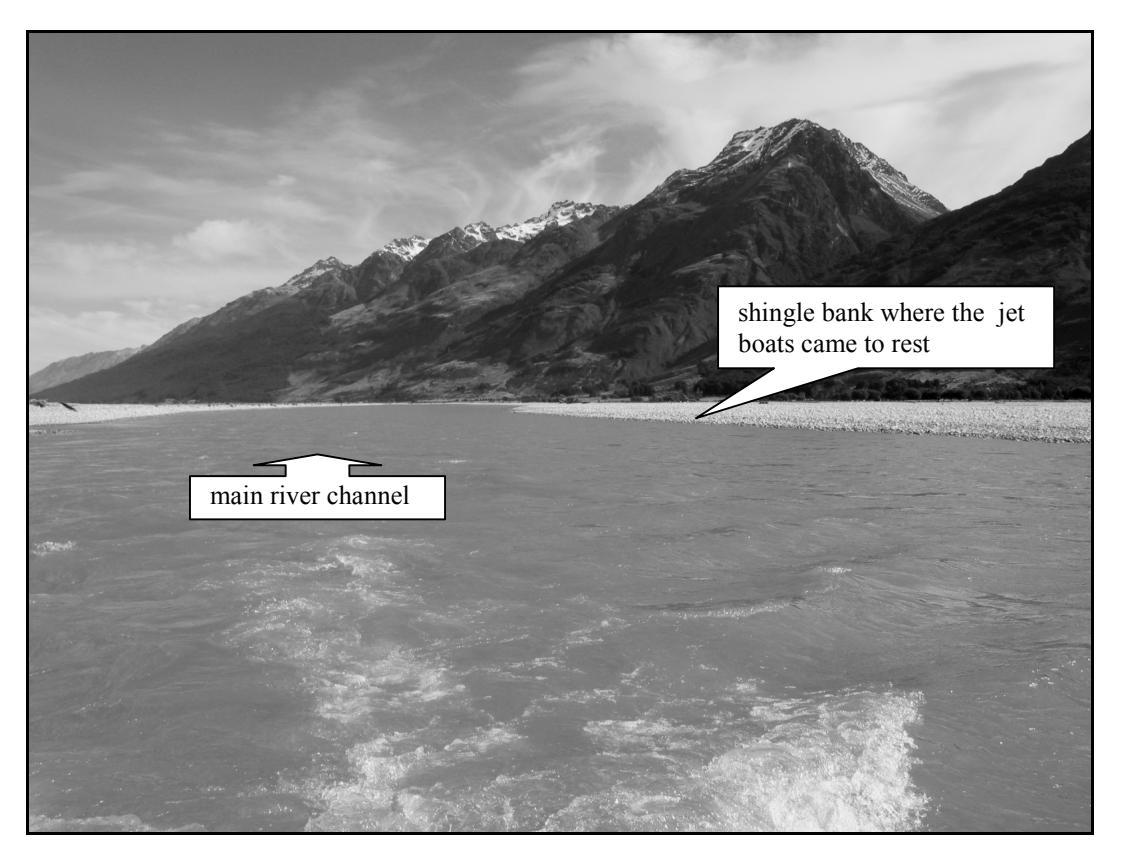
Figure 3 View of Dart River at the scene of the collision looking downstream, true river right is to the right of the picture

- 1.6.4 At the site of the accident, the main river channel was a relatively straight section of channel with a width of about 30 m and a slight right-hand bend followed by a left-hand bend. The main channel was contained between shingle banks and most of the river flow was through this channel but there were smaller un-navigable braided channels on either side.
- 1.6.5 Downstream of the accident site before the confluence of the Route Burn the width of the navigable channel decreased as the river became more braided for a short distance. Several smaller channels or braids split off the main channel thus reducing the flow and width of the main channel.

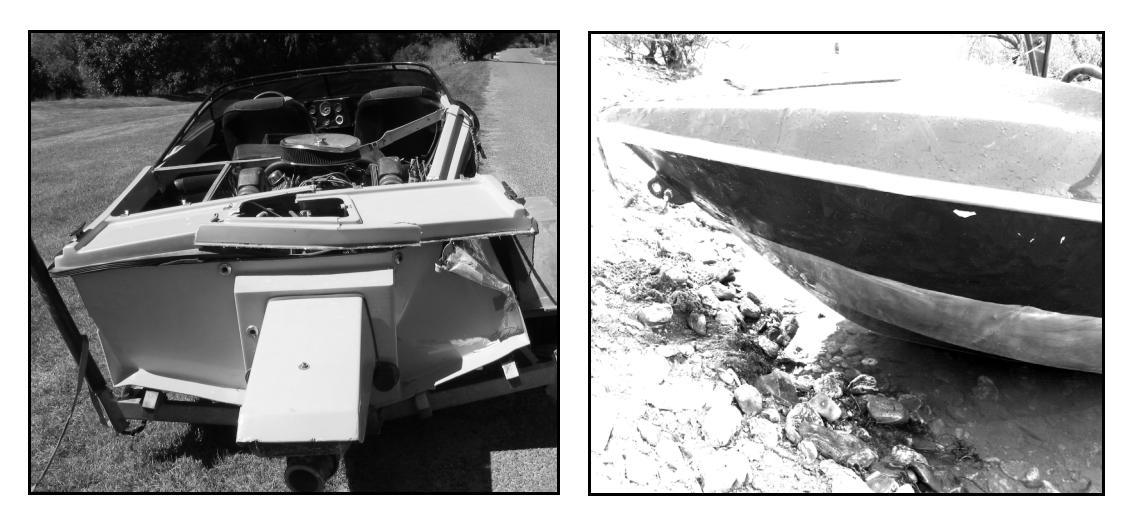
- 1.3.2 The *Wilderness Jet 3* was inspected at Glenorchy marina by Commission investigators on 24 February 2003, and was found to have minor damage to the port bow section in the form of several indentations. The indentations had already been semi beaten out and the boat had continued operations.

- 1.3.3 The *Private Jet Boat*, also inspected by Commission investigators on 24 February 2003, was extensively damaged with the whole of the glass reinforced plastic (GRP) deck structure being badly cracked, split and detached from the hull throughout. The starboard side hull was set in along most of its length. The upper brace in the engine compartment was bent and the engine air filter was deformed with possible further damage to the engine and mountings as a result of *Wilderness Jet 3* landing on top of it. The only damage evident within the passenger compartment was the deformed steering wheel.

Figure 4 Damage sustained to the *Private Jet Boat* on the left and *Wilderness Jet 3* on the right

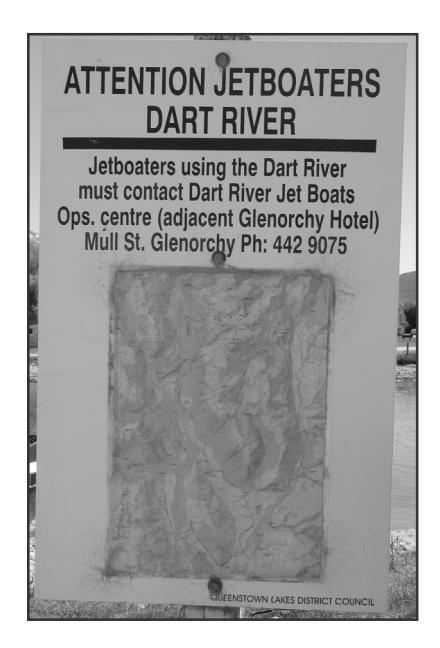
1.7.1 An Environmental Court decision required private jet boaters to inform one of the commercial operators, Dart River Safaris, of their intention to use their boats on the Dart River. Queenstown Lakes District Council erected signs informing private jet boaters of this requirement at the Glenorchy marina and at the Dart River Bridge; the two most probable points for launching jet boats (see Figure 5).

Figure 5 Notice at Glenorchy marina and Dart River Bridge for private jet boaters
