Report 08-001, Cessna 152 ZK-ETY and Robinson R22 ZK-HGV, mid-air collision, Paraparaumu, 17 February 2008

Cessna 152 ZK-ETY and Robinson R22 ZK-HGV

mid-air collision

17 February 2008

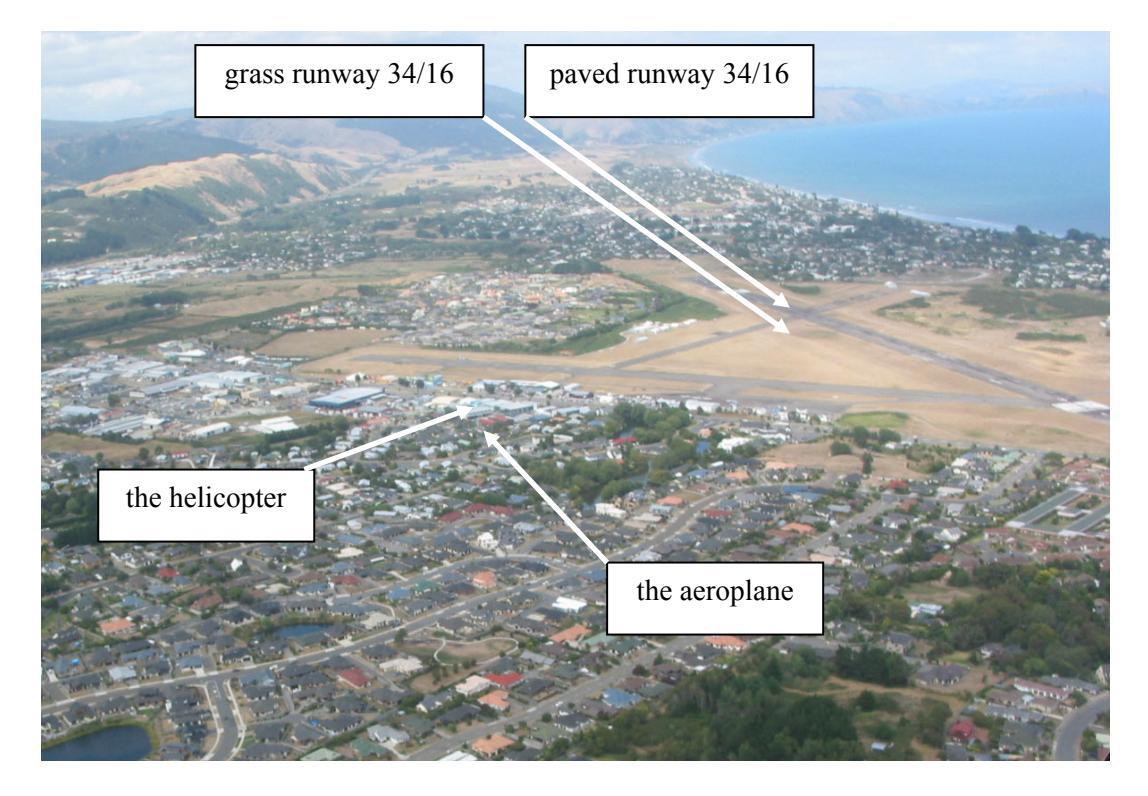
Figure 1 Aerial view of site (looking south)

- 1.1.11 The helicopter pilot and flight examiner died when the helicopter impacted on a commercial building. The aeroplane fell onto a roadway of a residential cul-de-sac about 230 m away. The aeroplane pilot survived the collision and ground impact, but died about 5 hours later of his injuries. No persons on the ground were injured and there was no fire (see Figure 1 for a description of the area).

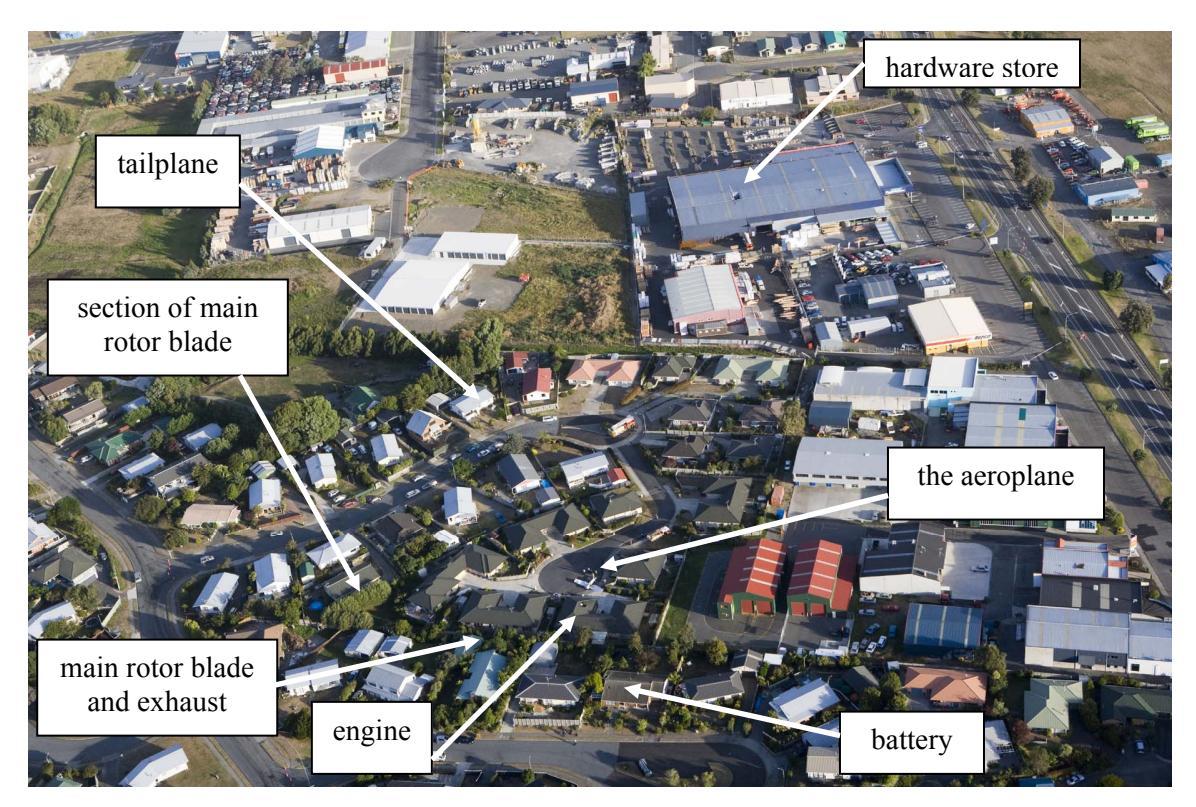
Figure 2 Accident site (looking east)

- 1.2.1 The wreckage of the 2 aircraft was spread over about 2 hectares to the north-east of Kapiti Road which bounded the northern side of the aerodrome. An initial examination of the site confirmed that the 2 aircraft had broken up in the air, with major components, for example the engine from the aeroplane and the main rotor blades from the helicopter, found separated from the 2 aircraft (see Figure 2).

- 1.2.3 The main wreckage of the aeroplane had fallen inverted on a roadway, with the wings still attached to the fuselage. The tailplane had separated in flight and was found about 90 m from the fuselage. The engine and some accessories had also separated from the aeroplane as it descended, with several items penetrating the roofs of nearby houses.

- 1.2.4 The fuselage of the helicopter had broken through the roof of a hardware company, with a section of the tail boom, including the tail rotor assembly, remaining on the roof. The tail rotor blades displayed no rotational damage.¹¹ The main rotor blades had separated from the aircraft at the hub attachment area and sections of both blades were found about the wreckage site. Following an initial examination and survey of the site, the wreckage was removed for further examination.

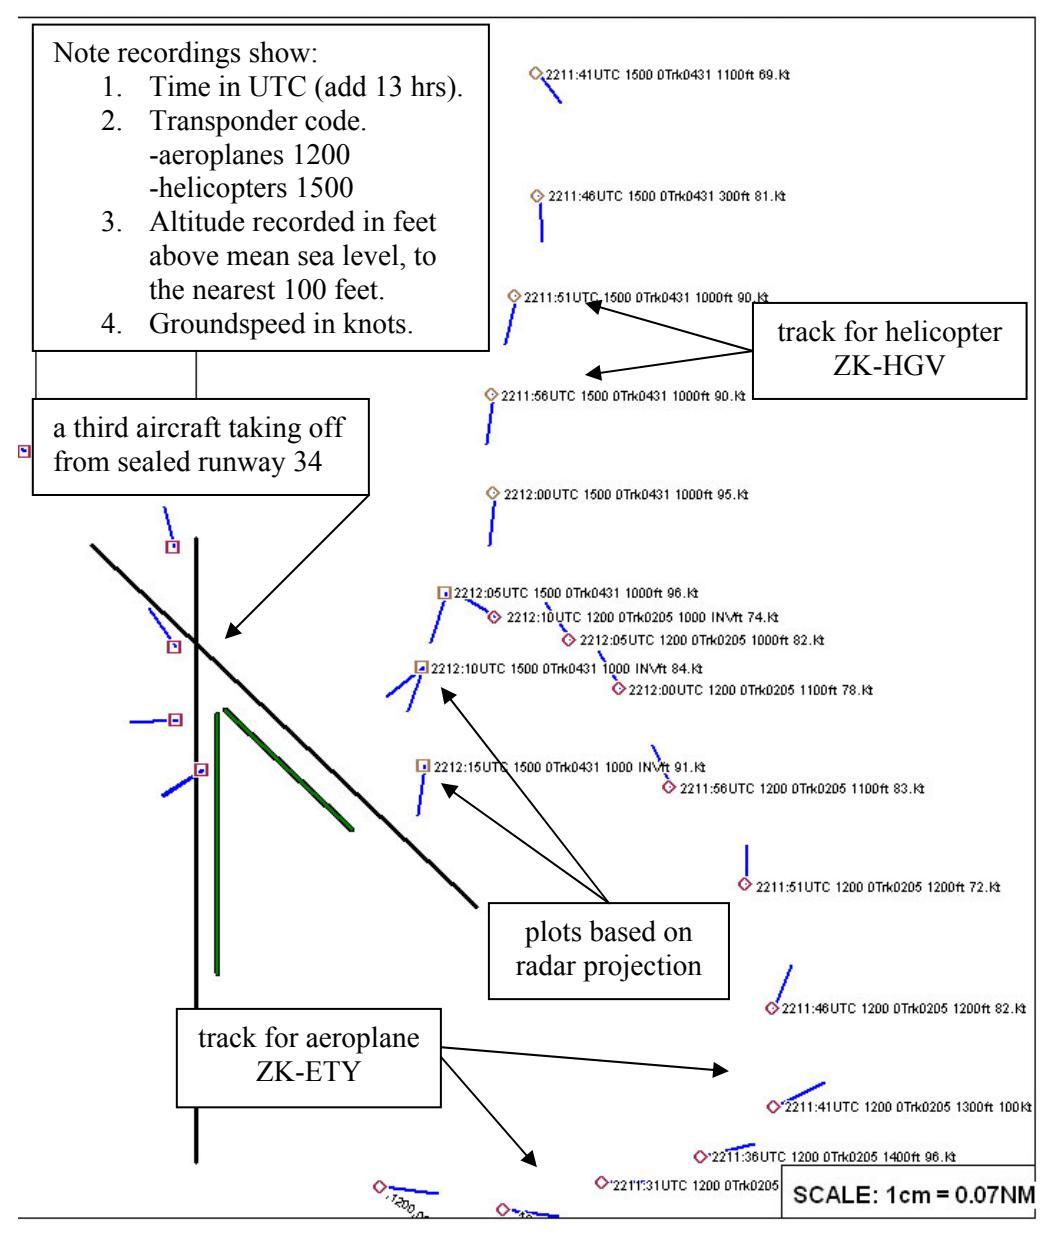
Figure 4 Radar plot

1.2.38 Airways New Zealand radar facilities recorded portions of the flights of both aircraft, including the aeroplane returning to Paraparaumu Aerodrome from the training area, and the helicopter as it positioned in the downwind leg for the 180° autorotation. The recording showed the flight paths of the 2 aircraft converging and meeting at 1112:10 (see Figure 4.)

(Note: The radar plot is based on information received from several sources, updated every 5 seconds, processed and displayed in a pictorial manner. Airways advised that in general radar positional error was less than 0.25 nautical miles (465 m), but in this case the tracking displacement was estimated to be no more than 0.04 nautical miles (75 m). However, it should be noted that due to the close proximity of transponders in the 2 aircraft, mutual garbling of replies may have caused data errors and this was probably the reason for some positional variations as the 2 aircraft approached each other and for the helicopter reporting an incorrect altitude (300 feet) at time 2211:46.)

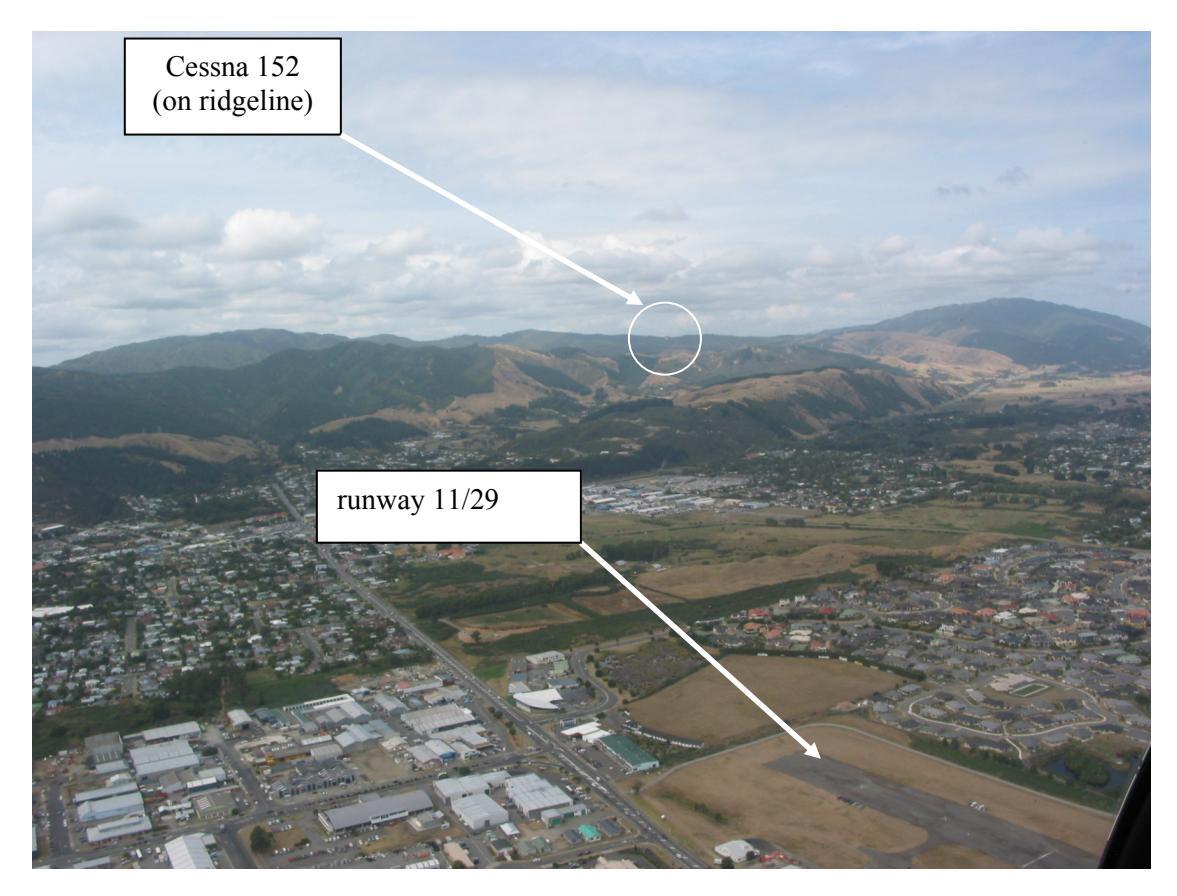
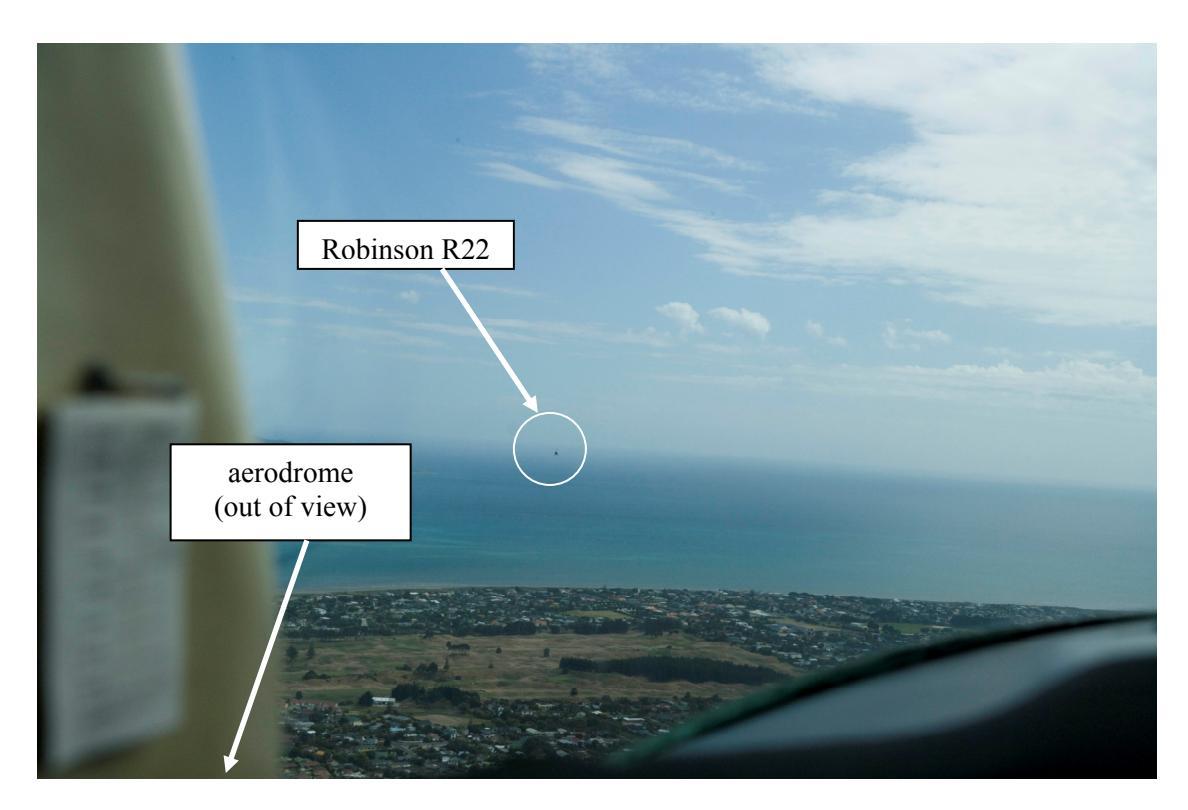
- 1.6.38 The partial reconstruction confirmed the challenges in sighting the opposing aircraft at distances greater than about 2 km to 3 km apart despite knowing the general location of the other aircraft. The local terrain, especially the hills to the south of the aerodrome, added to the difficulty in locating the opposing aircraft. The different paint scheme made little difference in sighting the R22, with the darkness of the cabin dominating the visible profile of the helicopter. Cameras on board both aircraft recorded the flights and views from each aircraft (see Figures 7 and 8).
