Transport Accident
Investigation
Commission

Final report

Aviation inquiry AO-2023-008
Q-300, ZK-NES and Beech 76 Duchess, ZK-JED
Air proximity occurrence
Near Brynderwyn
28 August 2023

December 2025

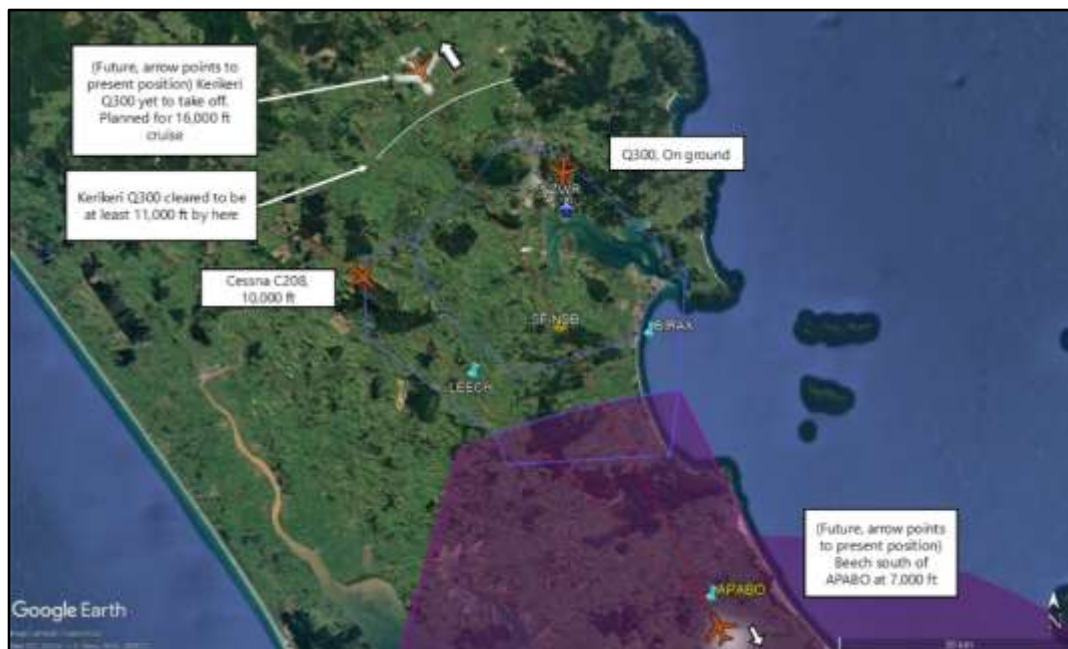
Figure 3: Air traffic situation before the aircraft air proximity incident

- 2.4. At the time of the incident, several aircraft were being controlled by the North Sector controller (the controller). The controller was accompanied on the day by an instructor. These aircraft were (see Figure 3):
 - the Q-300 at Whangārei, preparing to use the Standard Arrival Route (STAR) APABO-3C to Auckland at 12,000 feet (ft)
 - the Beech, approaching Whangārei from south of APABO at 7000 ft to then follow route segment Q520 to SPRINGFIELD

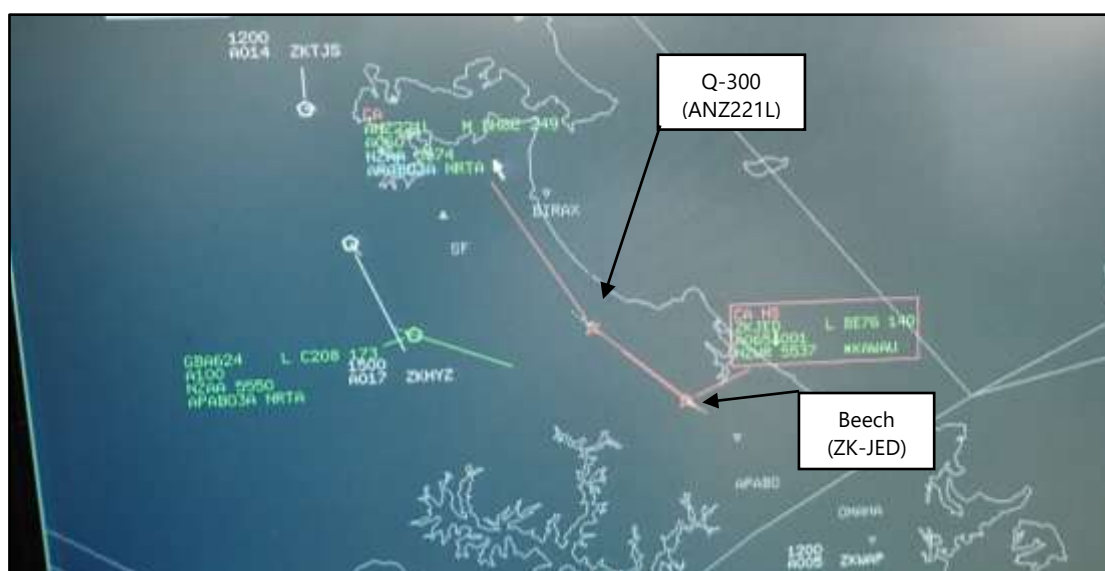
Figure 7: The controller's radar display

- 2.22. Meanwhile, the controller was monitoring the two aircraft in uncontrolled airspace, approaching head-on along route segment Q520. The instructor suggested to the controller that they clear the Q-300 to 8000 ft. The controller's radar then displayed a Short-Term Conflict Alert (STCA) at 1005:44 (displayed as CA on the radar display) (see Figure 7).

- 2.23. The radar display shows a predicted leader line that represents where the aircraft will be in three minutes, based upon its current airspeed and direction. When the leader line is red, this indicates that the aircraft is in a conflict situation. Green text indicates that the aircraft are within the controller's sector.

- 2.24. Within seconds of the STCA, the controller offered the Q-300 their expected radar climb to an initial 8000 ft. The captain immediately accepted and initiated a climb.
- 2.25. The Q-300's TCAS then advised the flight crew of a near-proximity event with an audible warning: 'TRAFFIC, TRAFFIC'.
- 2.26. The Beech called the Q-300 to further coordinate their pass, but the Q-300 flight crew were busy monitoring their level change and did not respond. There were no further radio conversations between the two aircraft until they had passed each other, and the Q-300 was at 8000 ft in controlled airspace.

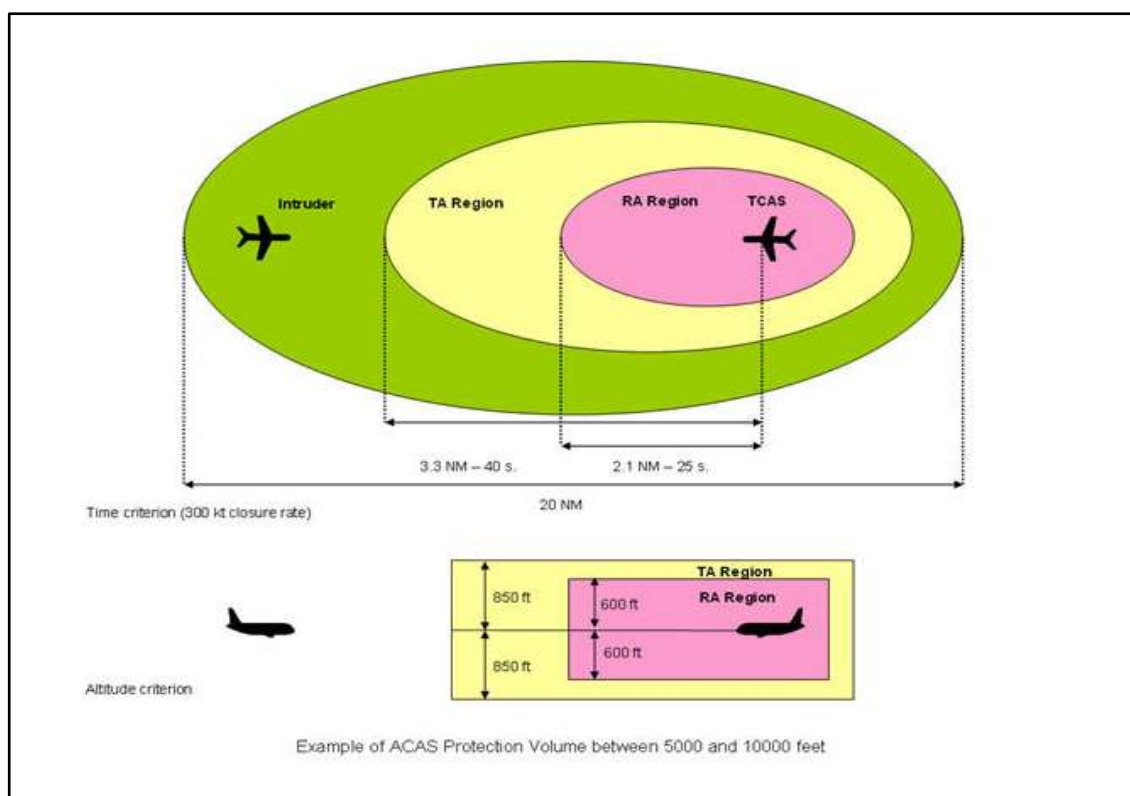
Figure 11: The TCAS detection range
(Source: Skybrary.aero – ACAS)

- A3.3 The TCAS is independent of any ground-based system and provides two types of alerts to the pilots (see Figure 11). The first alert is a traffic advisory (TA). A TA would be raised if another suitably equipped 'intruder' aircraft entered the yellow proximity zone (that is, less than 40 seconds ahead or less than 850 ft vertically from the current position of the TCAS aircraft). Then, if the intruder aircraft enters the pink oval, a Resolution Advisory (RA) alert is raised. The RA will include directions to the TCAS aircraft to climb or descend to resolve the conflict.

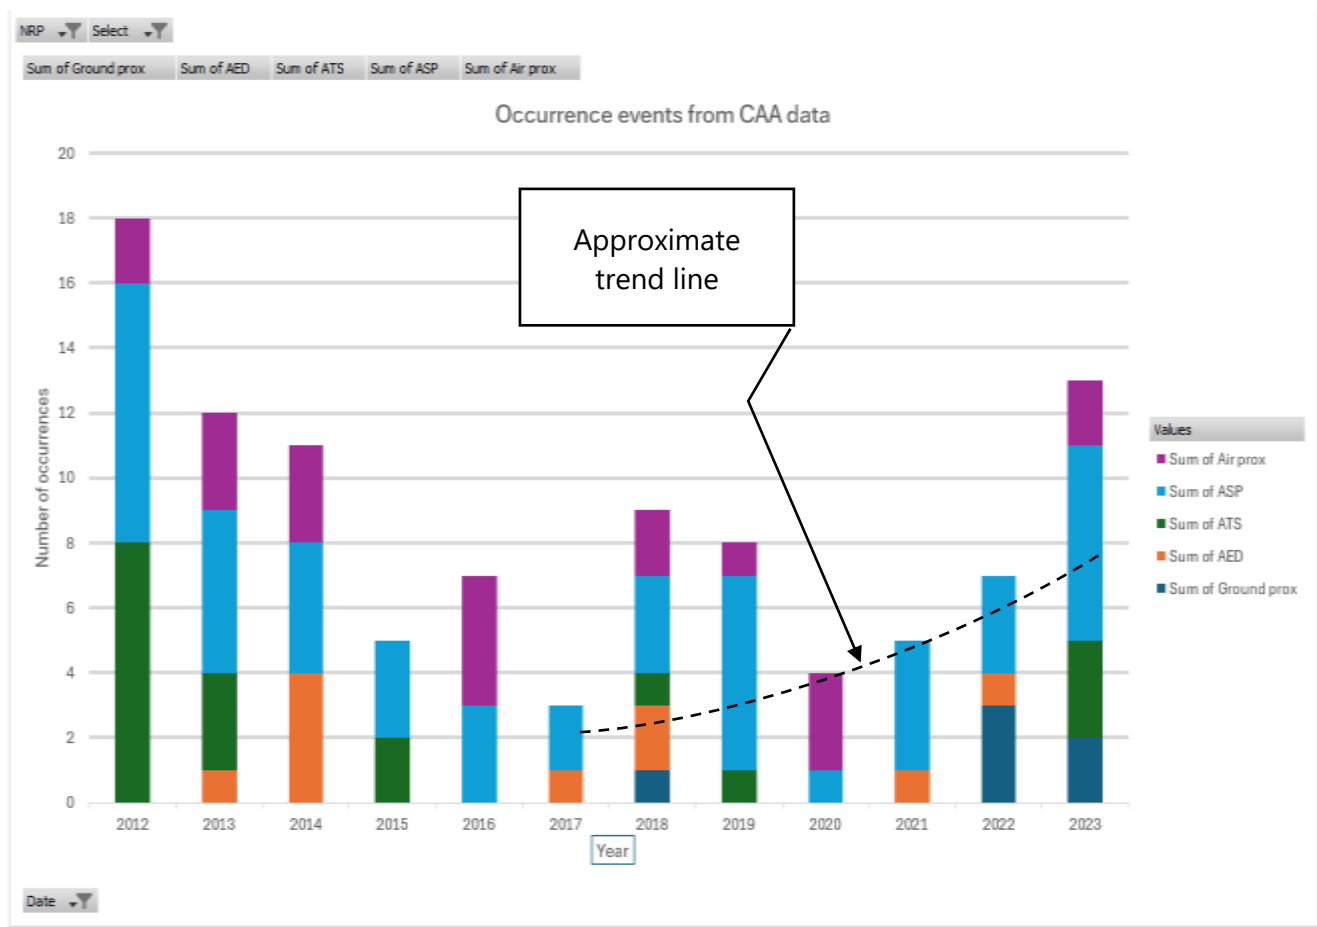
Appendix 8 Whangārei occurrence data

A8.1 This data was extracted from the CAA occurrence database file provided to the Commission, selected with Whangārei as the nearest reporting point. CAA classifications were used for initial filtering to remove accidents, bird and defect occurrences. Each of the remaining occurrence descriptions were reviewed and separately classified into the following more general groups:

A8.2 The reviewed CAA occurrence data shows that the number of reported occurrences in all these categories was high in 2012 but dropped steadily until about 2020. There was then an increase again over the pandemic period, reaching a high in 2023.

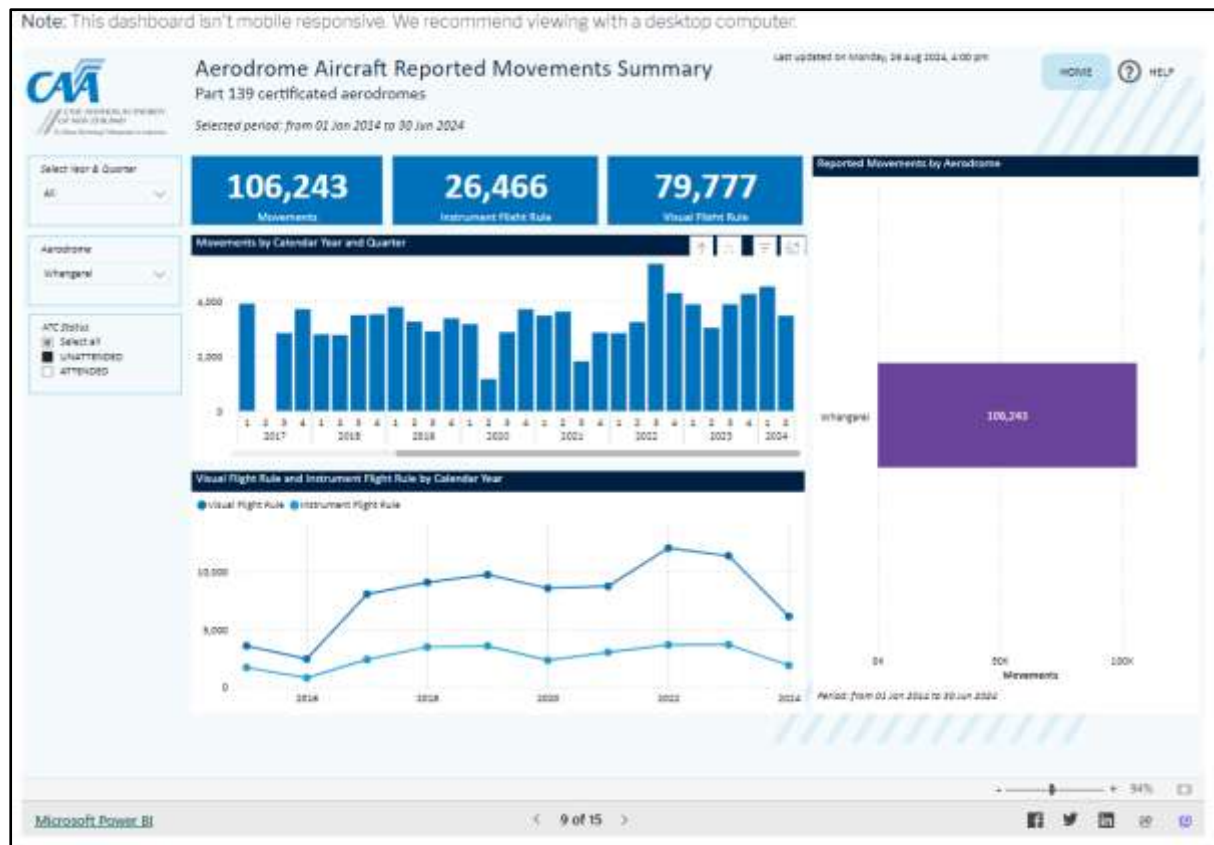
Appendix 9 Whangārei Aerodrome movements

- A9.1 This data was extracted from the CAA website occurrence database using the public dashboard interface.
- A9.2 This data shows that movements at Whangārei are about 3000 IFR flights and 9000 VFR flights each year. There is a slight trend upwards for VFR, but IFR have remained reasonable steady.
- A9.3 The VFR and IFR data do not distinguish what is different between IFR and VFR flights, or what difference that makes at this aerodrome. The aerodrome is uncontrolled and surrounded by an MBZ. All IFR procedures still require visual separation in uncontrolled airspace. So, in this instance, total flight movements are a more reliable parameter to make a comparison of traffic density.

- 3.82. Occurrence data was compared with aircraft movement data.⁵² It was found that VFR activity has increased but IFR activity has largely remained constant since 2012. Overall, there had been an increase in total aircraft movements (see Appendix 9).
