Transport Accident  
Investigation  
Commission

# **Final interim report**

***Aviation inquiry AO-2026-002***  
***Airbus AS350-B3 helicopter, ZK-IJW***  
***Collision with terrain***  
***Mt Aspiring National Park,***  
***24 kilometres west of Makarora***  
***17 May 2026***

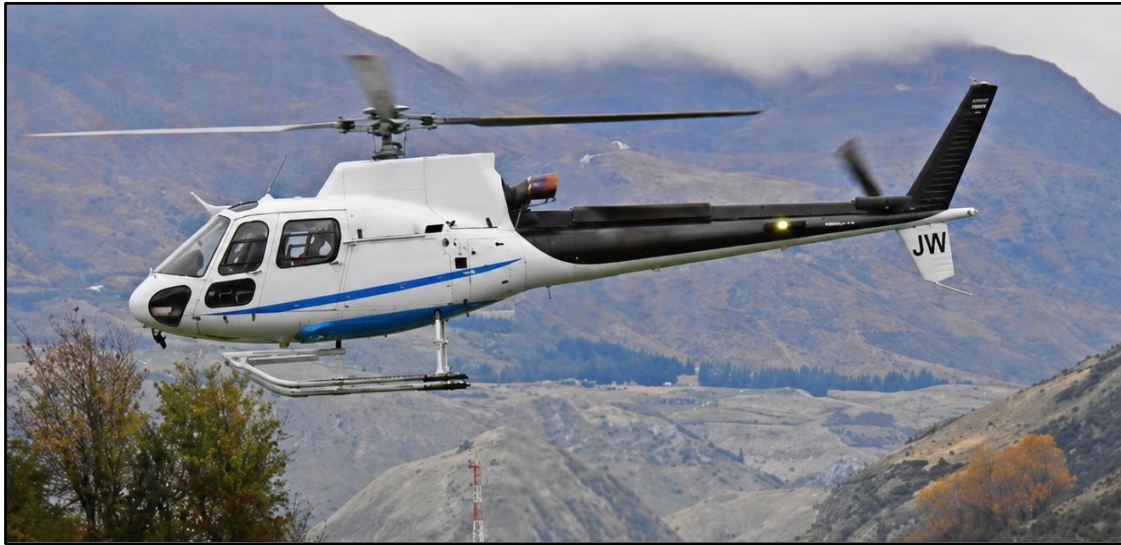
**Figure 1: Airbus AS350-B3, ZK-IJW**  
(Credit: Alpine Helicopters)

- 1.18. The accident helicopter, registration ZK-IJW, was an Airbus AS350-B3 helicopter, serial number 4735, constructed in 2009. It was powered by a Safran Arriel 2B1 turboshaft engine. The helicopter airframe hours at the time of the accident were 8618.
- 1.19. ZK-IJW was issued with a non-terminating certificate of airworthiness in the standard category. An annual review of airworthiness had been completed on 7 August 2025.

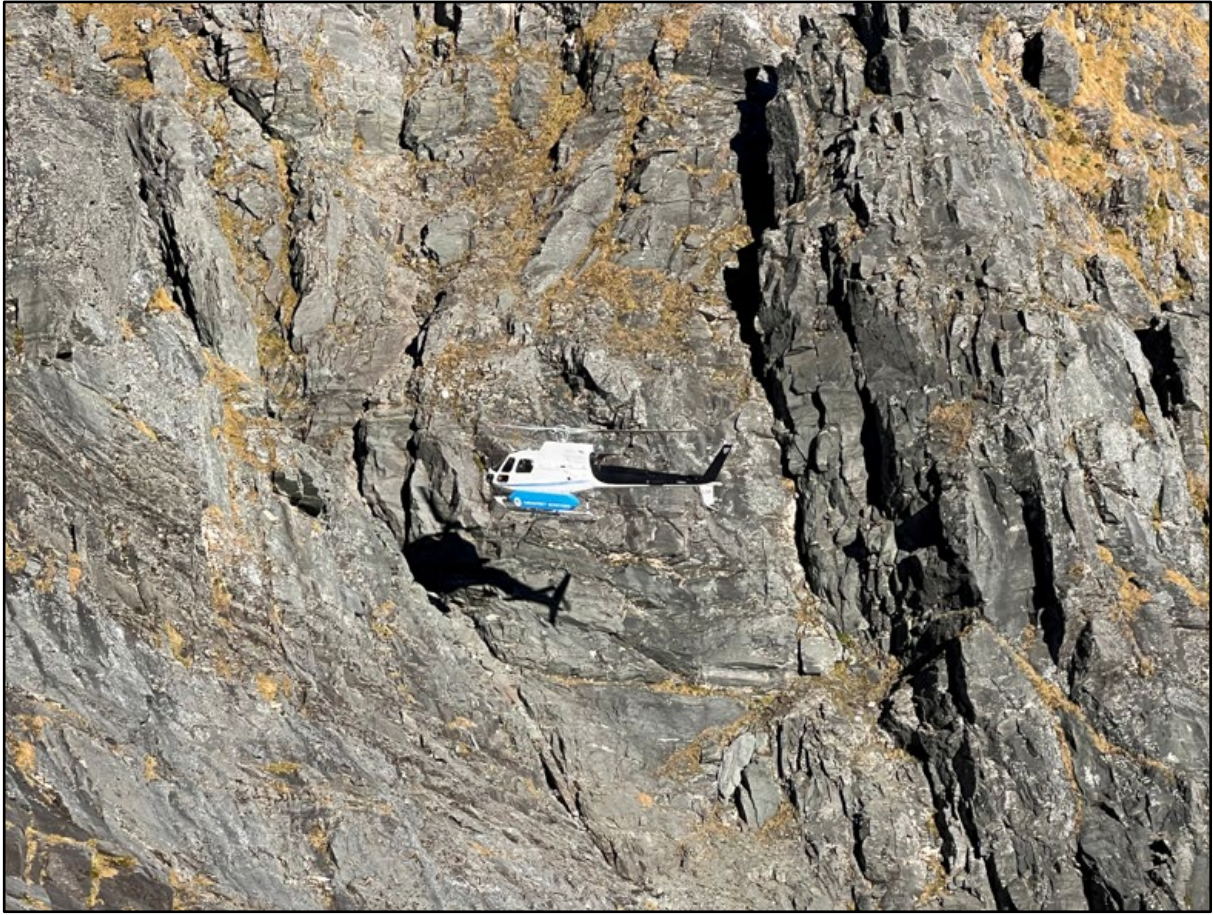
**Figure 3: Witness photograph**

- 1.10. The main rotor blades were destroyed and the accident helicopter fell about 30 metres (m) down the mountain side. The helicopter's final position was at an altitude of about 5,700 feet (ft).
- 1.11. One of the passengers from the accident helicopter was observing the recovery of the chamois and took a photograph of the accident helicopter moments before the accident (see Figure 3). They then saw the helicopter falling down the mountain face and coming to rest below (see Figure 4). The hunter and two passengers alerted the pilot and guide of the second helicopter after it landed in an area just out of view of the accident a few seconds later.

- 1.12. The cockpit camera and the photograph taken by the witness indicated that the accident occurred at 0935.
- 1.13. The second helicopter pilot then manoeuvred the second helicopter above the wreckage of the accident helicopter and was able to direct the second guide on the ground to the pilot and guide. The second guide radioed the second helicopter pilot, advising the status of the guide and the pilot and that neither had survived the accident.
