# AVIATION OCCURRENCE REPORT

01-005R Bell UH-1H Iroquois ZK-HJH, in-flight break-up, Taumarunui

4 June 2001

**Report 01-005R  
(Resumed investigation)**

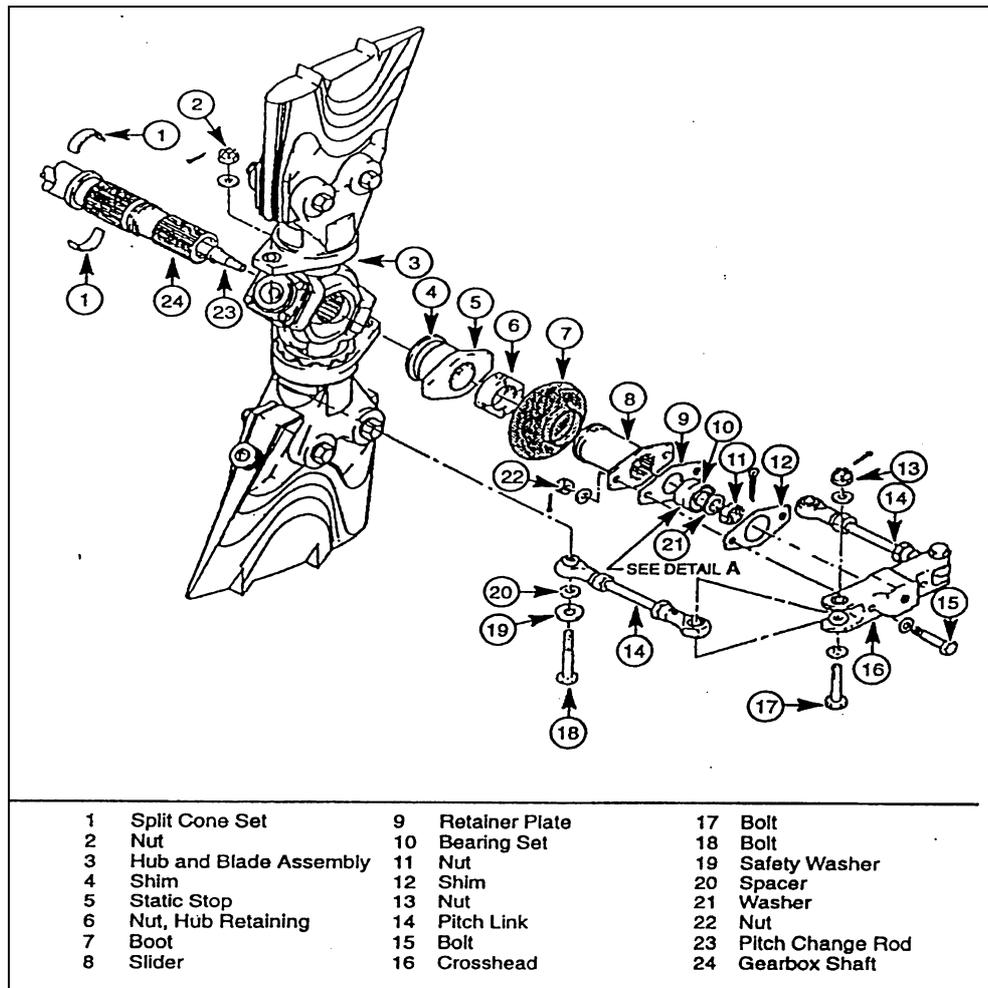
**Figure 2**  
**Bell UH-1H Iroquois tail rotor assembly**

- 1.9.9 The fin, with 90° gearbox and part of the tail rotor assembly attached, was found at about 260 m<sup>11</sup>. The fin had torn away from the boom towards the right side of the helicopter. There were crush marks along the leading edge of the fin. The 2 pitch links had broken at the jam nuts with the ball-end fittings and jam nut remaining attached to the blade grip pitch horns on the hub assembly. The stack, including the slider and retainer plate, was still attached to the hub assembly and held in place by the split (cotter) pinned nut (item 11 Figure 2).

- 1.9.14 The crosshead and the outboard segments of its 2 pitch links (see Figures 2 and 6) could not be found.

- 1.13.5 The pitch change rod (item 23 Figure 2) and stack had been bent over by about 15° at some time during the accident sequence. Some grease was still present on the slider, retainer plate and the end of the pitch change rod where the nut (item 11 Figure 2) was located.

- 1.13.6 The manufacturer also contended that if one crosshead bolt (item 15 Figure 2) came free, the second bolt assembly should continue to hold the crosshead in place for some time. If the crosshead did start to move and break free, the slider and retainer plate would be damaged in the process.

- 1.13.26 A broken section of the red tail rotor blade pitch link was attached to the tail rotor blade pitch change horn (item 14 Figure 2, and Figure 4). The pitch link had failed outboard of the jam nut where the link attached to the horn. The outer section of the link was not found, nor was the crosshead to which it attached.

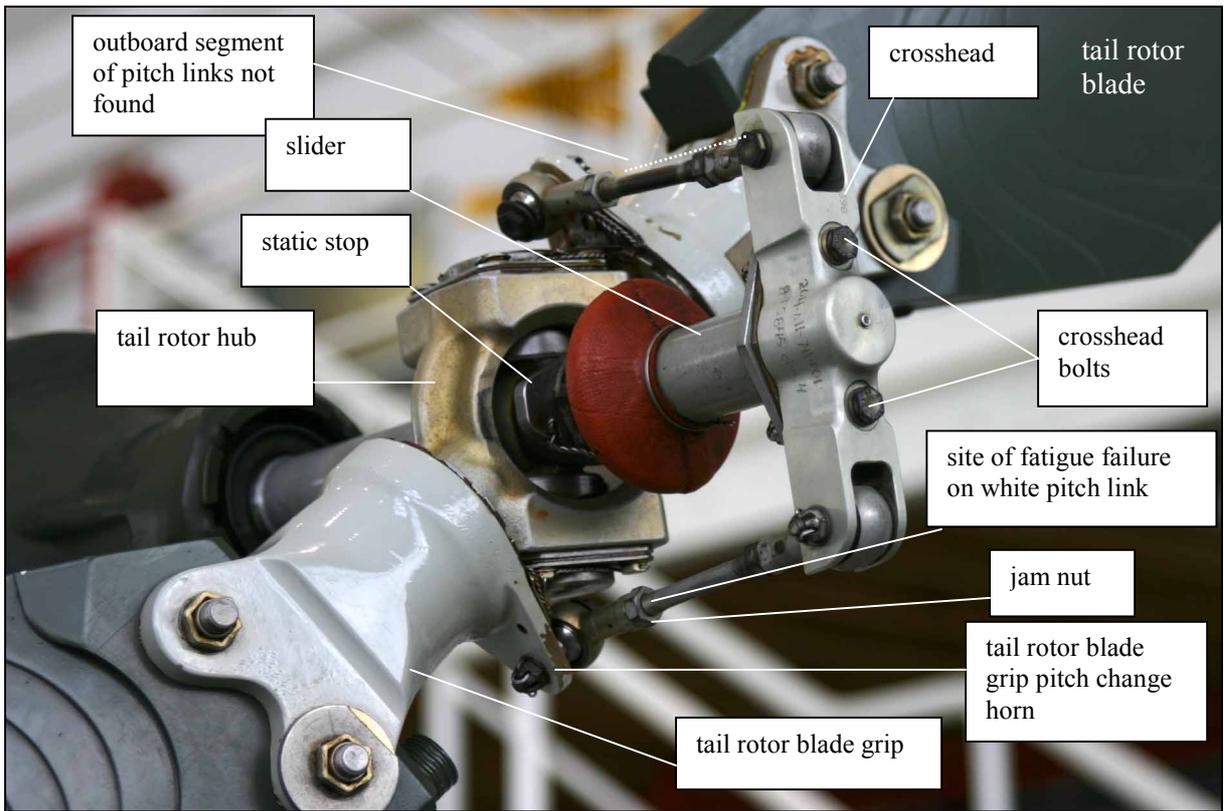
**Figure 4**  
**Typical UH-1H tail rotor hub assembly**

1.13.48 Examination of the tail rotor hub static stop (see item 5 Figure 1, Figure 4, Figure 10 and Figure 11) showed that the ear on the white tail rotor blade static stop was deformed and bent noticeably outwards, away from the fin. The white side of the tail rotor hub showed corresponding evidence that it had struck the static stop. The tail rotor hub retaining nut, which tightened against the stop, was also deformed noticeably and bent outwards. Examination showed that because of the deformation to the ear of the white blade static stop, the red tail rotor blade could contact the fin. An undamaged static stop on a correctly rigged tail rotor assembly would mechanically limit the degree of tail rotor blade flapping and prevent the tail rotor blades contacting the fin, by limiting their travel to 2.5 inches (6.35 centimetres) from the fin. Also, normal rigidity of the blades would not allow them to flex enough to strike the fin. During normal in-flight operation, the tail rotor hub would not contact the static stop.

1.13.49 Examination of the tail rotor hub crosshead slider (see item 8 Figure 2, and Figure 4) showed that the slider ear on the red tail rotor blade side, where the crosshead bolt attached, was bent outwards away from the tail rotor hub. The corresponding slider ear, on the white tail rotor blade side, was bent inwards towards the tail rotor hub (Figure 12). The retainor plate that fitted between the slider and crosshead (see item 9 Figure 2) was bowed away from the slider and had some rotational scoring marks on its outer face. The end of the pitch change rod (see item 23 Figure 1, and Figure 10), which passed through the tail rotor drive shaft and connected to the crosshead, was bent away from the red blade slider ear.
