## **Report 01-202**

### **commercial jet boat *Shotover 6***

#### **engine failure and collision with river bank**

#### **Shotover River, Queenstown**

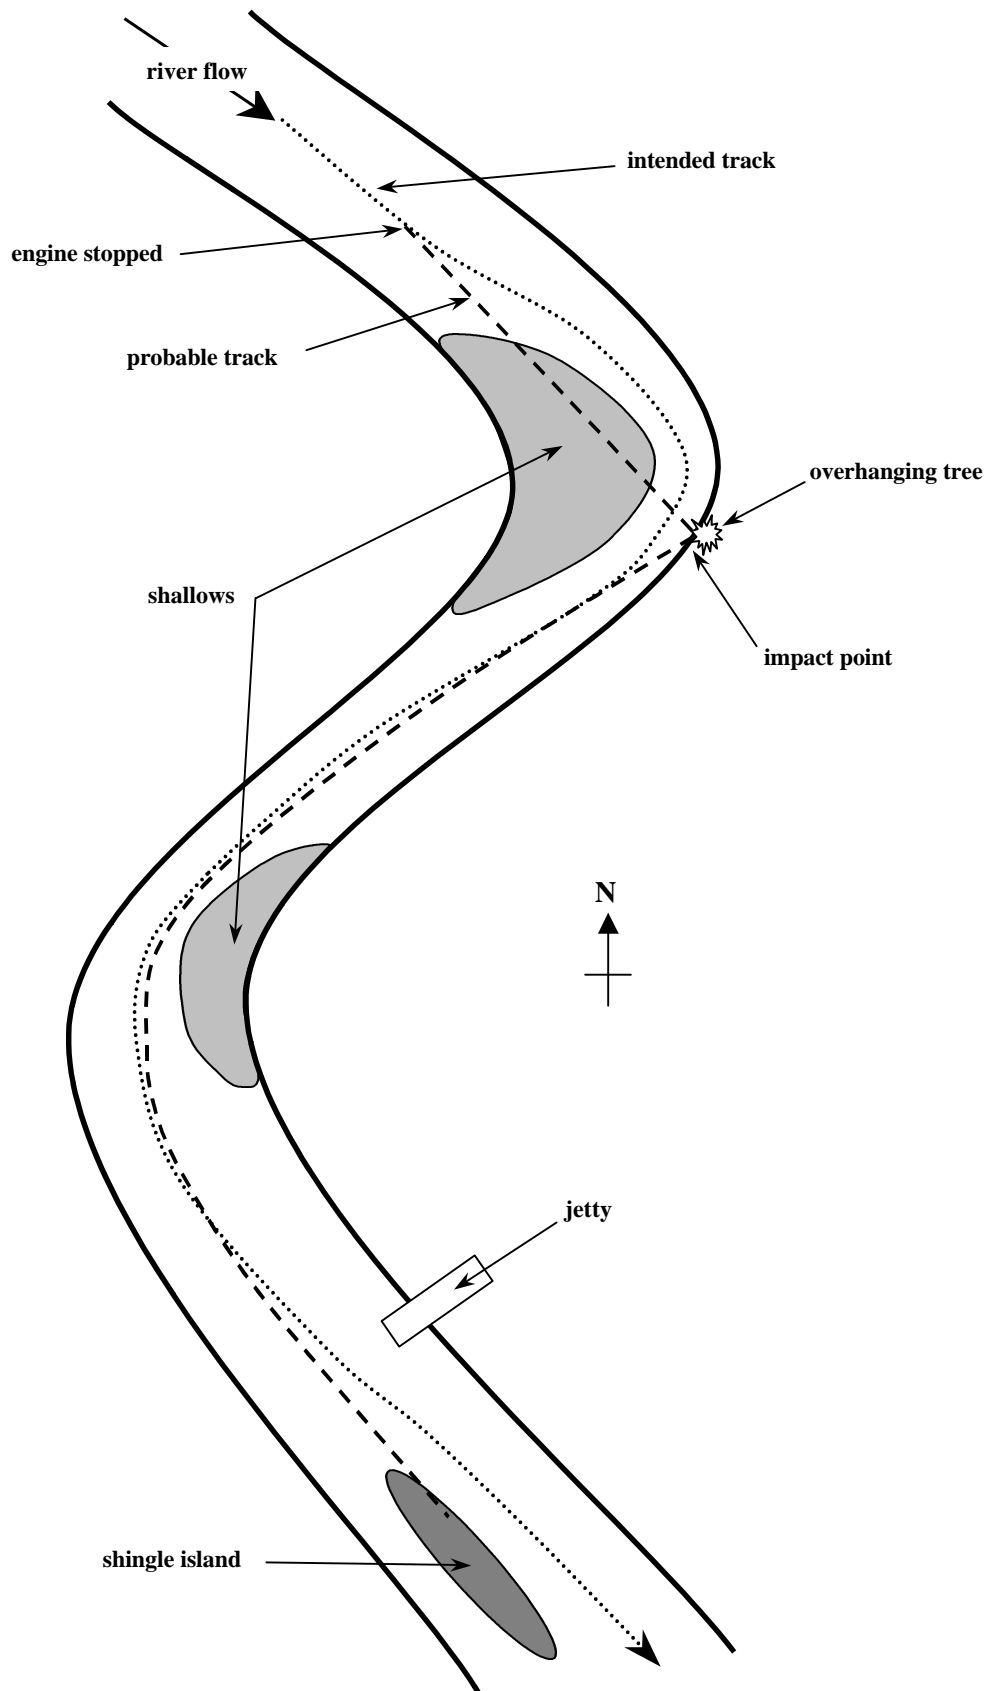
**Figure 1**  
**Drawing of accident site and surrounding area**  
**(not to scale)**

- 1.1.6 Downstream from the tunnel the path of the river followed virtually a straight line for about 800 m before it turned about 90 degrees to the right. On the true right side of the river, there was a shallow patch of shingle, which extended across the river for about three-quarters of its width. The intended path of *Shotover 6* was to the left of this shallow patch. (See Figure 1)
