MARINE OCCURRENCE REPORT

01-216

Yacht *Toolka-T* and tug and barge *Wainui* and *Sea-tow 11*,
collision, Takatu Point, north of Auckland

16 November 2001

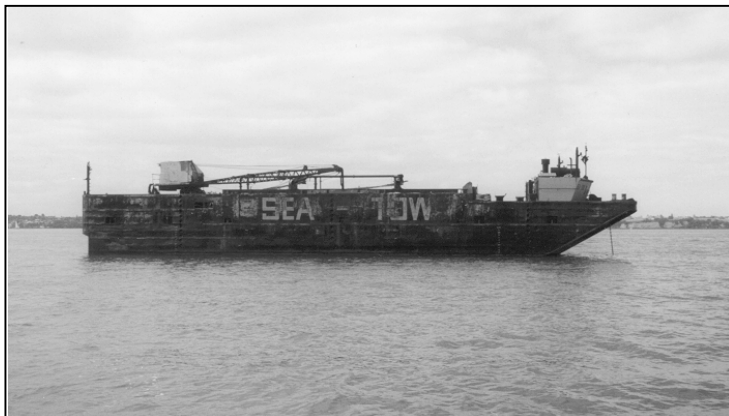
barge *Sea-Tow 11*

- 1.5.1 The barge *Sea-Tow II* suffered only minimal damage during the collision. There were witness marks on the bow of the barge showing where the *Toolka-T* had hit and been dragged under the barge. The wire bridle contained traces of metal indicating where the rigging of the yacht had struck. The towing pennant was marked with blue/green paint for about 40 m of its length (see Figure 2).
- 1.5.2 The tug *Wainui* suffered no damage during the collision. The towline, which was wound onto a towing winch, was marked with green/blue paint (see Figure 3). The paint on the towline and the barge pennant was said to match the antifouling paint of the *Toolka-T*.
- 1.5.3 The towline was attached to the bridle of another of the company's barges and stretched out. The towline was marked with the paint over a length of 53 m from where it attached to the towing pennant of the barge.
