AVIATION OCCURRENCE REPORT

02-001 Cessna 207, ZK-SEV, collision with terrain, Gertrude Saddle area
11 km southeast of Milford Sound

19 January 2002

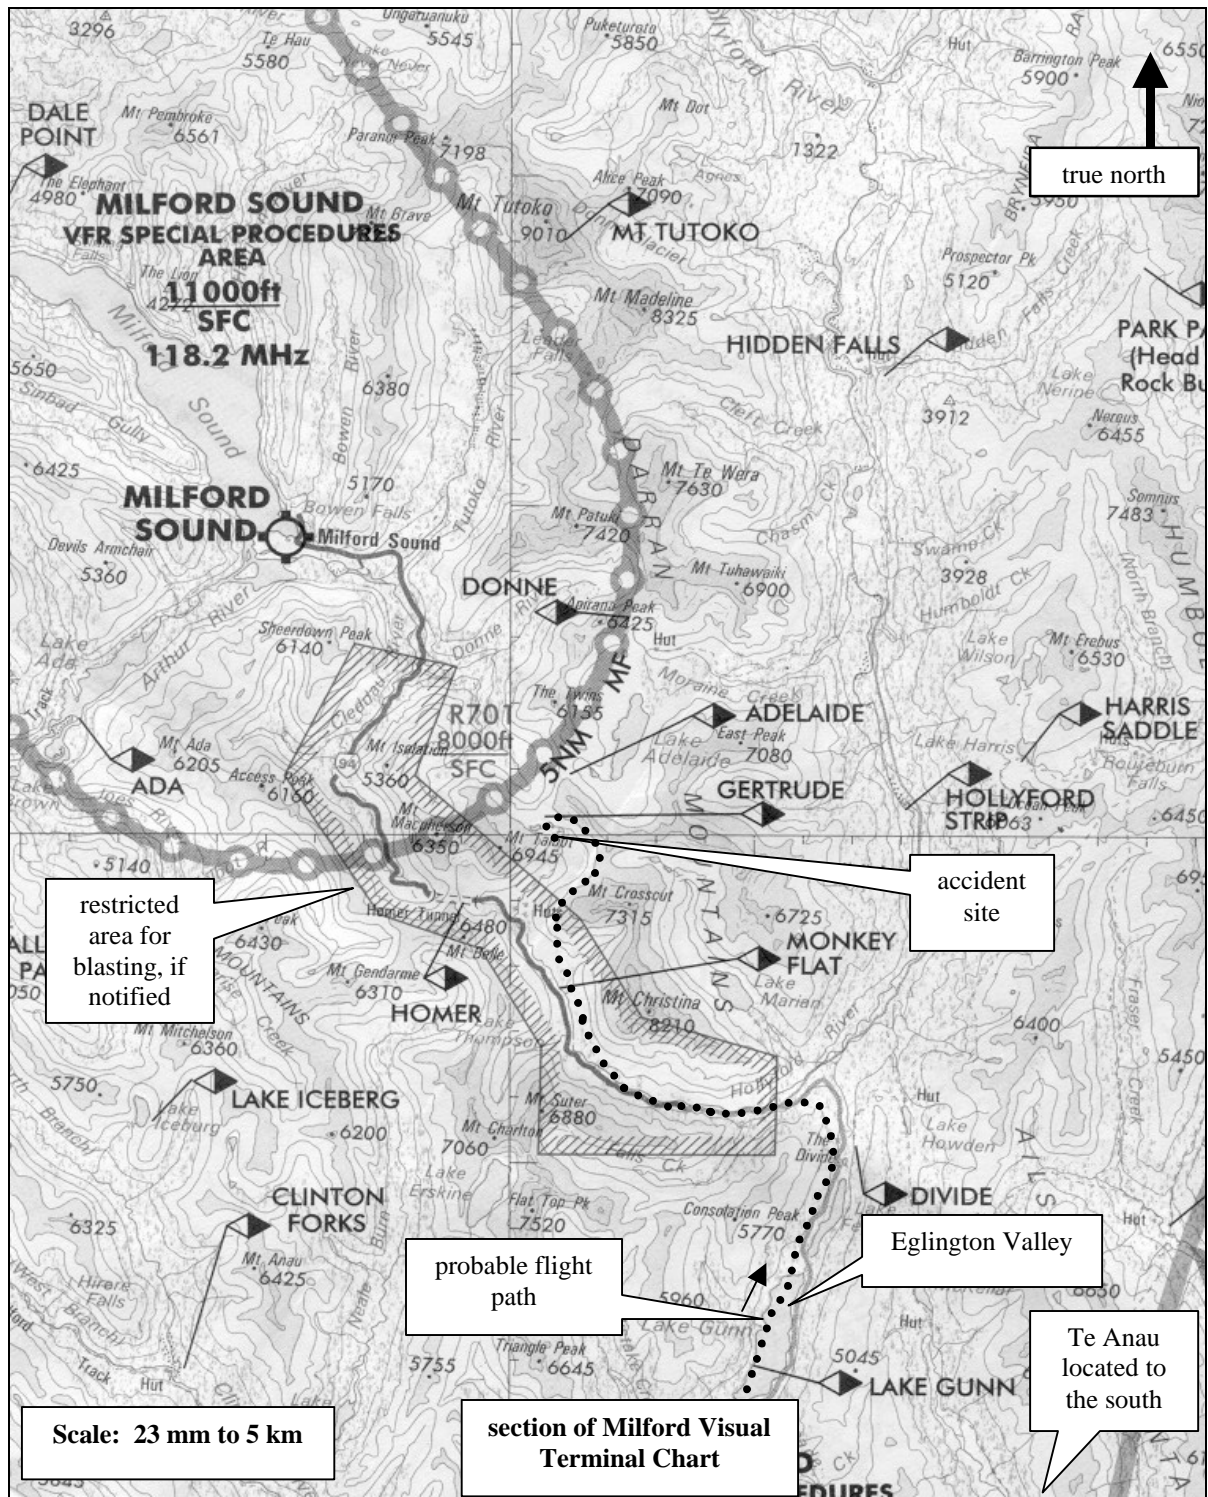
Figure 1
Route map

- 1.1.12 At Lake Gunn the lead pilot gave a position report stating he was flying toward The Divide, the next reporting point. The lead pilot could see the weather was clear to the north, along the intended route to Milford Sound, and informed the pilot. Following the report the lead pilot put his aircraft into a climb in order to gain sufficient height to safely cross the eastern passes to Milford Sound (see Figure 1 for route details).
