AVIATION OCCURRENCE REPORT

02-010

**Boeing 747-419 ZK-NBS flight NZ 2, in flight flap separation
over Manukau Harbour by Auckland International Airport**

30 August 2002

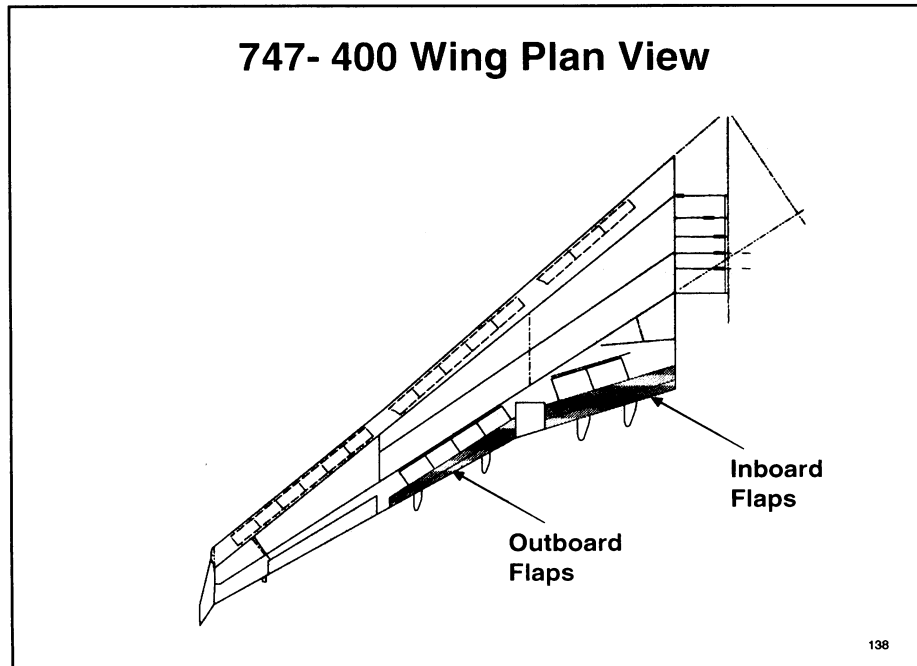
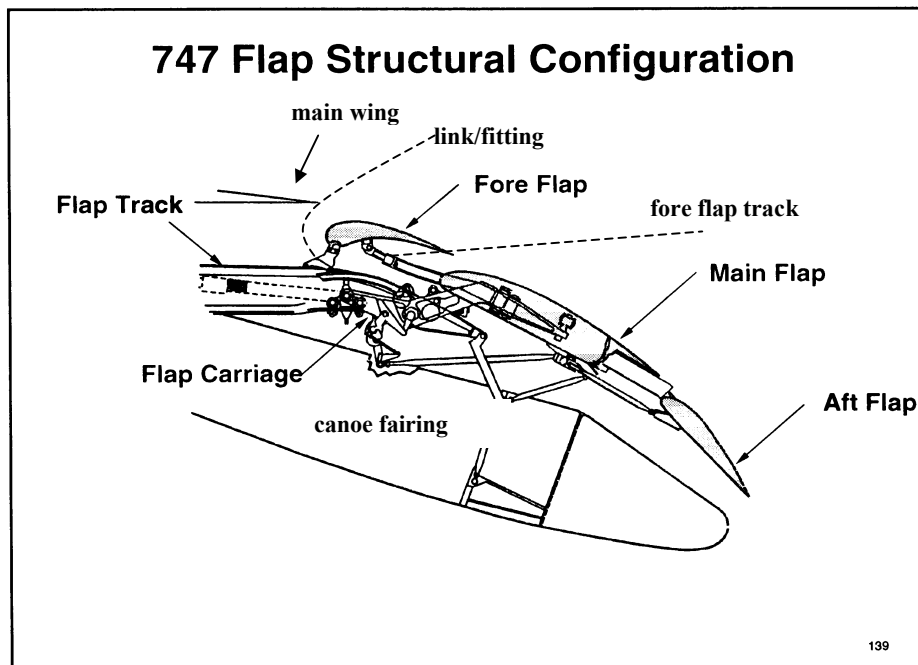
Figure 2
Boeing 747-400 trailing edge flaps

- 1.4.11 The trailing edge main flap was attached to, and supported by, 2 flap tracks in the wing by carriages (the moveable attachments between the flap and flap track), which were driven by a ball screw. The fore and aft flaps were attached to and moved with the main flap. The 3 segments were mechanically separate and formed 3 slots as the flaps extended. The flap tracks programmed the change in flap angles as the flap extended. Three fore flap (or mid flap) tracks in the main flap attached to and supported the fore flap. The front of the fore flap was attached to its respective roller carriage assembly by an inner link and an outer fitting (see Figures 2, 3 & 5).
