RAILWAY OCCURRENCE REPORT

02-110

Tranz Alpine passenger express Train 801, collision between locomotives and passenger rolling stock, Christchurch

5 April 2002

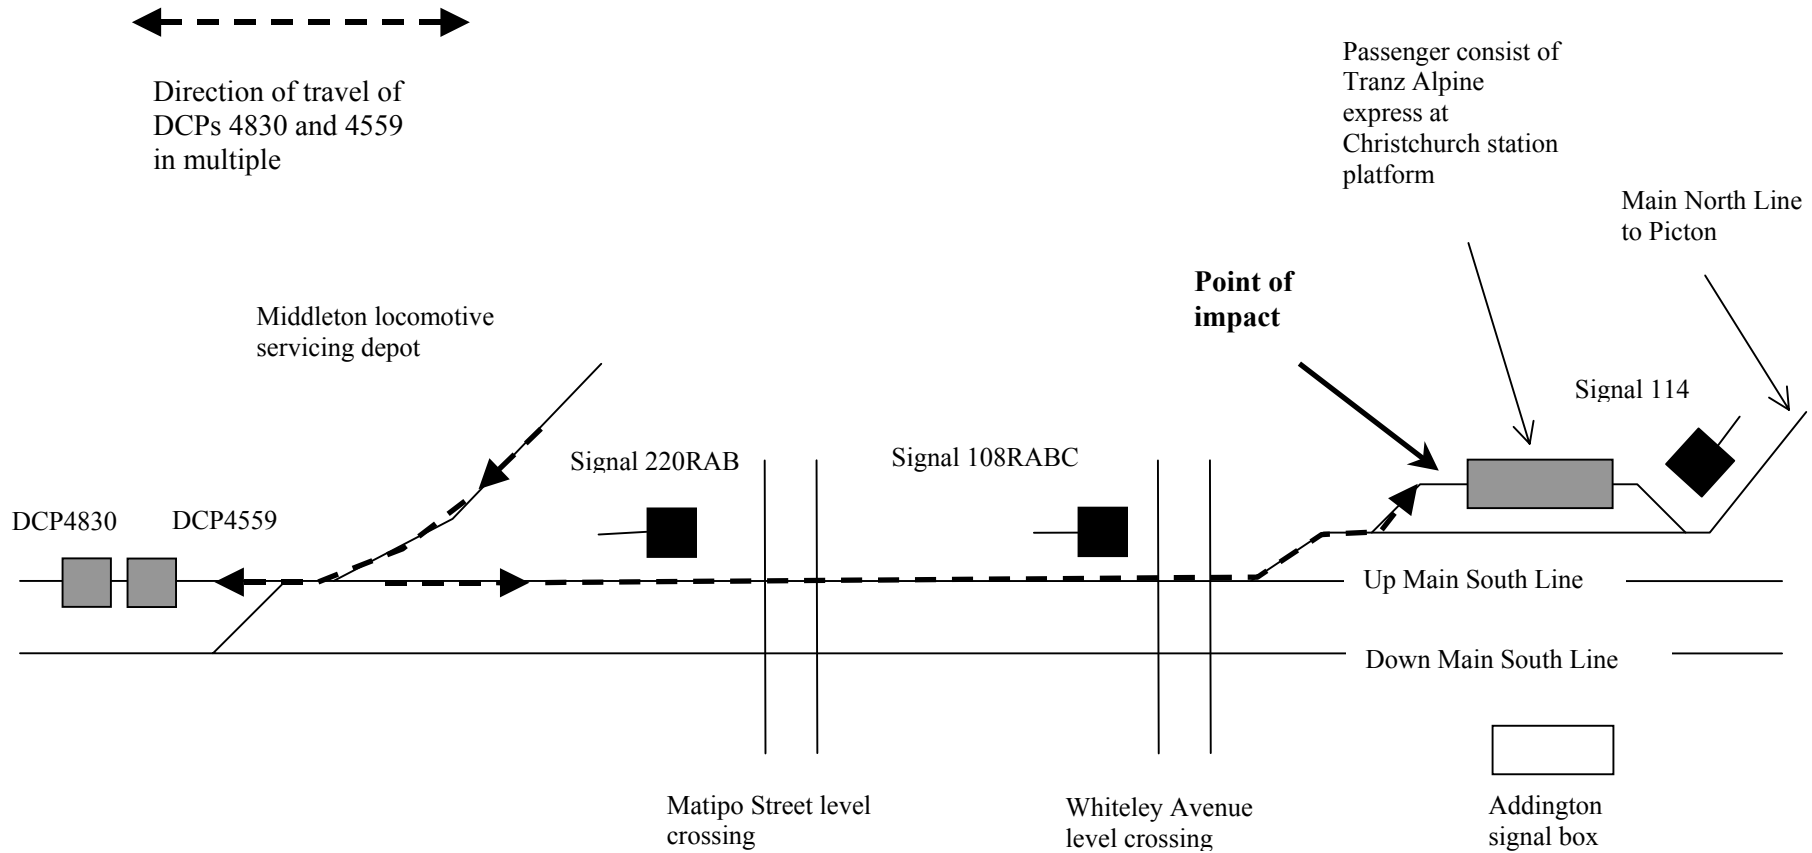
Figure 1
Route of locomotives from Middleton to Christchurch station platform
(not to scale)

- 1.1.2 The locomotives proceeded through Middleton in a southerly direction until they joined the Main South Line up main where the locomotive engineer, who was in the cab of DCP 4830, the leading locomotive, brought them to a stop. He then set up this locomotive for trail operation and moved to DCP 4559, from where he drove the locomotives in a northerly direction towards Christchurch station (see Figure 1).

- 1.2.1 The movement of the locomotives from Middleton locomotive depot to the Christchurch station platform was controlled by fixed signals operated by the signalman at the Addington signal box.
- 1.2.2 The Christchurch station platform was located adjacent to the loop road, which is connected to the Main North Line (see Figure 1). The passenger car consist overhung the south end of the platform by about 35 m.

- 1.5.1 On Saturday 6 April 2002, the day after the collision, the *Tranz Alpine* passenger express returned to Christchurch, again with DCP 4559 leading and DCP 4830 trailing. The 2 locomotives were cut off from the passenger cars and departed via the north end of the loop on to the main north line (see Figure 1).
